**Report on the Recent Fatal Accidents at Fukushima Daiichi and Daini, and on the Serious Injury at Kashiwazaki-Kariwa, and on Efforts to Prevent Future Serious Accidents**

**March 30, 2015**

**Nuclear Power & Plant Siting Division  
Fukushima Daiichi D&D Engineering Company**

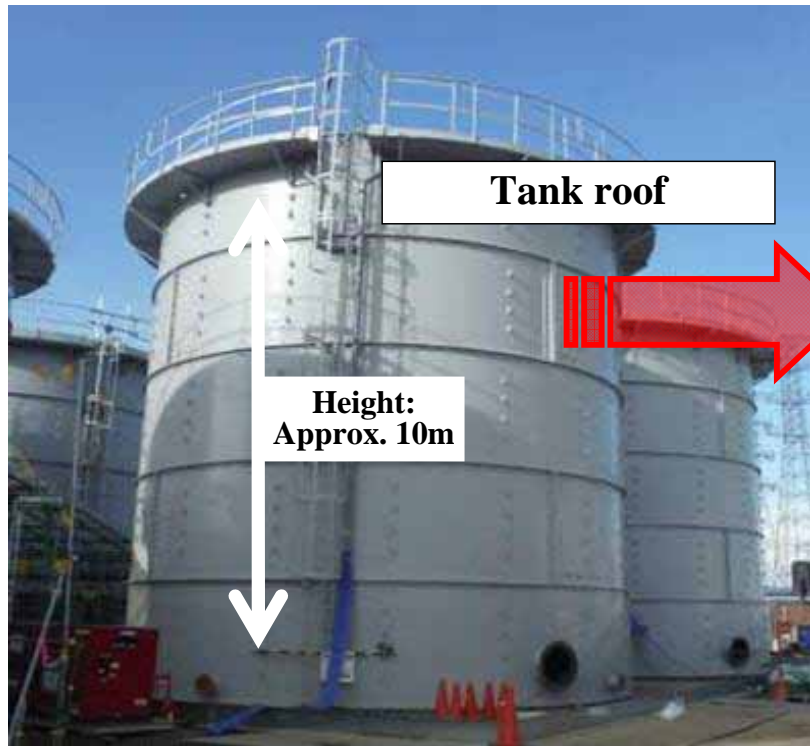
- **Date:** January 19, 2015 around 9:06 AM
- **Place:** Rain collection tank No. 2 (East side of No. 4 underground reservoir area)
- **Workers:** 3 (1 TEPCO employee, 2 contractor employees)
- **Equipment:** Tyvek suits, full face masks, helmets, safety boots, gloves (two pairs: rubber gloves and cotton gloves), safety belt
- **Situation:** During on-site rain collection tank installation the contractor fell from the roof of the aforementioned tank (Approx. 10 m) when making preparations to inspect the inside of the tank after water filling tests. The worker was rushed to the on-site emergency medical center and then to a hospital for further treatment at 10:31 AM on the same day but was pronounced dead by a physician at 1:22 PM on the following day (20<sup>th</sup>) after all treatment options had been exhausted.

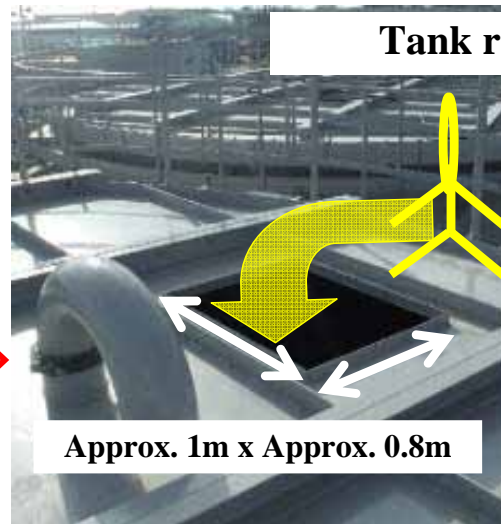
Tank roof

Causes	Countermeasures
<p><i>Design:</i></p> <ul style="list-style-type: none"> <li>•The design of the hatch on the roof of the tank allowed the hatch cover to fall through</li> </ul>	<ul style="list-style-type: none"> <li>•Hatch lids on tanks to be built will be designed so that they cannot fall</li> </ul>
<p><i>Communications/Training:</i></p> <ul style="list-style-type: none"> <li>•There is insufficient sharing of information about similar incidents (Falling of Unit 5/6 Area F tank hatch lid)</li> <li>•No actions were taken to predict dangers or ensure safety.</li> <li>•Independent worker action was not stopped</li> </ul>	<ul style="list-style-type: none"> <li>•Improvements shall be made to how operational experience data is used, in sharing information with other power stations, in safety management, and in the degree of TEPCO's involvement in safety of contractors' work.</li> <li>•Contractors shall implement safety education about the risk of injuries from falls for all employees and workers, and will train workers on how to use their experience to increase awareness of possible risks.</li> <li>•TEPCO shall leverage safety information (such as nonconformity information), operational experience information, and accident information, in order to improve danger prediction and safety awareness. We will also use countermeasures on a daily basis.</li> </ul>

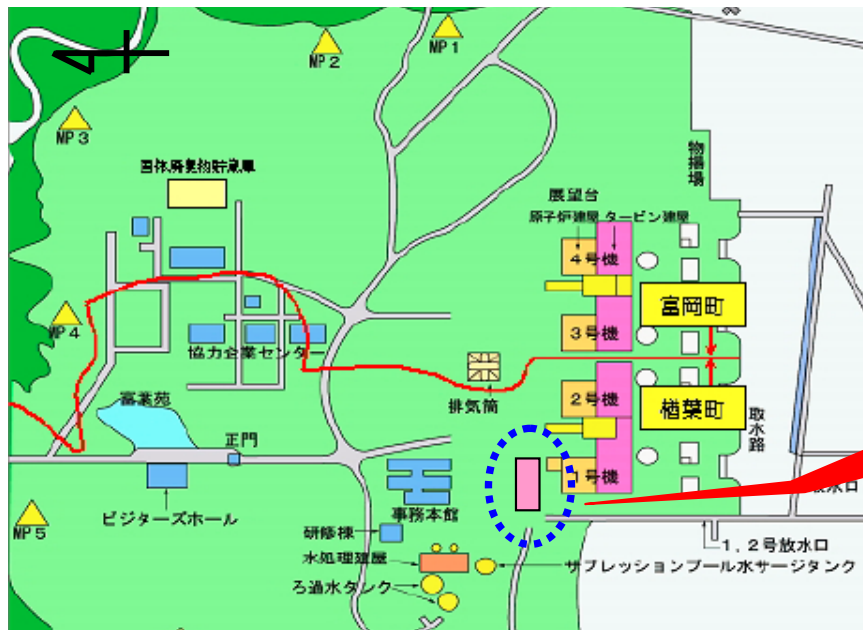
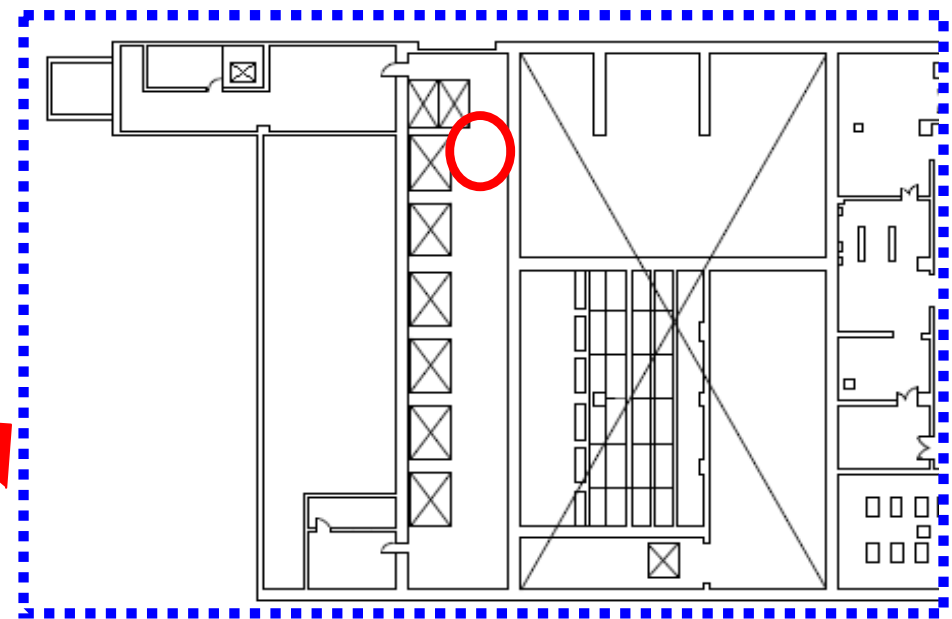
Diagram of 5<sup>th</sup> floor of Unit 1/2 waste disposal building

- **Date:** January 20, 2015 at approximately 9:30 AM
- **Place:** 5<sup>th</sup> floor (controlled area) of Unit 1/2 waste disposal building
- **Workers:** 6 contractor employees, however, only one was working when the accident occurred
- **Equipment:** Work clothes for Area C, Tyvek suits, helmets, work boots, gloves (two pairs: cotton gloves and rubber gloves)
- **Situation:** When one of the contractors who was inspecting equipment for concentrating and reducing the volume of radioactive waste liquid was loosening the bolts/nuts that anchor the receiver\* to the frame the receiver rolled thereby crushing the worker's head between the receiver and the frame. The worker was immediately transported by ambulance and helicopter to the nearest hospital at 10:48 AM but was pronounced dead by a physician at 11:57 AM on the same day.

\* When inspecting equipment for concentrating and reducing the volume of radioactive waste this receiver must be turned on its side using the aforementioned frame

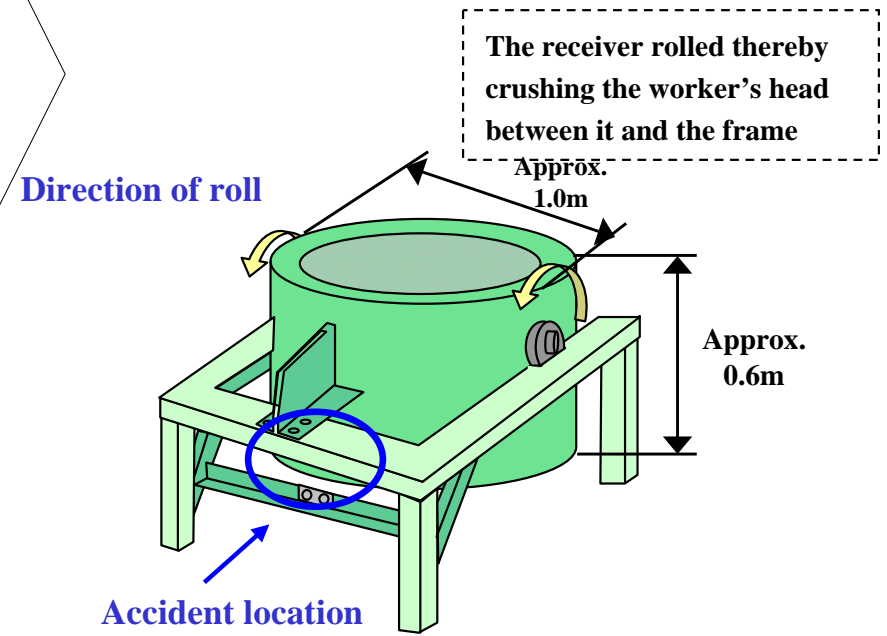
Situation after the accident

Causes	Countermeasures
<p><b><i>Design:</i></b></p> <ul style="list-style-type: none"> <li>•The frame was designed so that a worker needed to get under the receiver in order to loosen and tighten the anchor bolts.</li> </ul>	<ul style="list-style-type: none"> <li>•The frame will be modified so that a worker does not need to get under the receiver when loosening or tightening the anchor bolts</li> </ul>
<p><b><i>Communications/Training:</i></b></p> <ul style="list-style-type: none"> <li>•The danger of getting sandwiched between the frame and the receiver when the anchor bolts are removed was recognized but there were no warning signs mentioning it.</li> <li>•Methods for using the framework were not conveyed to all workers during TBM-KY. (TBM-KY is a “tool box meeting” prior to work that involves <i>kiken-yochi</i>, the effort to predict danger or risk.)</li> <li>•Contractor workers were not thinking for themselves and failed to think together about serious risks due to a lack of substance in TBM-KY activities.</li> </ul>	<ul style="list-style-type: none"> <li>•Warning signs will be posted to prevent people from unnecessarily getting under the frame or receiver.</li> <li>•During TBM-KY the methods for using the frame and receiver will be explained using detailed written materials</li> <li>•TEPCO supervisors will participate in TBM-KY for dangerous work, (such as work involving heavy equipment) and guidance from the supervisor will be reported to the group manager</li> <li>•It will be made sure that all workers participate in TBM-KY and TEPCO will train the workers so that each participant voices one area of caution or potentially dangerous location that has not been otherwise mentioned</li> </ul>

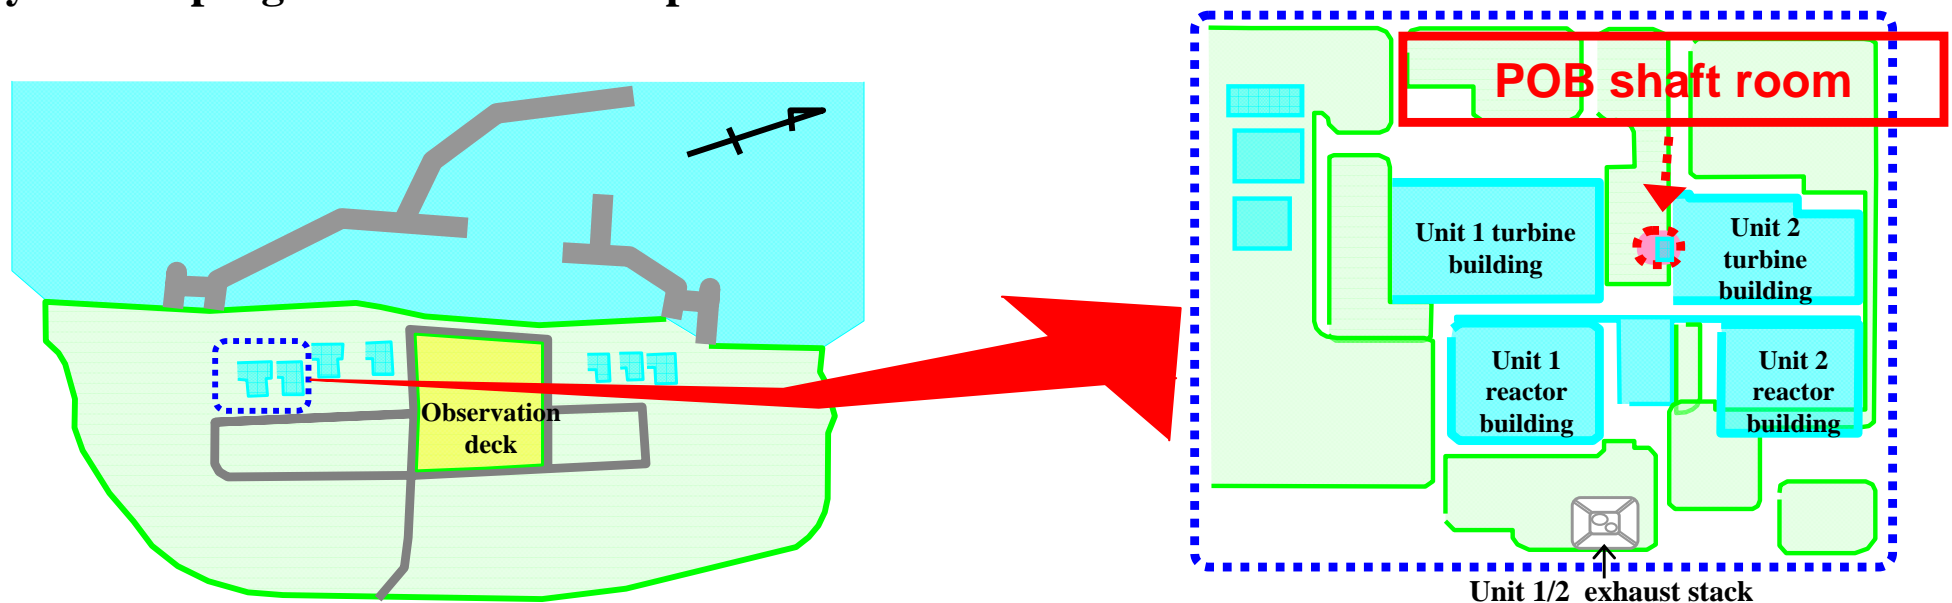
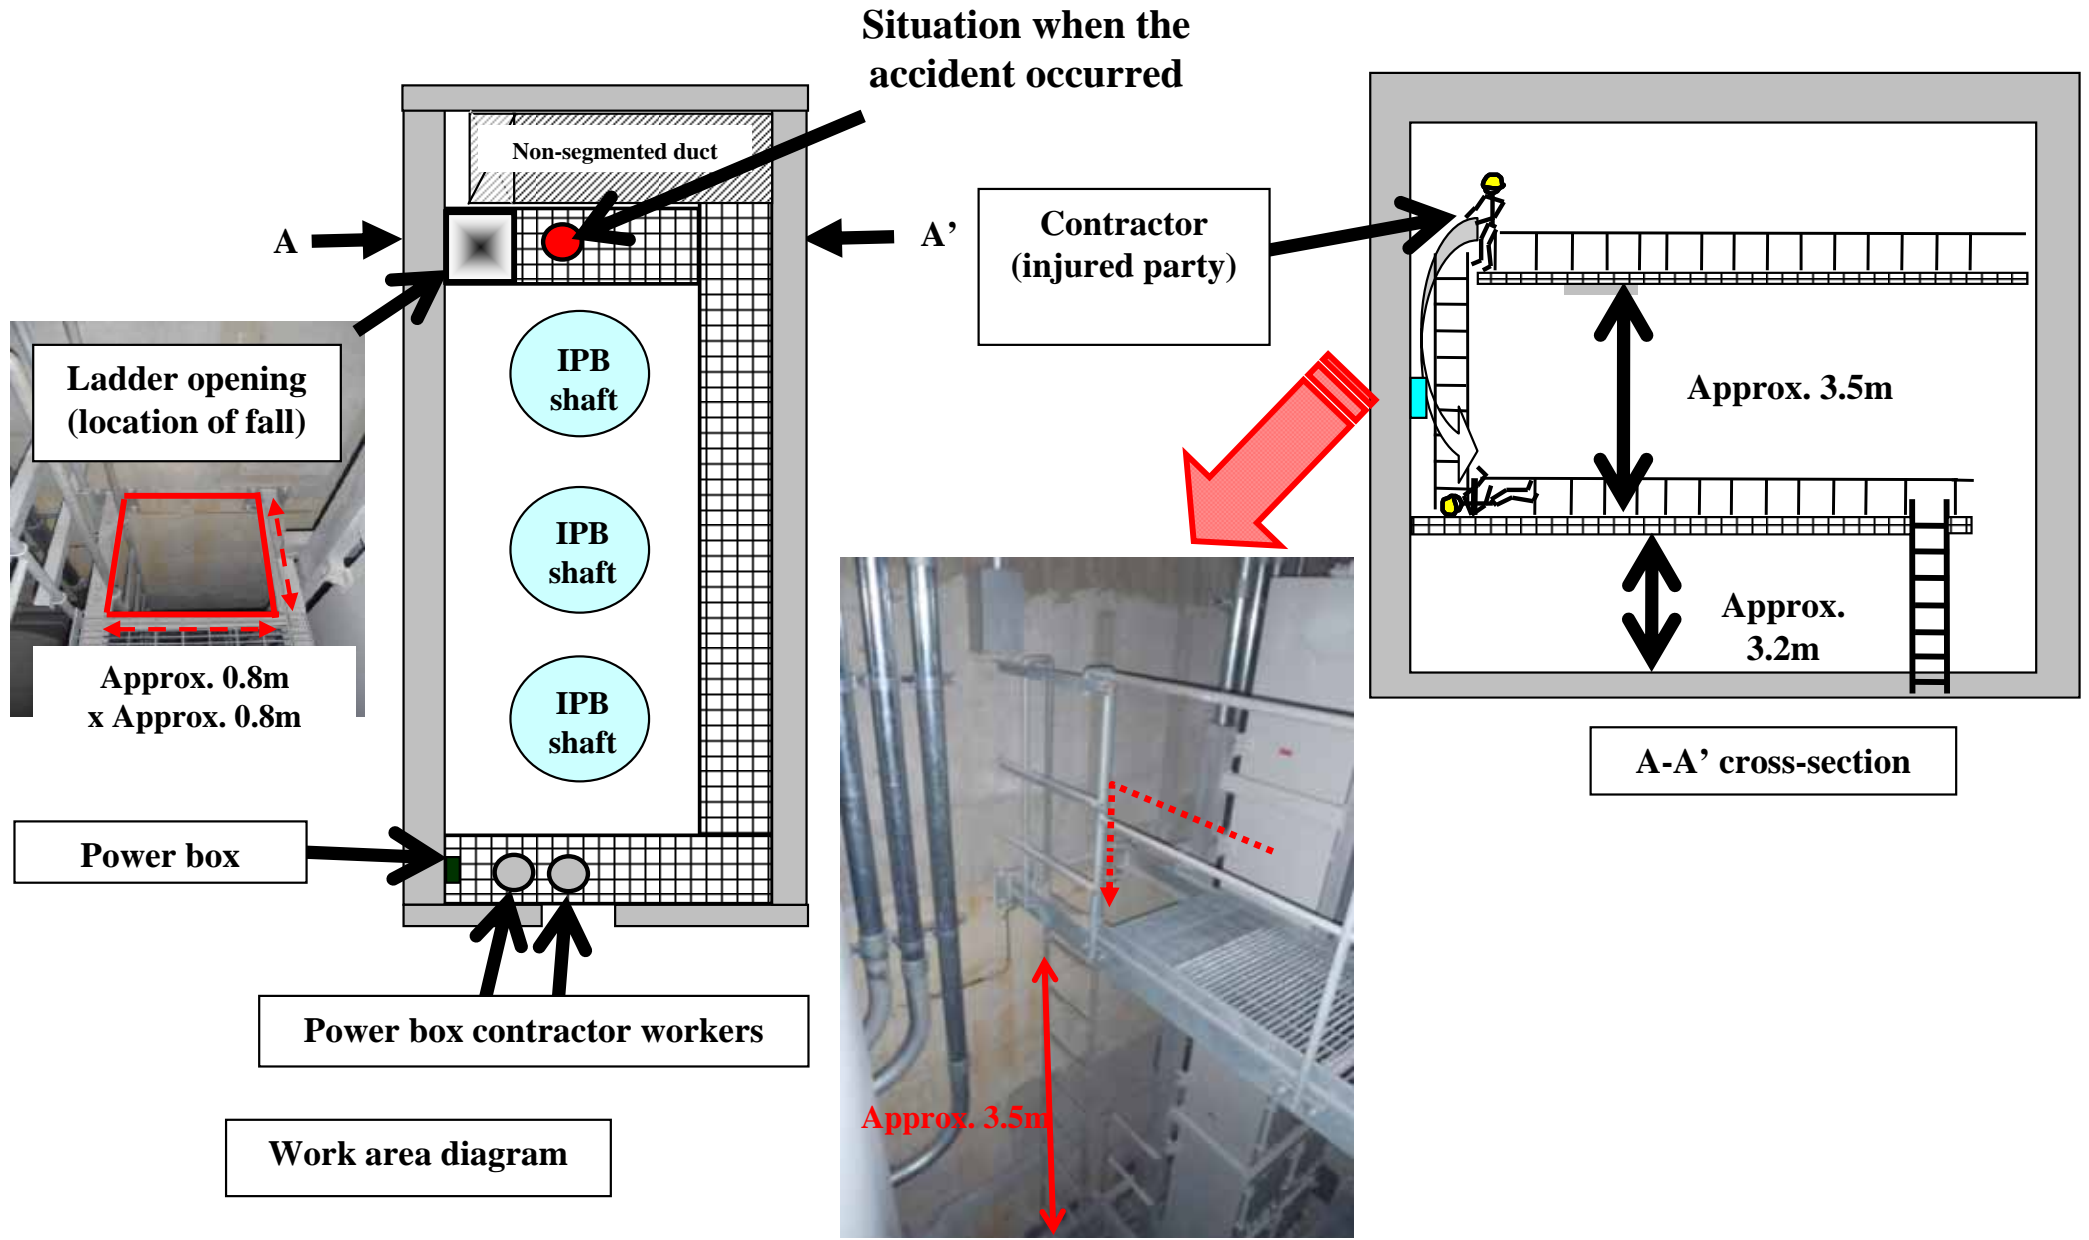
- **Equipment:** helmet, headlamps, flashlights, work boots, gloves
- **Situation:** A contractor inspecting the work power box fell approximately 3.5 m through the opening in a grate when taking pictures of a location different from that of the aforementioned work. No power was being provided to the lighting in the aforementioned room for safety reasons (the lights were not on) so the door was opened to allow natural light to enter and headlamps and flashlights were being used when performing the aforementioned work, however when taking photographs the worker shut off his headlight because it was reflecting too much. An ambulance was called and the worker was rushed to a nearby hospital at 3:55 PM on the same day. The physician's prognosis called for hospitalization for three months.

Causes	Countermeasures
<p><i>Design</i></p> <ul style="list-style-type: none"> <li>• There were no countermeasures (chain) to prevent falling through the hatch</li> <li>• The hatch was not covered (demarcated/lid, etc.)</li> </ul>	<ul style="list-style-type: none"> <li>• Measures to prevent falling through the hatch will be implemented.</li> <li>• Measures for preventing falling through hatches will be immediately implemented in all locations for which they have yet to be implemented</li> </ul>
<p><i>Communications/Training</i></p> <ul style="list-style-type: none"> <li>• Unplanned work was performed alone</li> <li>• Risks (open hatch nearby) were not sufficiently identified during TBM-KY</li> </ul>	<ul style="list-style-type: none"> <li>• Rules will be clarified to stipulate that indirect work, such as photography, performed by the contractor work foreman or quality management officer should be positioned as part of the work</li> <li>• The implementation period and scope of TBM-KY shall be clarified and TBM-KY shall be developed further by proactively using information on accidents</li> <li>• Education shall be revised to improve KY skills</li> </ul>

<p><i>Safety Procedures/Rules</i></p> <ul style="list-style-type: none"> <li>• Safety belts were not used, in violation of existing rule</li> <li>• Work was performed in a location that was not managed for safety (dark, high)</li> </ul>	<ul style="list-style-type: none"> <li>• TEPCO supervisors and the contractor officials that are active in different areas shall carry a safety belt with them so that they are prepared for changing work environments and conditions</li> <li>• Field danger factors will be identified and improved</li> </ul>

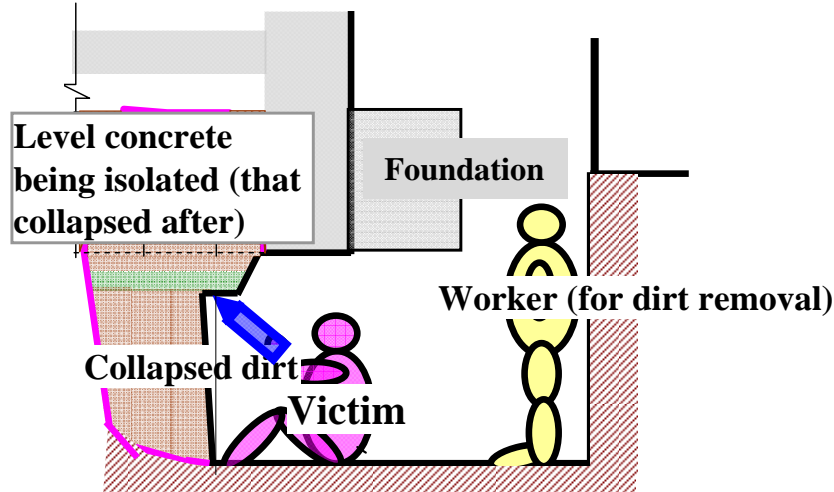
March 28, 2014: Worker is buried alive when dirt collapses

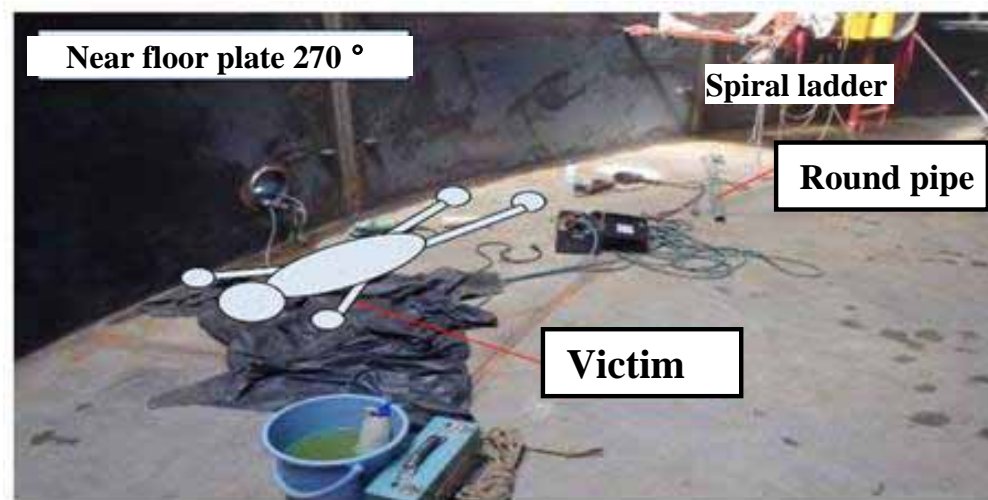
September 20, 2014: Round pipes fall injuring worker

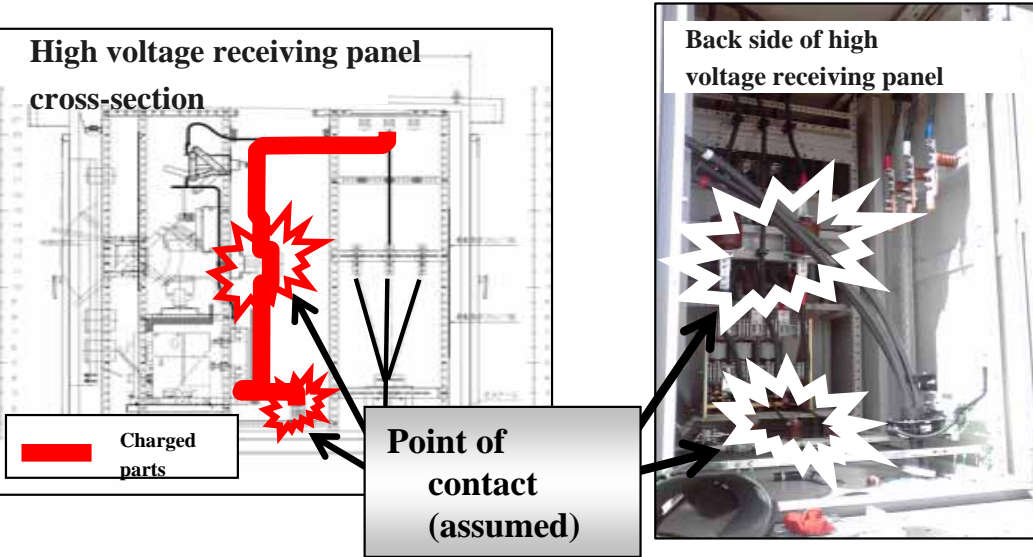
September 30, 2014: Worker is injured when electrocuted by new office building power source (6.9kV)

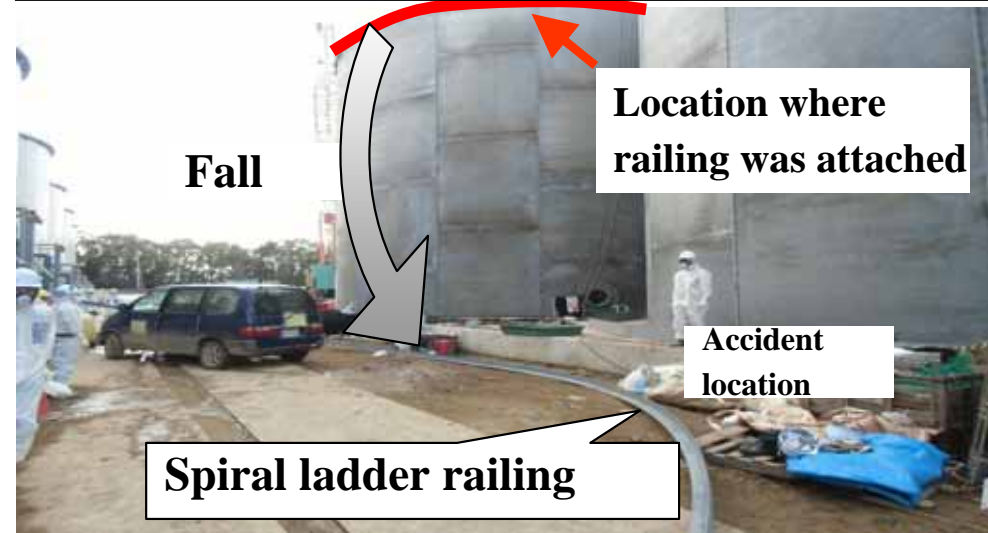
January 17, 2014: Worker injured when railing falls from spiral ladder
