# Report on the Investigation and Study of Unconfirmed/Unclear Matters

## Progress Report No.2

August 6, 2014

Tokyo Electric Power Company, Inc.

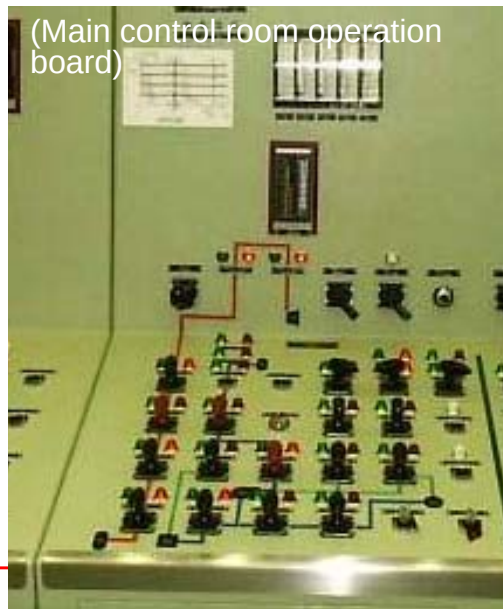
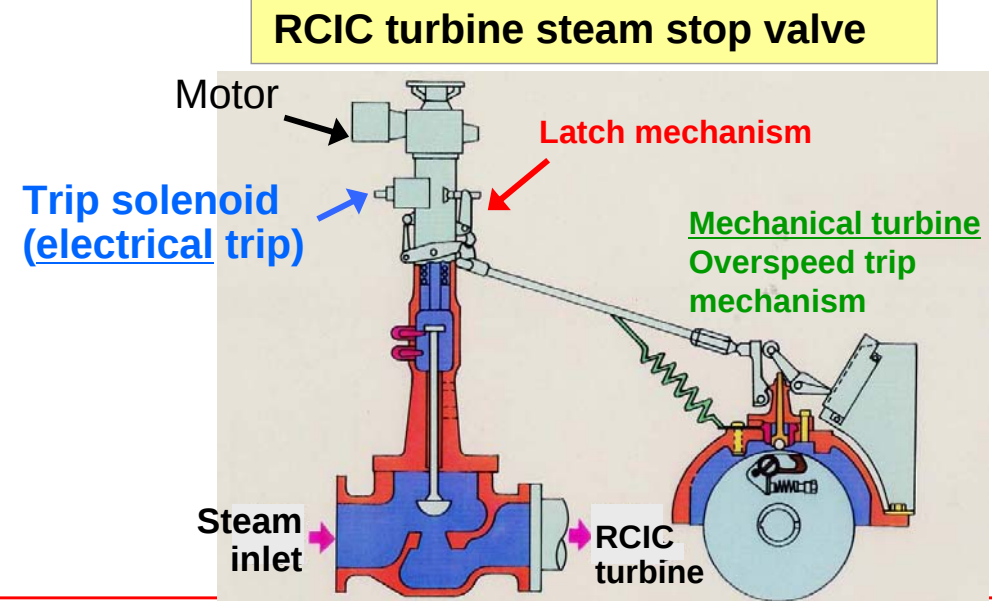
Based on the state of operations in the main control room and on conditions verified in the field, we believe that an electrical trip occurred.

- We found that the turbine's steam stop valve, which has a trip mechanism, was closed, causing shutdown.
- After shutdown, the stop valve was reset from the main control room in order to switch to standby (the mechanical turbine overspeed trip that would have been necessary for in-field reset operations was not triggered).
- As of the shutdown of 3/12, the main control room allowed RCIC valve operation and monitoring of condition indicator lamps and meters, and the DC power source required for triggering an electrical trip had been secured.
- Restarting after reset operations was followed by another stop valve shutdown and trip (the cause of the trip may have been the same).

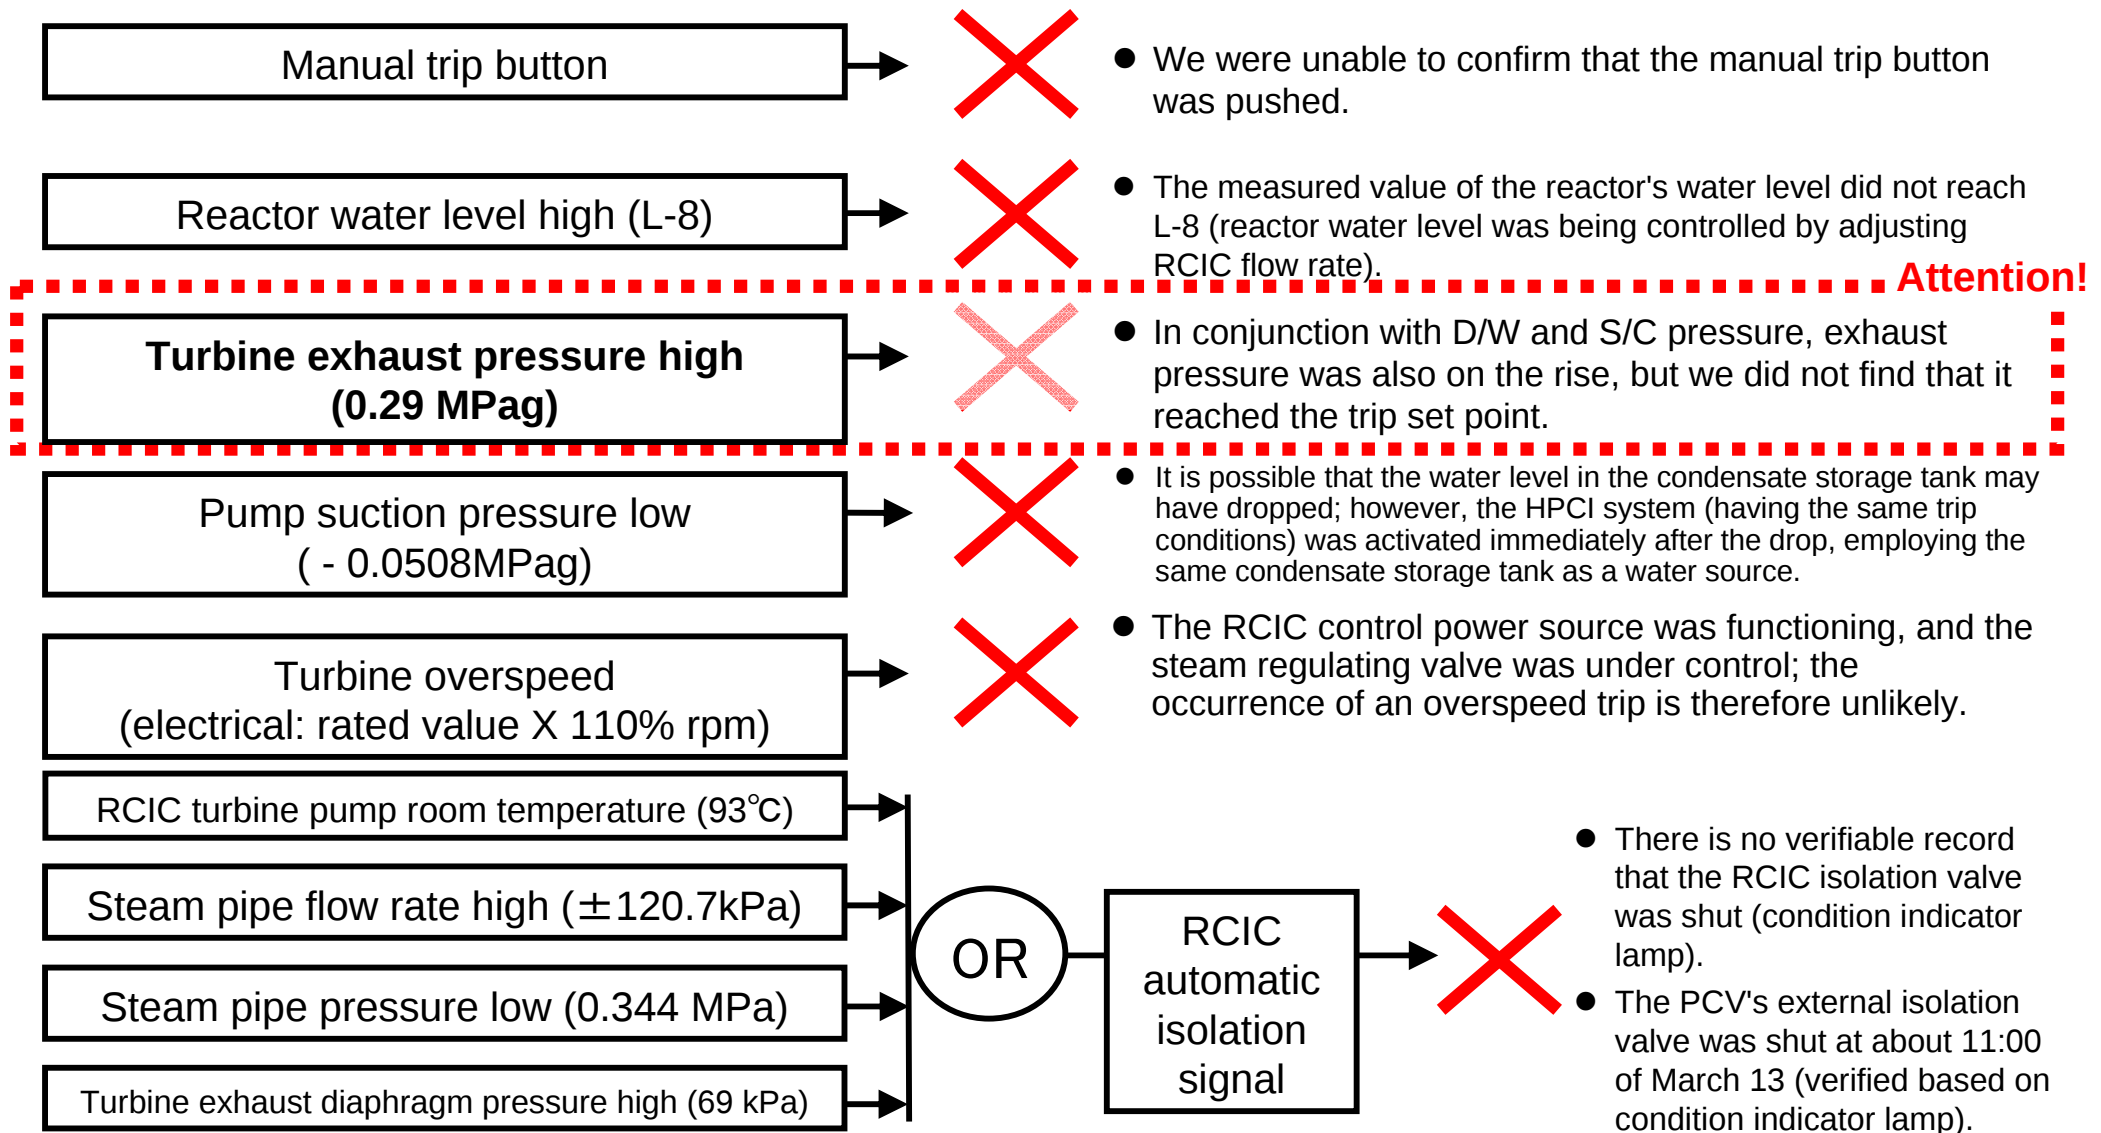
None of the trip conditions required under electrical trip logic was confirmed.

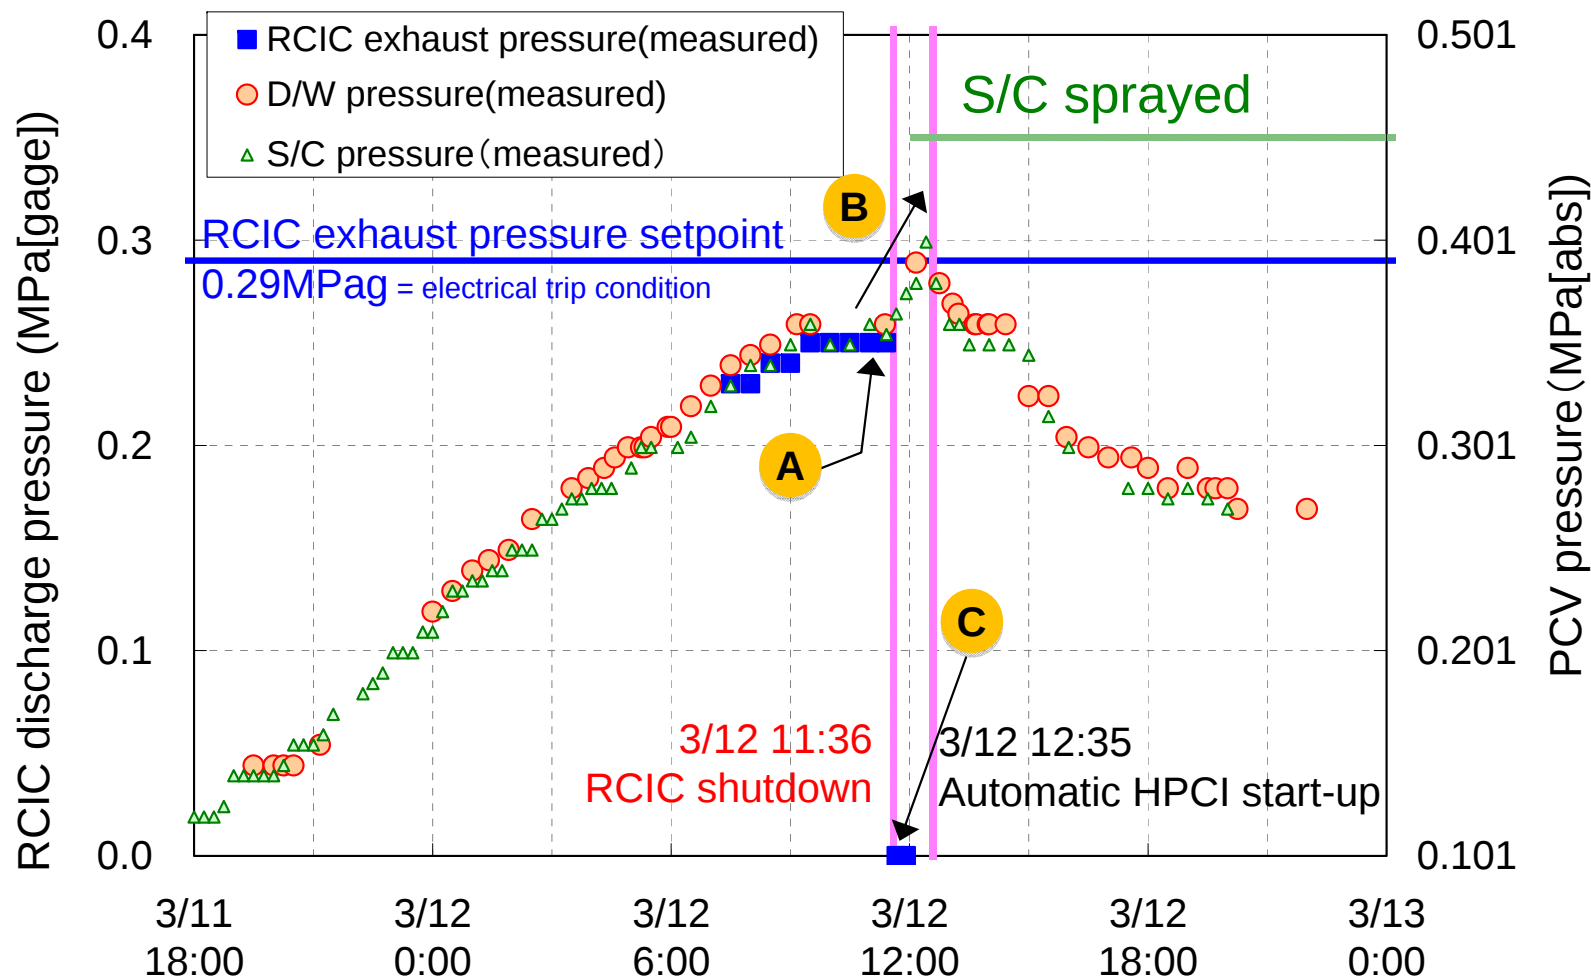
Out of electrical trip conditions, turbine exhaust pressure and S/C pressure were both on the rise, getting close to the trip set point.

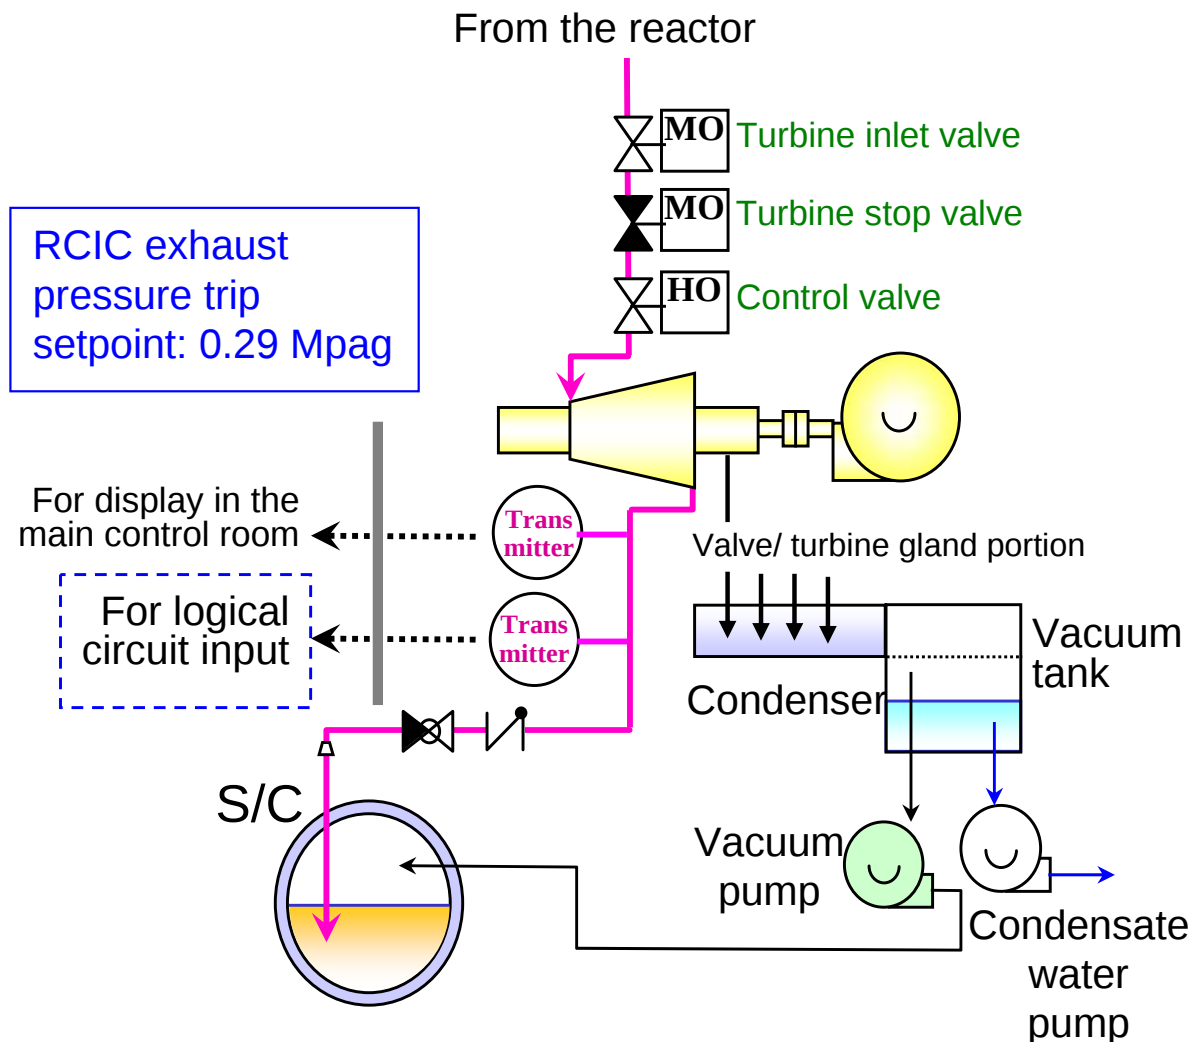
**Trip due to high exhaust pressure is possible although there is no direct record**

- S/C pressure at shutdown was about 0.25 MPag, which would have caused exhaust pressure to exceed the trip set point if we take into account the pressure drop in exhaust pipes (0.05 MPa according to trial run data).

→ Different pressure gauges are employed for display in the main control room and for logical circuit input; it is possible that, when S/C pressure rose at 11:36, the latter may have reached the trip set point.

- Another trip occurred again as steam began to flow following start-up, in spite of successful reset operation. This sequence of events can be explained based on the above (trip conditions were momentarily cleared upon exhaust pressure reaching 0).

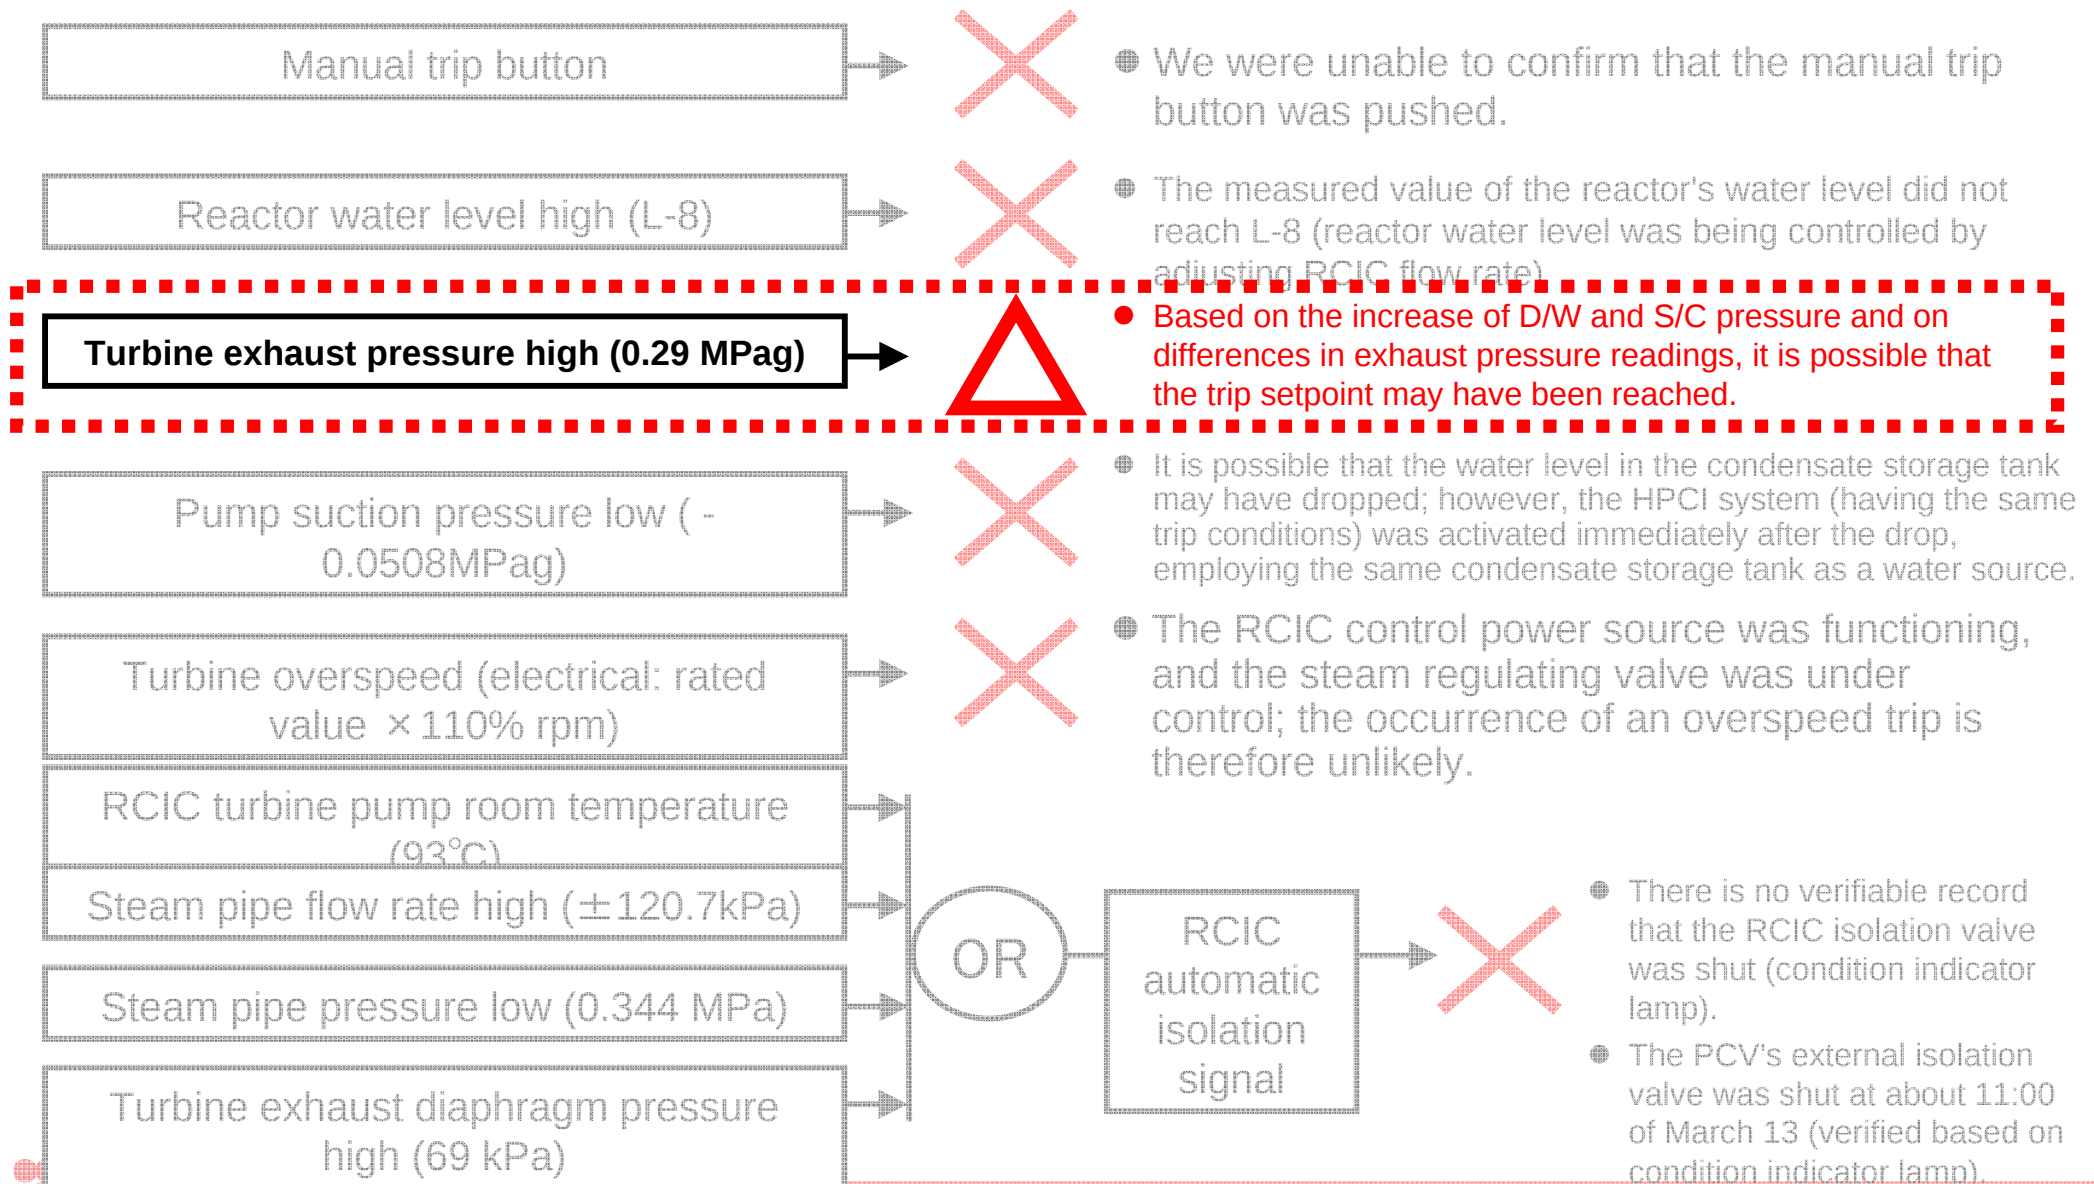
### Likelihood of exhaust trip forming while other conditions are not convincing

In addition to measures for bolstering the function of the water injection under high reactor pressure,  
**an operational procedure is being prepared to release the interlock  
for high turbine exhaust pressure**

- In the response procedures for Tsunami Accident Management, which assume a station black out, an operational procedure is being prepared to release the interlock for high turbine exhaust pressure in order to prioritize the continuation of RCIC operation even while S/C pressure is on the rise.

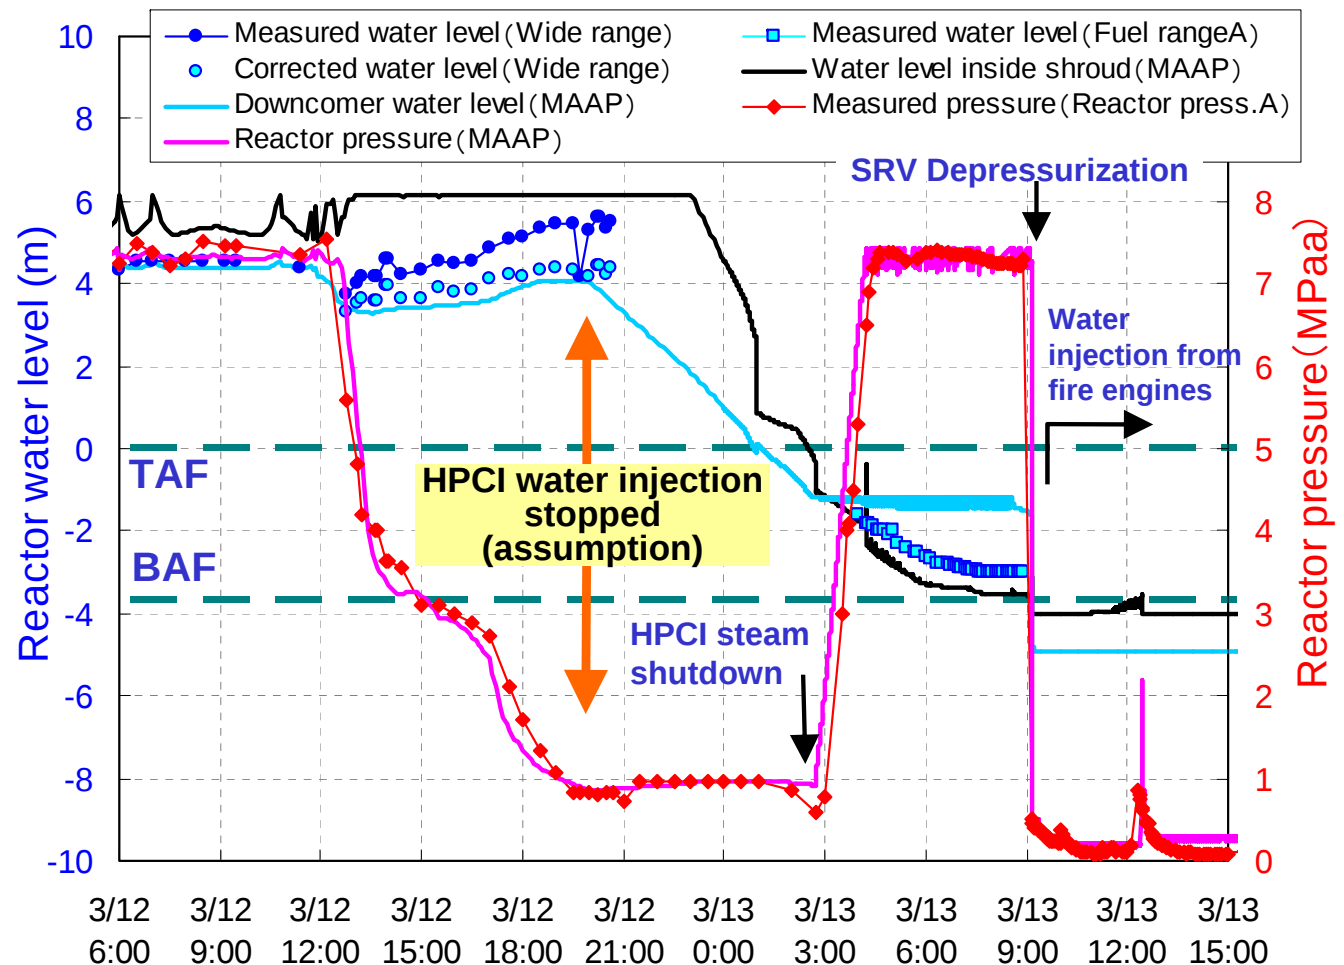
We conducted MAAP analysis, taking into account HPCI operational state.  
**We assumed that no cooling water was injected into the reactor after 20:00 on March 12.**

- ✓ At 20:00 on March 12, reactor pressure fell below HPCI design condition 1MPag to about 0.8 MPag. We assumed that no cooling water was injected into the reactor after that time.
- ✓ As for the state of HPCI operation, steam supply to the turbine continued, but we estimate that virtually all of the discharge flow rate went back from the test line to CST.
- ✓ After the HPCI's manual shutdown, reactor pressure began to rise due to steam supply being cut off.

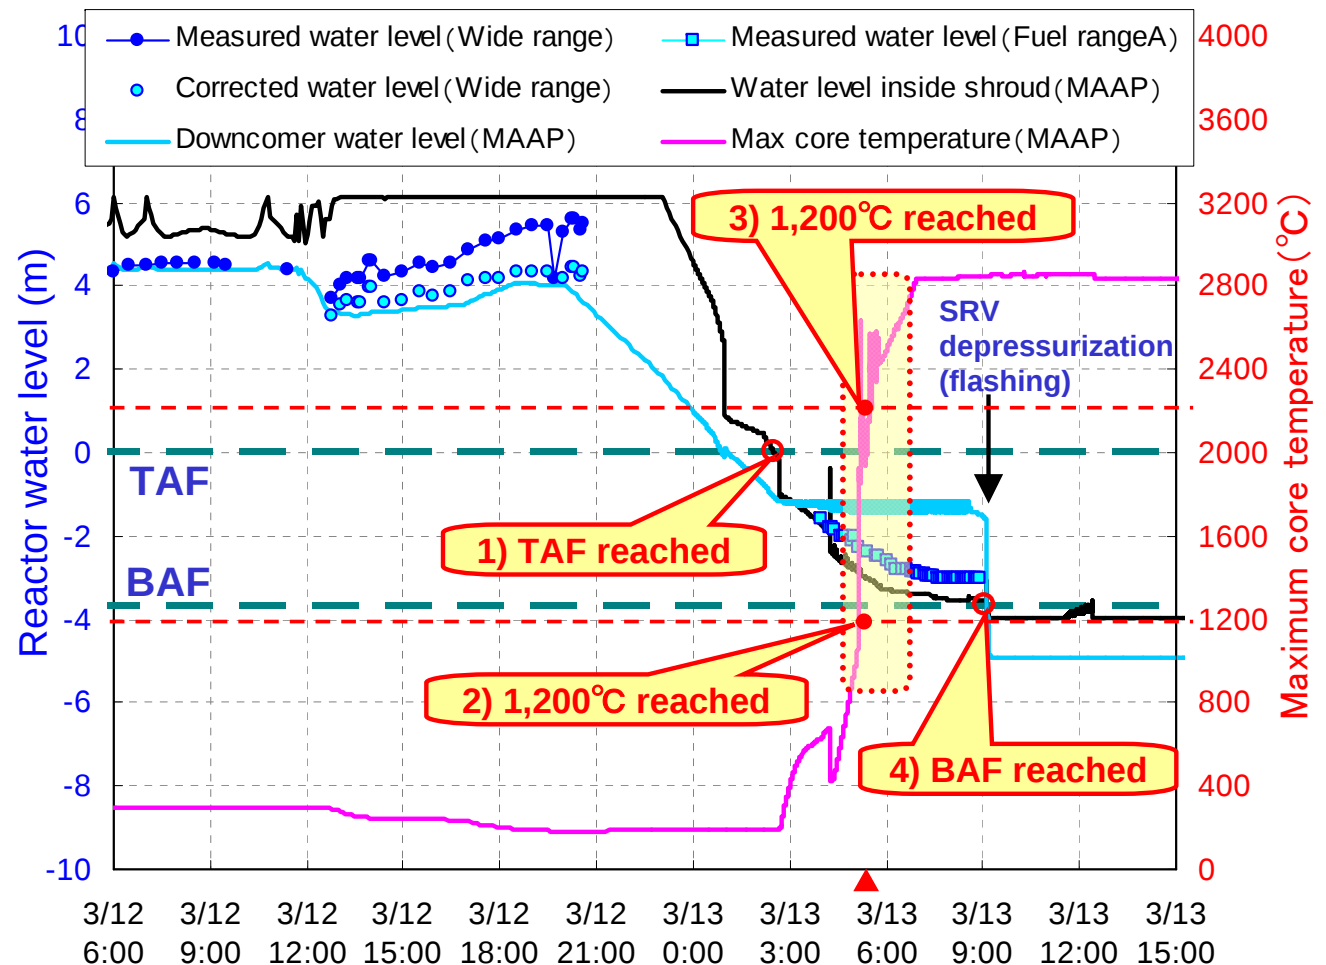
Fuel began melting before the water level reached the fuel's bottom.  
**We estimate that it was the heat from the zirconium-water reaction caused as the water level dropped to cause the fuel to melt.**

| 1) TAF reached | About 2:30 on 3/13 |
| 2) Maximum core temperature 1,200°C reached | About 5:10 on 3/13 |
| 3) Maximum core temperature 2200°C reached | (Fuel melting)<br>About 5:30 on 3/13 |
| 4) BAF reached | About 9:10 on 3/13 |

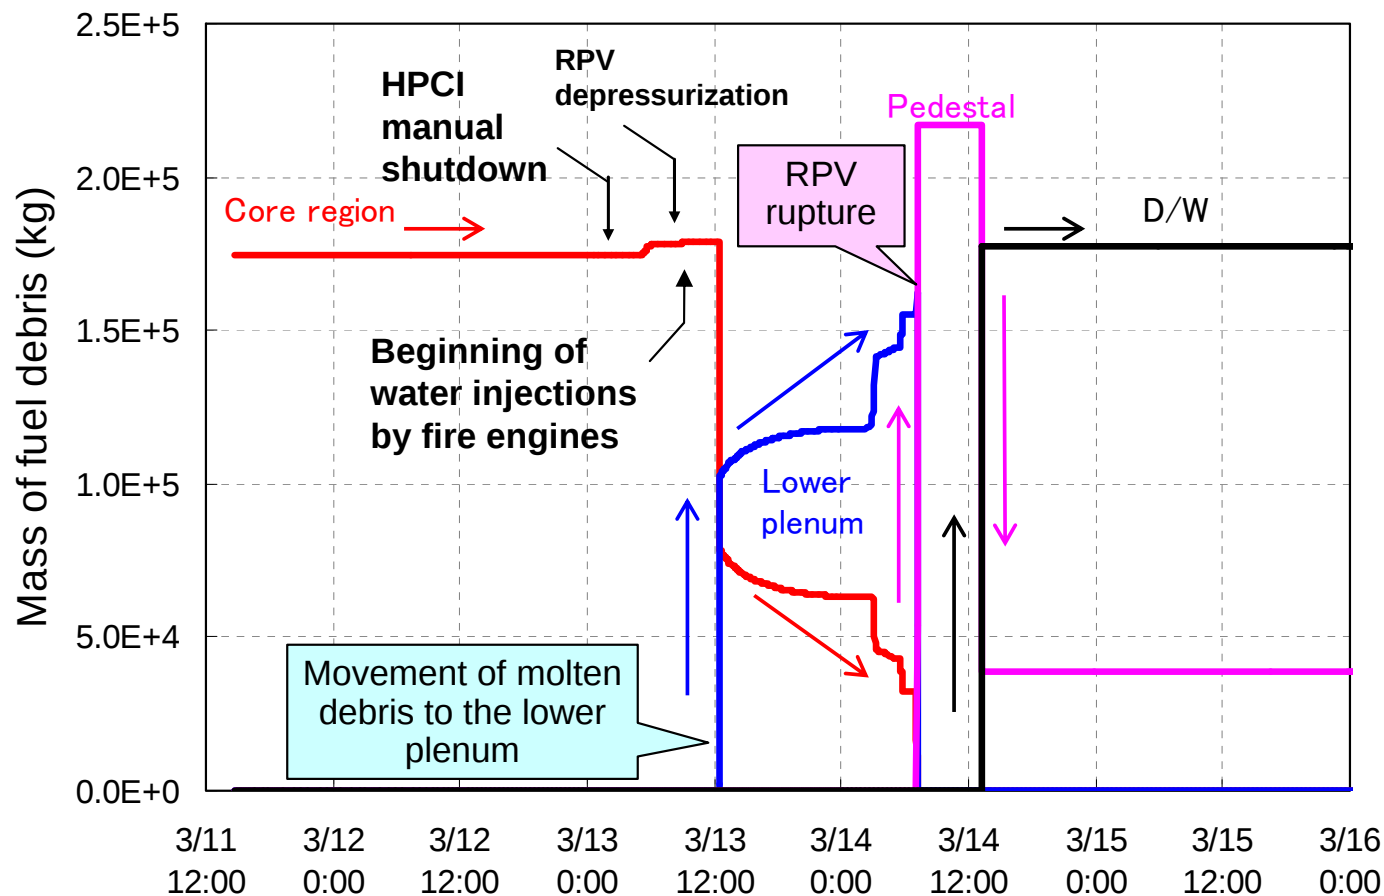
By taking into account the state of HPCI operation, simulation result shows that the majority of fuel fell dropped

- ✓ The water injections made starting on September 1, 2011 from the core spray system caused a decrease in RPV temperature. Therefore, we believe there may be fuel debris in the core as well.
- ✓ Whether the RPV is ruptured is largely determined by the volume of cooling water injected from fire engines; model and analysis conditions entail considerable uncertainty.
- ✓ Simulation resulted in Debris on the PCV of 100%, but there are issues with the MAAP model (in MAAP, RPV rupture case tends to result in entire debris' dropping).

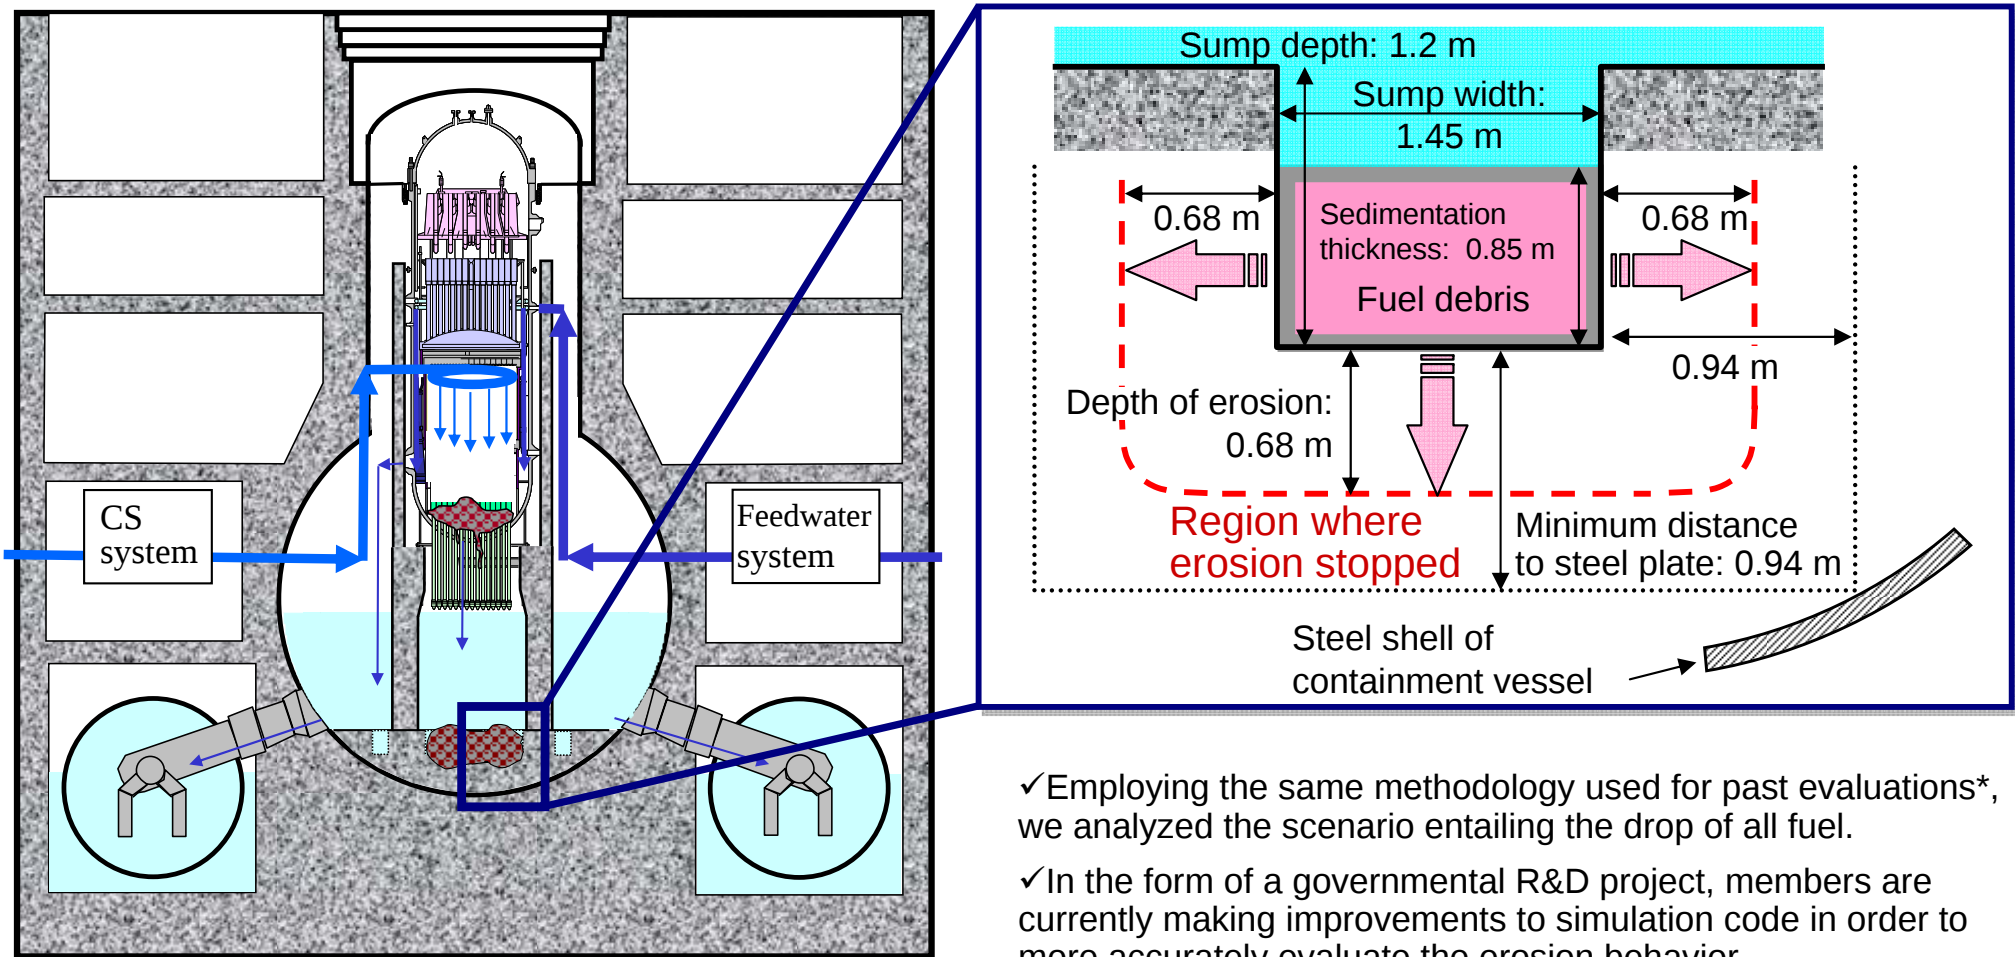
We estimated the degree of concrete erosion by MCCI.  
While our analysis entails some degree of uncertainty,  
erosion was limited to within the reactor containment vessel.

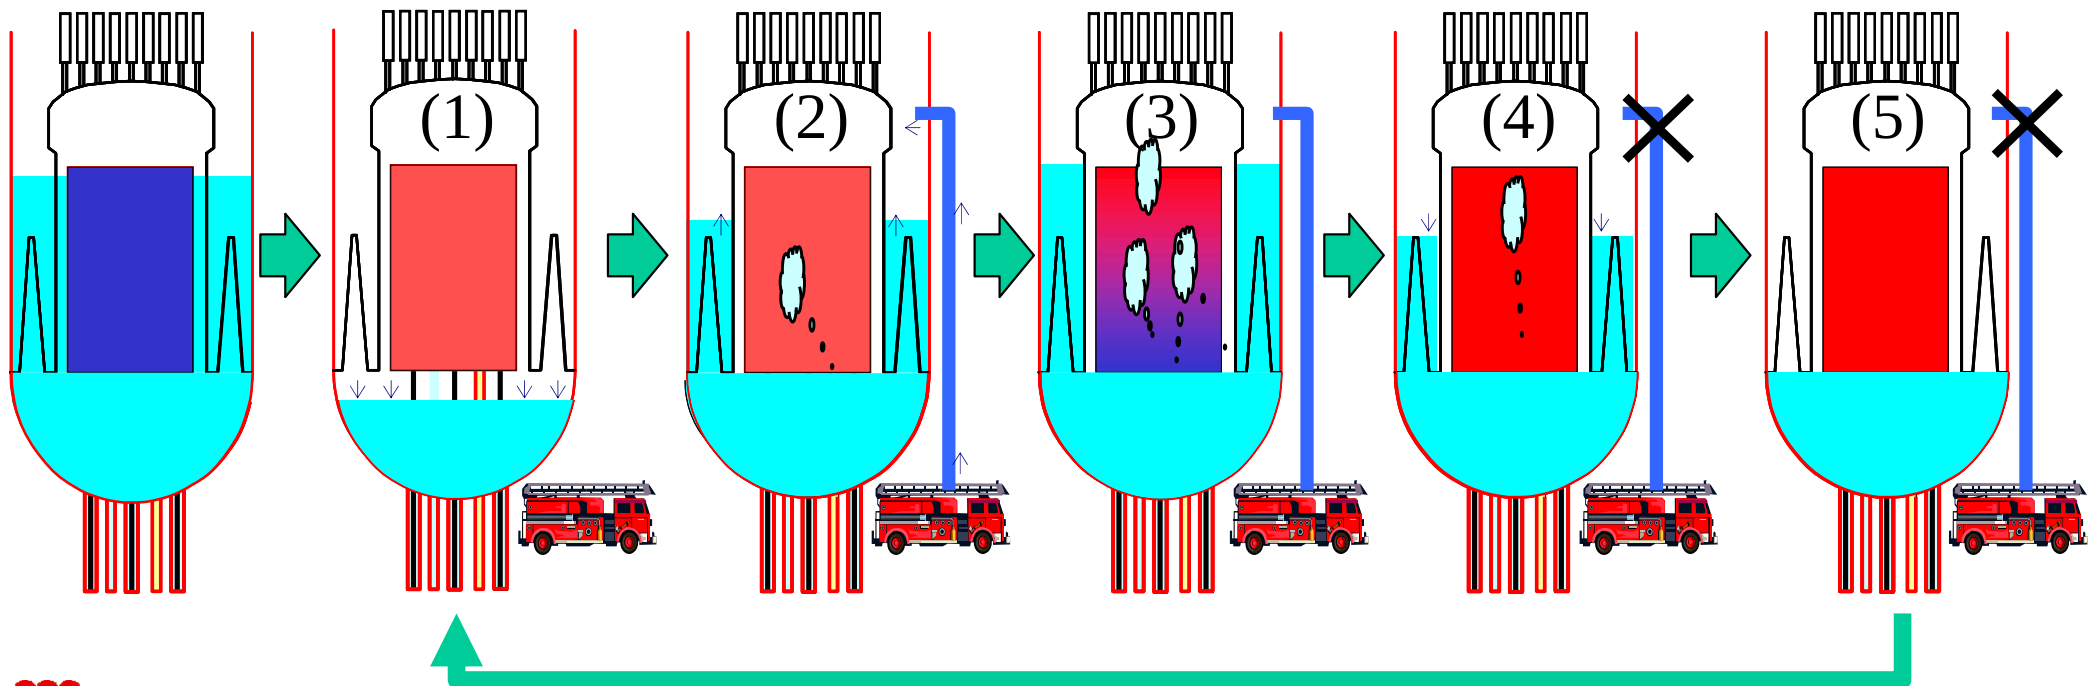
**We estimate a scenario where, after reactor depressurization, the steam generated by cooling water injection from fire engines caused a zirconium-water reaction, in turn causing reactor pressure to rise and lead to fuel melting.**

- (1) On the reactor's forced depressurization, flashing caused the water level to drop steeply, completely exposing the core.
- (2) Water level was restored by water injections from fire engines.
- (3) Steam generation caused a zirconium-water reaction, in turn generating hydrogen and large amounts of heat, and causing reactor pressure to rise.
- (4) Cooling water injections from fire engines were suspended due to the rise in reactor pressure.
- (5) The suspension of cooling water injections brought steam generation under control, letting pressure drop.

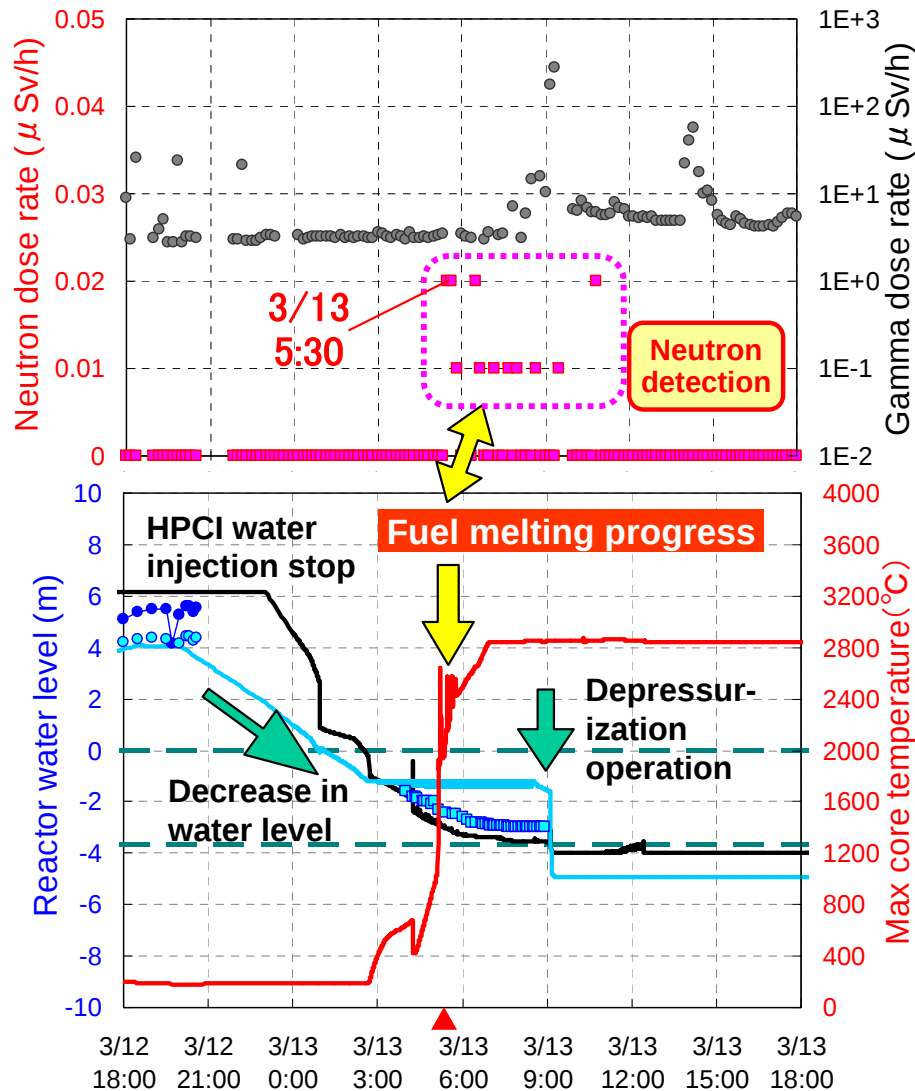
The timing of neutron detection on the morning of March 13 coincides with that of fuel melting at Unit 3.

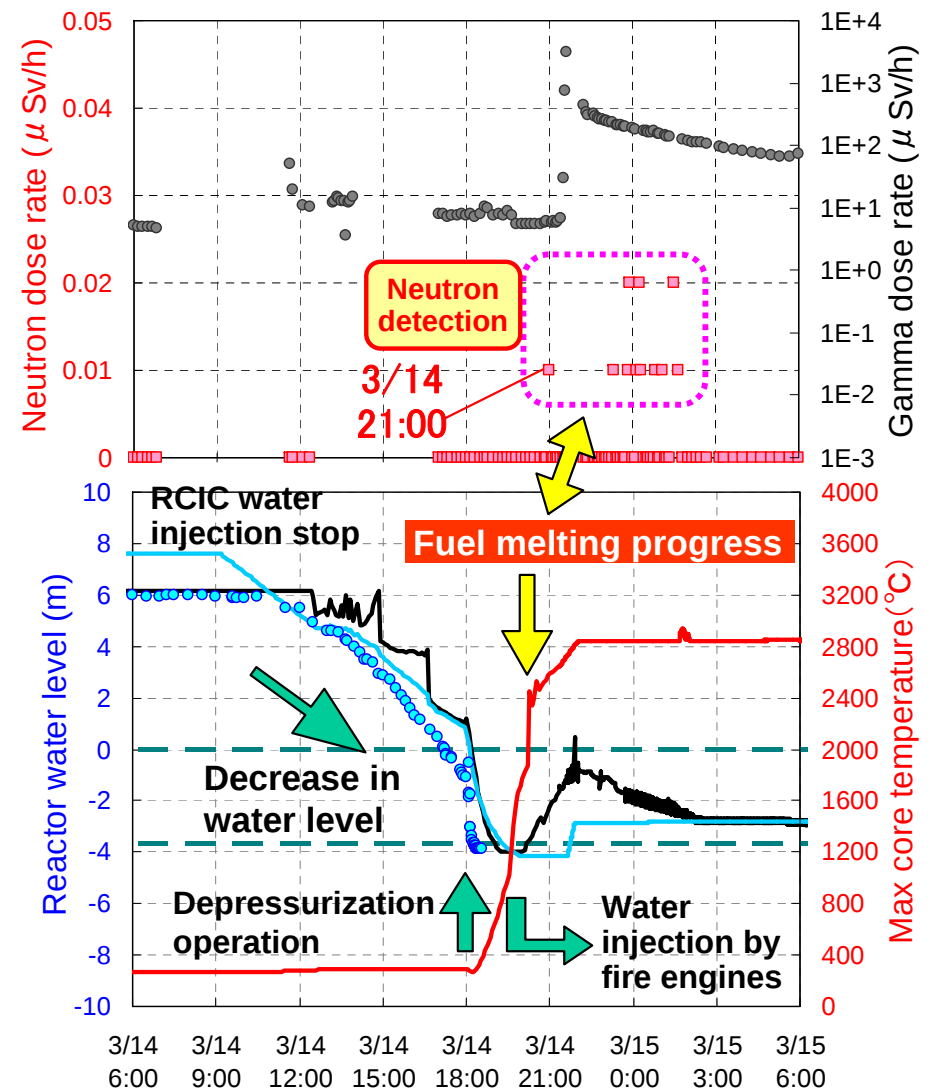
The timing of neutron detection in the night of March 14 coincides with that of fuel melting at Unit 2.

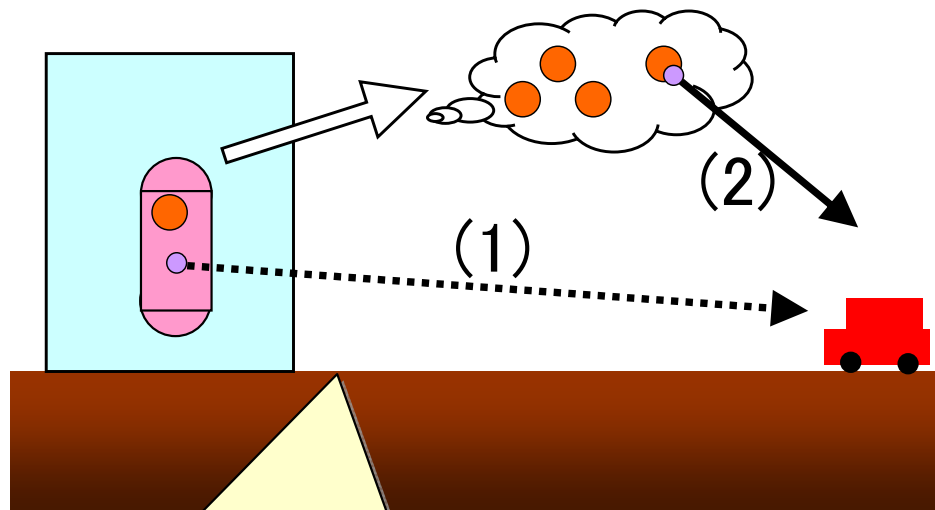
The neutrons observed near the main gate may have been generated by the spontaneous fission of released actinides in the course of fuel melting at Units 2 and 3.

The concentration in soil sampled in the Fukushima Daiichi site was similar to that preceding the accident. However, based on the detection of actinides with relatively short half-life, such as Cm-242 and Cm-244, we believe these may have been originated in the Fukushima Daiichi accident.

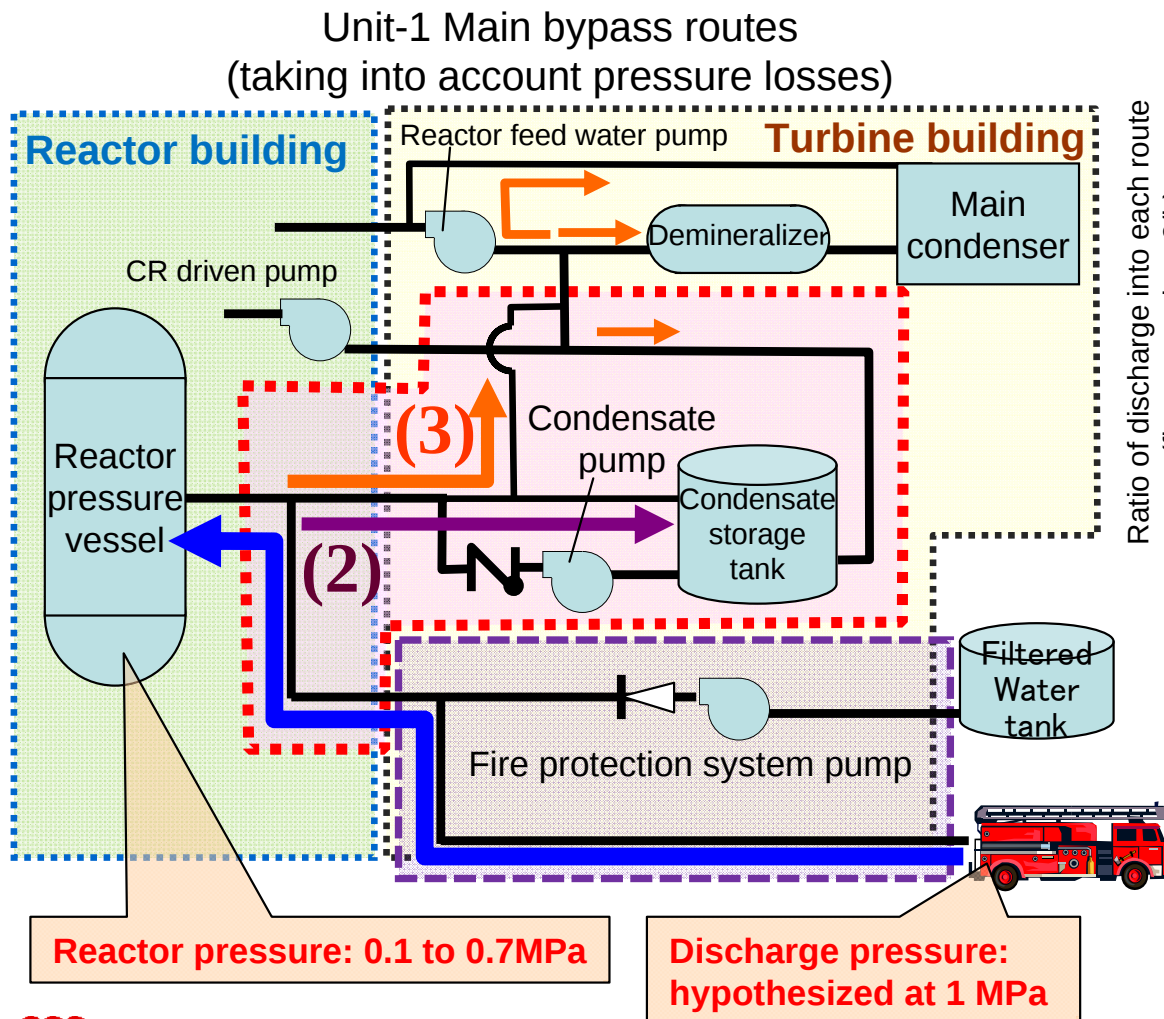
If we assume fire engine discharge pressure to have been constant at 1MPa, then about 20% to 50% of water injected reached the reactor.

**Note, however, that records of discharge pressure and flow rate, etc. from fire engines are few, and leave many aspects unclear, thus requiring further study.**

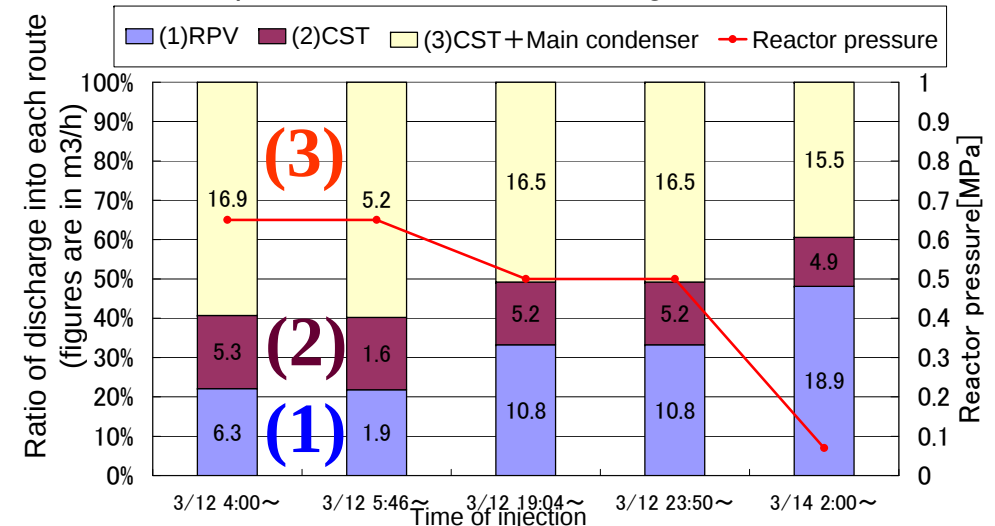
Reactor pressure and ratio of discharge into each route

- At times, fire engine discharge pressure fell below 1 MPa.
- No D/W pressure response while water injection from fire engines were suspended  
→ These results may overestimate the volume of water injected into the reactor.
