Causes and Measures for deviation from LCO of Subdrain Operation at 1F

November 20, 2017

Fukushima Daiichi D&D Engineering Company
Tokyo Electric Power Company Holdings, Inc.

- 1. Water Level Decrease in Subdrain No. 51**
- 2. LCO Entry Following a Setting Error in the Water Level Gauge for the New Subdrain**

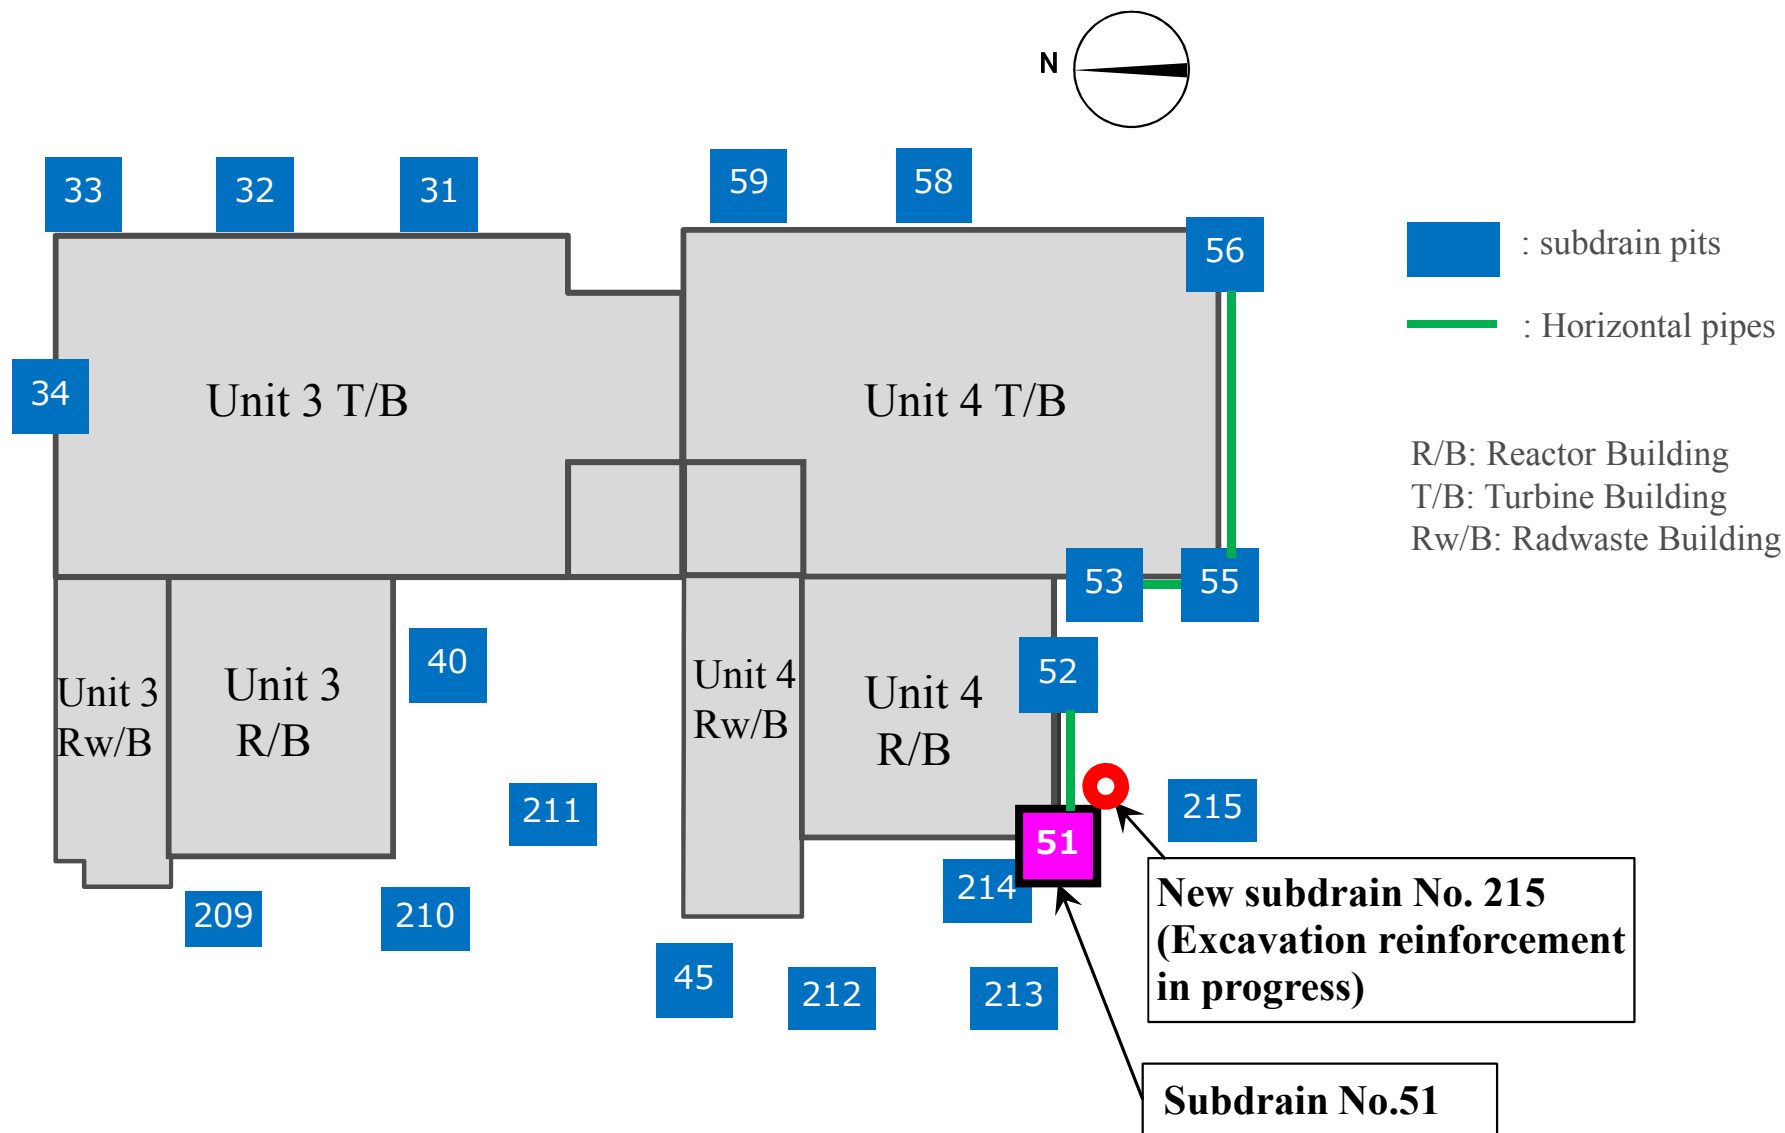
Unit 3 & 4 peripheral subdrain pit layout plan

When the relevant parameters were checked, it was found that the water levels of the No. 51 subdrain (hereafter “Subdrain”) installed on the southwest side of the Unit 4 Reactor Building had rapidly decreased, and was below the accumulated water levels of the Unit 4 Reactor Building and Radwaste Building (hereafter, “accumulated water levels of the buildings”).

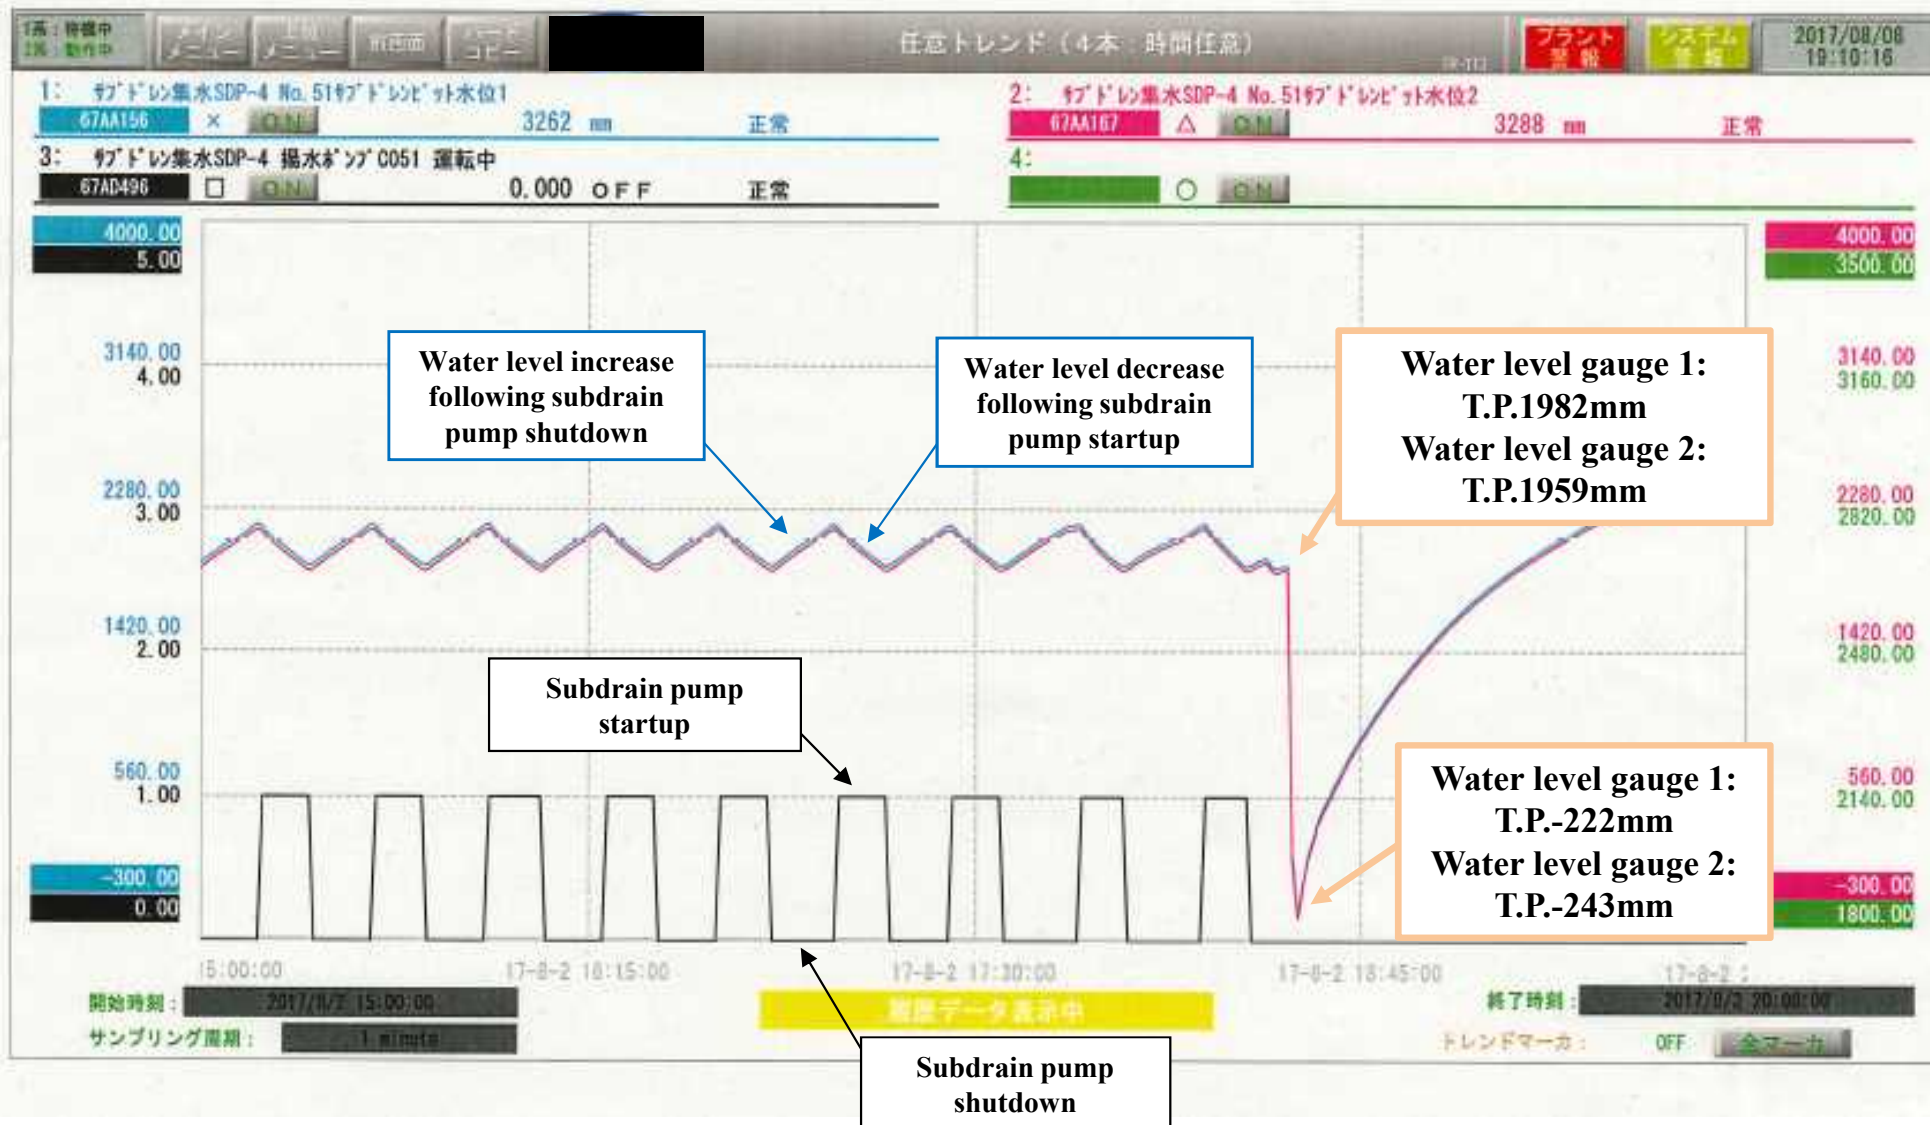
(2) Trend of water levels of subdrain in question before and after the event

On August 3, when the water level gauge of Subdrain was inspected (measured) , it was found that the actual measured water level was the same as the reading on the water meter. Afterwards, a Trouble Review Committee meeting was held, and based on the inspection results of the water level gauge , it was determined that there was a low possibility of the water level gauge being defective and a high possibility that the water level of Subdrain actually decreased.

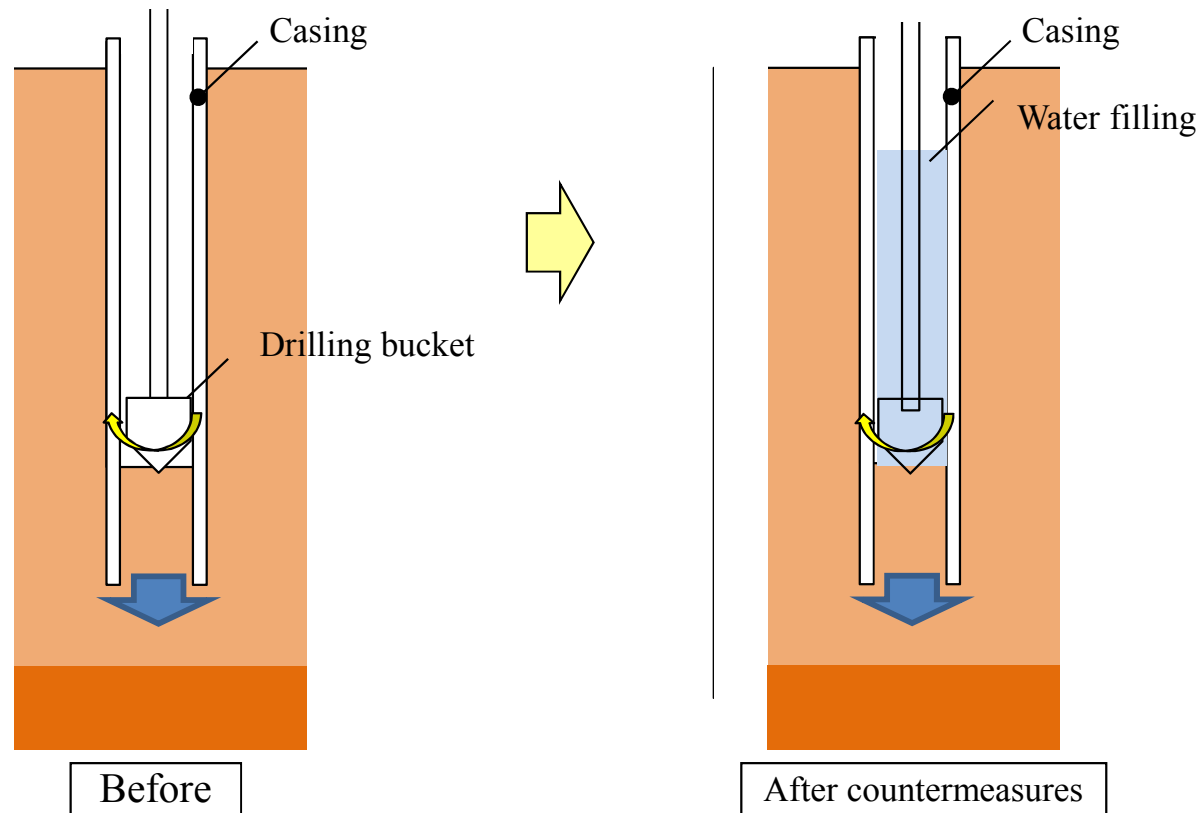
As the drastic decrease in No.51 water levels on August 2 is presumed to have been caused by nearby excavation work, construction shall be resumed after the following recurrence prevention measures are taken.

Casing drilling and inner excavation shall be conducted after filling the casing with water up to a level that does not affect the periphery subdrain pits. This will prevent water from flowing into the casing, preventing changes in the water levels of surrounding subdrain pits.

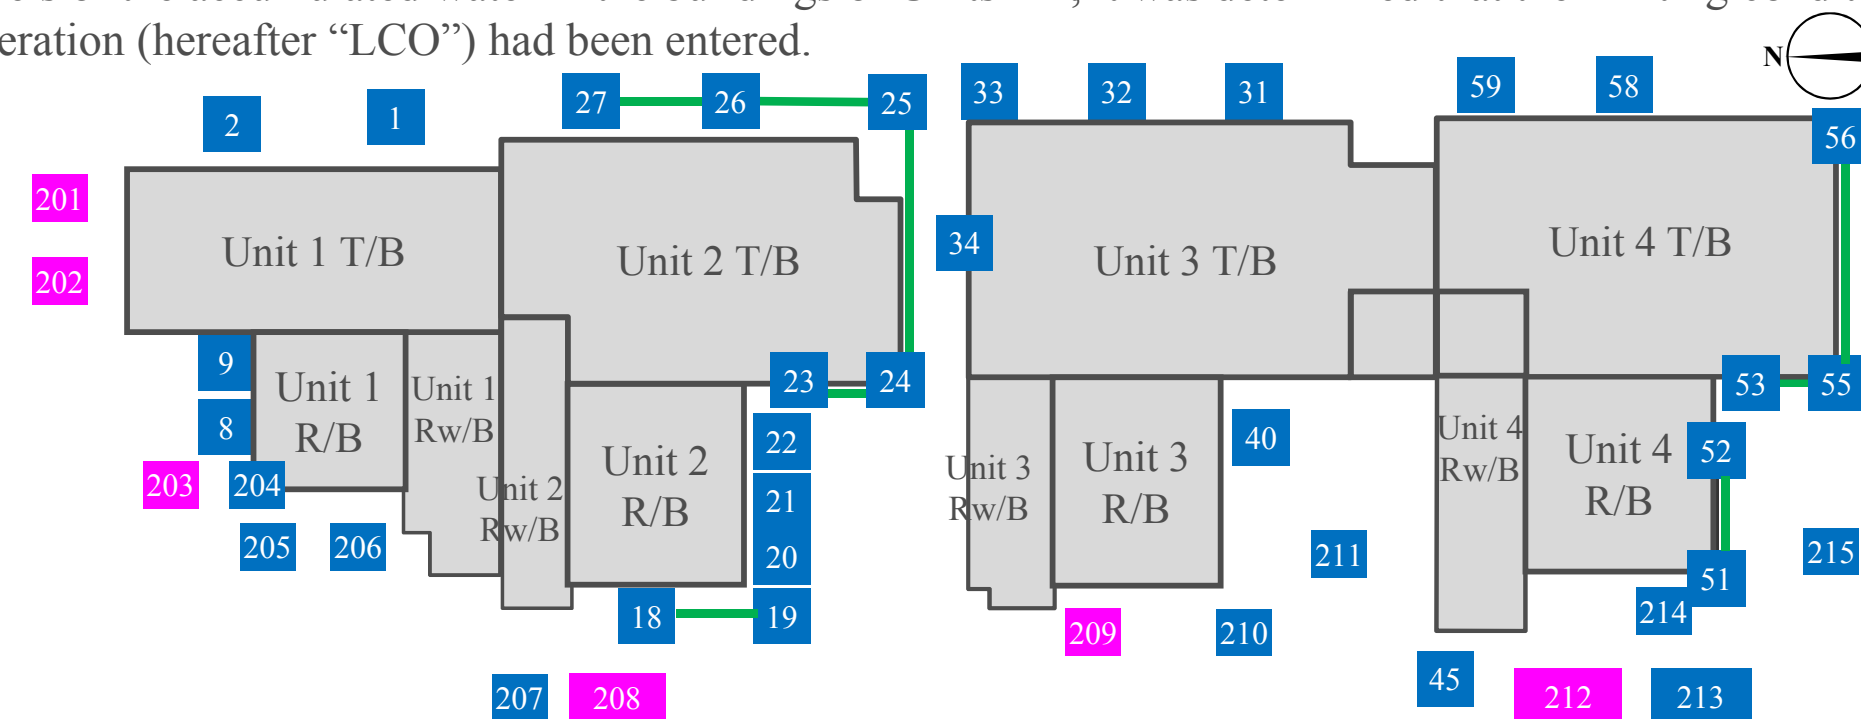
Subdrain pit layout

Among these, a water level gauge setting error of 690mm was found in the new subdrain pits (6 locations) installed on or after April 19, 2017.

As there was a possibility of reversal in the water levels of the new subdrain pits (6 locations) and the water levels of the accumulated water in the buildings of Units 1-4, it was determined that the limiting conditions of operation (hereafter “LCO”) had been entered.

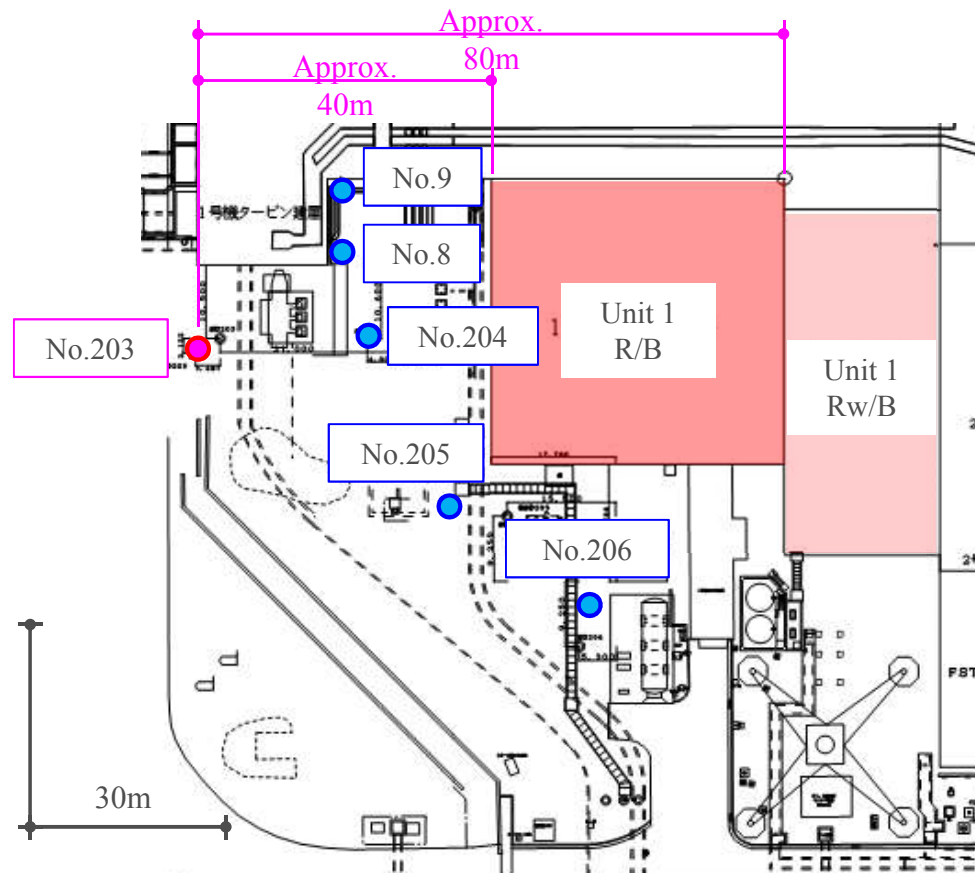
Positions of subdrain No.203 and the buildings in relation to one another (plan view)

The water level of subdrain pit No.203 was lower than the level of accumulated water levels in Unit 1 R/B, but as the water levels of subdrain pit No.204, located midway between the two, and the water levels of surrounding subdrain pits No. 8, 9, 205, and 206 were higher than the Unit 1 R/B accumulated water levels, it was determined that there was no leakage from the same building attributable to the low water level of No.203.

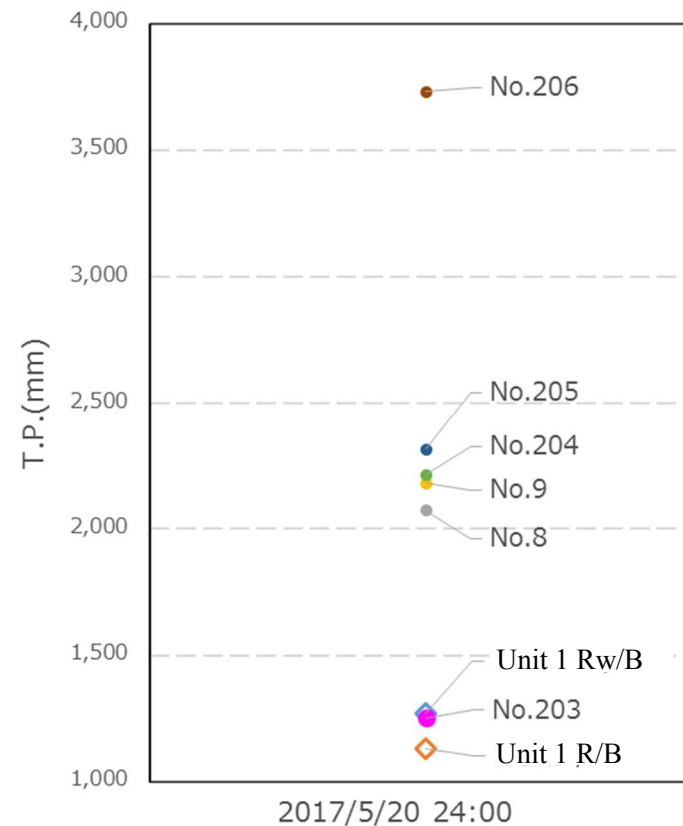
Relationship between the levels of accumulated water in the buildings and the subdrain water levels

In order to prevent accumulated water in the buildings from leaking outside the buildings, the subdrain water levels are maintained at a level that is at least 800mm higher than the levels of the accumulated water in the nearby buildings. water levels.

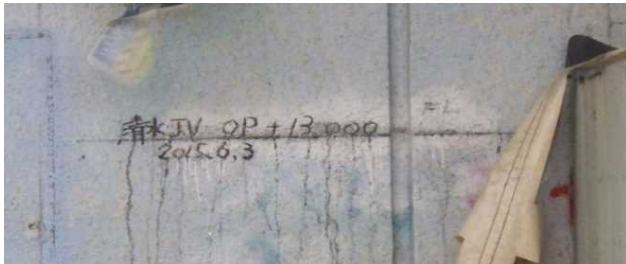
Example of a site reference point:
O.P. notation in the field was corrected to T.P. notation

Use “T.P.” as the elevation guideline in the power station.

- All drawings created in the future shall use T.P. notation (to be started promptly)
- O.P. notation used in previous drawings shall not be used as elevation information.
The drawing will be stamped, etc., as a measure to prevent erroneous use of O.P. notation for elevation. (Scheduled to be implemented and completed within the fiscal year.)
- All elevations for the site reference points shall be in T.P. notation, and existing O.P. notation shall be labelled with a note preventing use. (Within the year)
