February 13, 2024 Briefing for the Nuclear Reform Monitoring Committee

# Fukushima Daiichi Nuclear Power Station Decommissioning Initiatives

Fukushima Daiichi Decontamination &  
Decommissioning Engineering Company

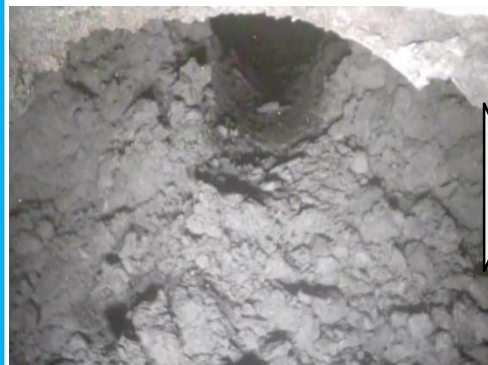
Prior to commencing work on January 17 (prior to spraying the deposits with low-pressure water)

- After opening the X-6 penetration hatch, a dozer rod is being used to push deposits after which low-pressure water is being sprayed to remove them. The deposits are gradually being removed and we have found cables.
- There are still mud-like deposits at the bottom of the penetration so we will use high-pressure water/AWJ to remove them. However, this will take more time than anticipated, and it is possible that we may not be able to remove all of the deposits.

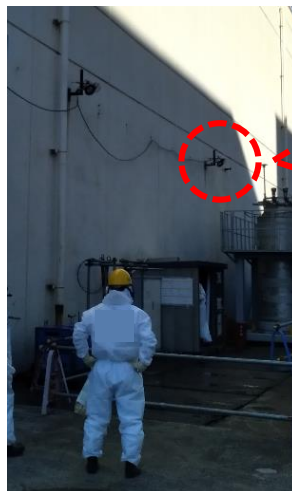
【Field conditions (external view of the building)】

- At around 8:53 AM on Feb. 7, a contractor worker discovered water leaking from vent opening<sup>\*1</sup> from the #2 cesium adsorption apparatus (SARRY), which is located approximately 5m from the ground on the east side wall of the high-temperature incinerator building.

- The leaked water consisted of system water and filtrated water, and resulting approximately 1mm deep puddle covered an area approximately 4m x 4m on the metal plates laid on the ground in this location. Since it is possible that the leaked water seeped into the ground through the gaps in the metal plates, as an emergency measure the aforementioned area has been cordoned off and the soil in this area is being collected.

- The cause of this incident is under investigation, but after determining the cause we will implement suitable recurrence prevention measures.

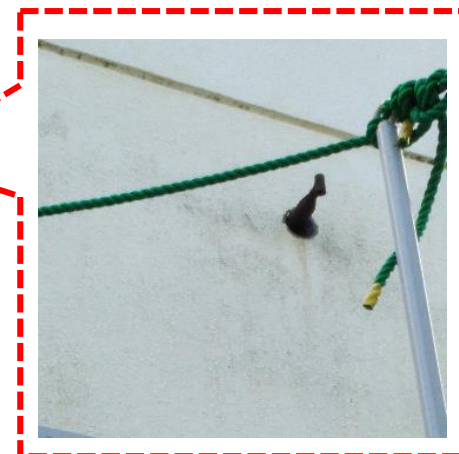
【Enlarged picture of the vent opening】

\*1 To vent hydrogen generated inside the adsorption apparatus

\*2 Conservatively calculated to be approximately 5.5m<sup>3</sup> of system water; gross  $\gamma$  assessment: 2.2E+10Bq
