Current Status and Challenges at Fukushima Daiichi Decontamination and Decommissioning

January 30, 2017

Naohiro MASUDA

President of Fukushima Daiichi Decontamination and
Decommissioning Engineering Company,
Tokyo Electric Power Company Holdings, Inc.

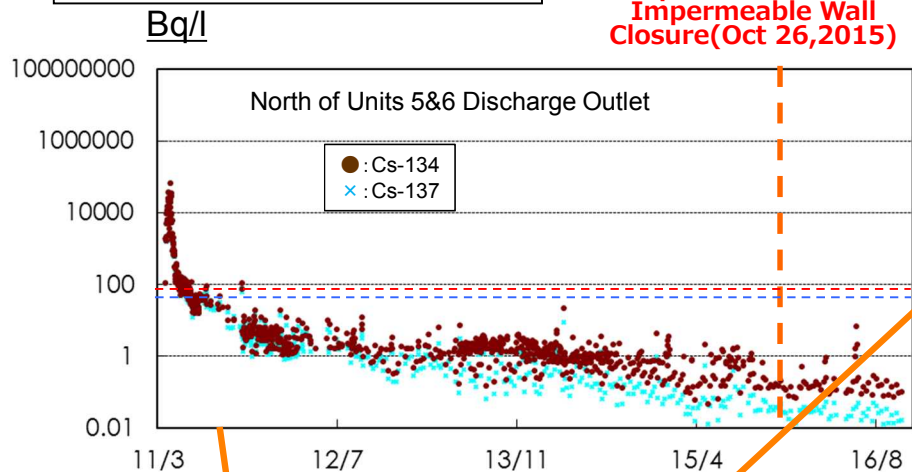
Completion of Sea-side Impermeable Wall Closure (Oct 26, 2015)

- Concentration of radioactive materials has been gradually decreasing since the accident.
- Concentration levels decreased further after closure of the sea-side impermeable wall.

- About one-1,000,000th to one-100,000th compared to immediately after the accident
- The concentrations outside the port are substantially below regulation limits

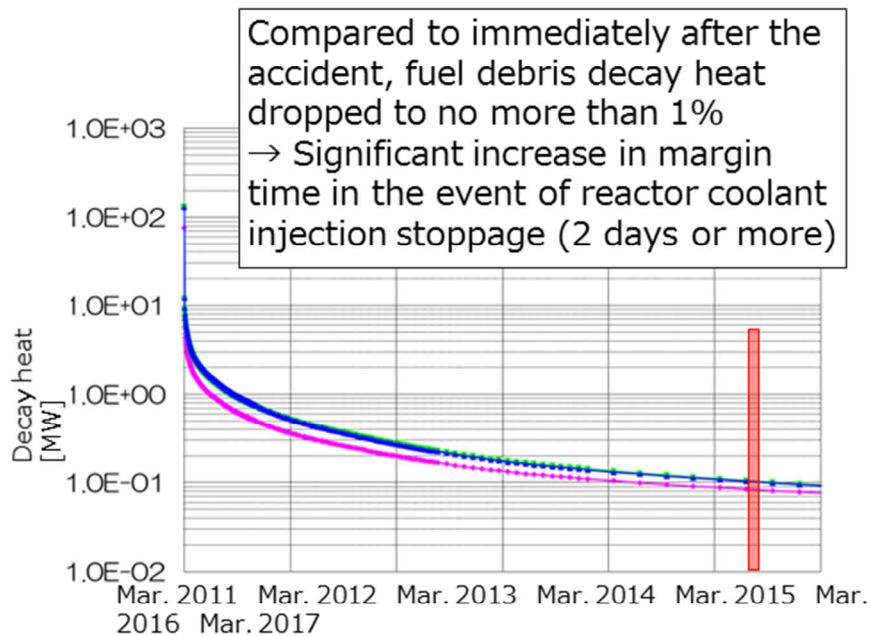
Figure 1
Transition of fuel debris decay heat

- The risk of a discharge of radioactive substances into the environment has decreased with the decrease in decay heat of fuel debris and pool fuel.

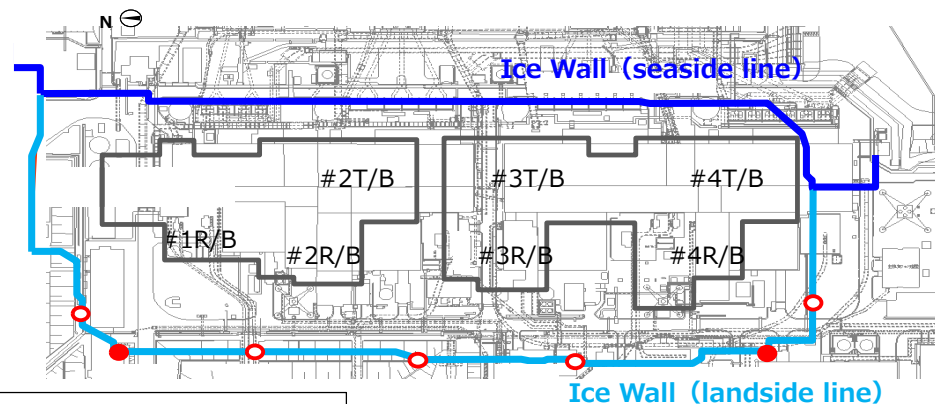
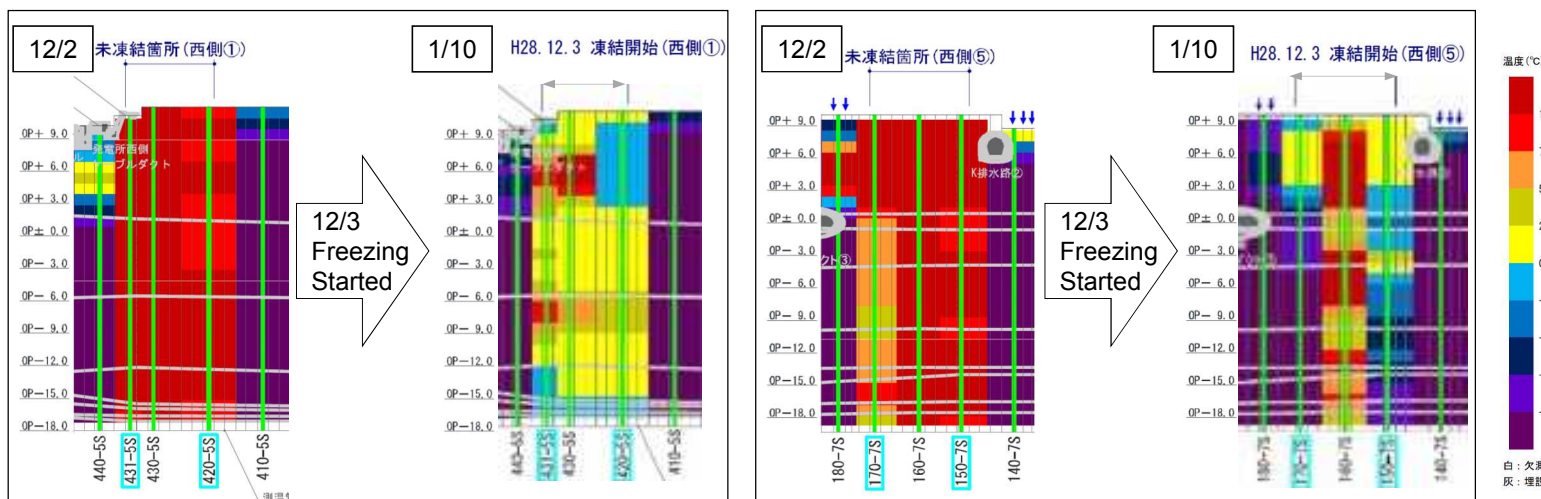
Change in temperature at the 2 places where freezing is underway

- Freezing started on March 31 at the entire seaside line and some parts of the landside line.
- Freezing area was expanded to 95% of the landside line on June 6.
- Supplementary method is being carried out at the places where the decrease in temperature is delayed.
- The underground temperature declined below 0°C throughout the scope requiring freezing by the end of October.
- To control the amount of groundwater flowing in from the mountain side, freezing of some of the places where freezing had not been undertaken (2 places out of the 7 places) started on December 3.

Places where freezing is underway (2 places)

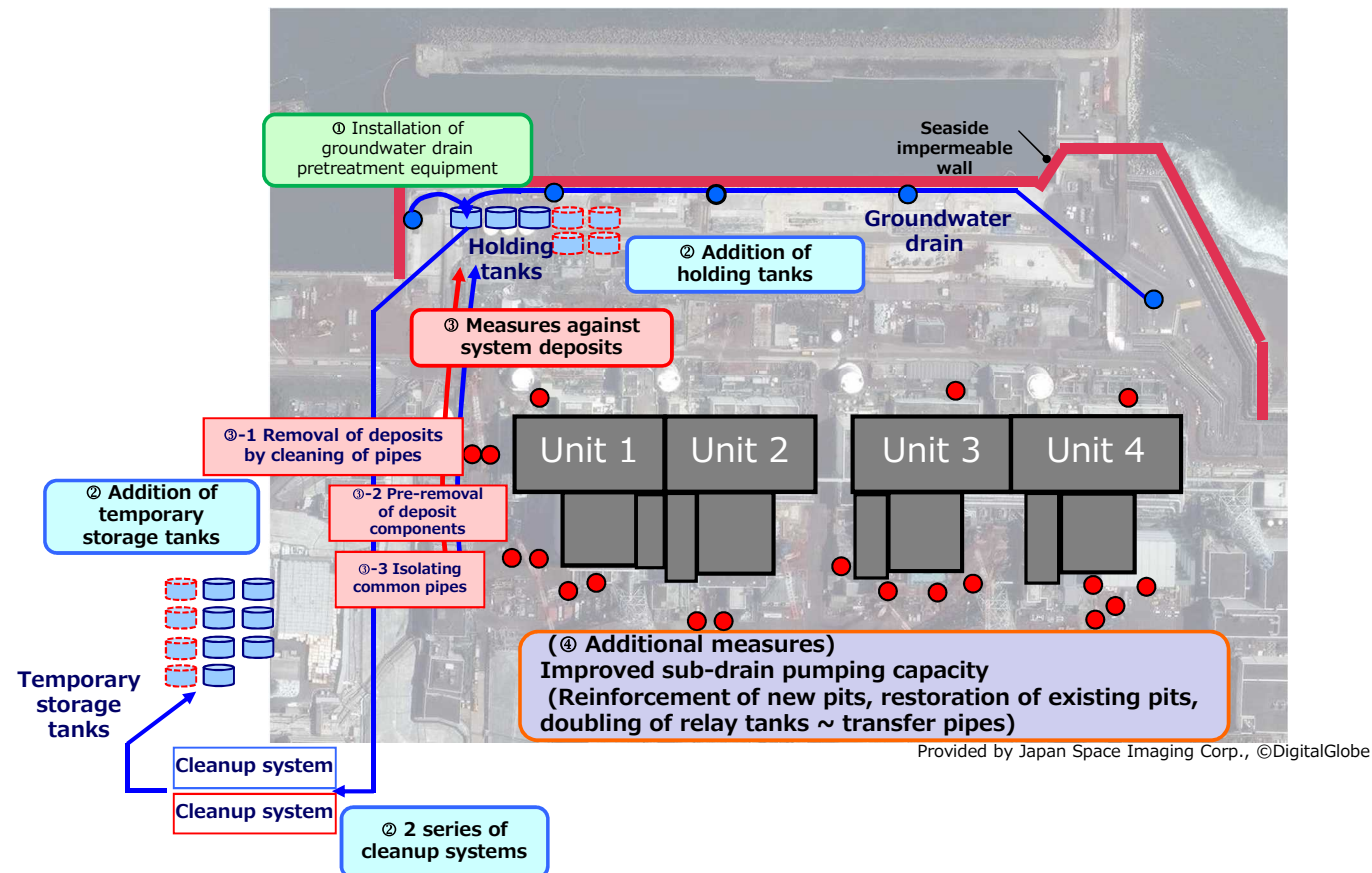
- The following measures were taken to improve the sub-drains:

- ① Improved quality of water in groundwater drains ⇒ Installation of groundwater drain pretreatment equipment
- ② Increased system capacity ⇒ Addition of holding tanks and temporary storage tanks, two series of cleanup systems
- ③ Measures against system deposits ⇒ Removal of deposits by cleaning of pipes, pre-removal of deposit components, isolating common pipes
- (④ Additional measures) Improved sub-drain pumping capacity ⇒ Reinforcement of new pits, restoration of existing pits, doubling of transfer pipes

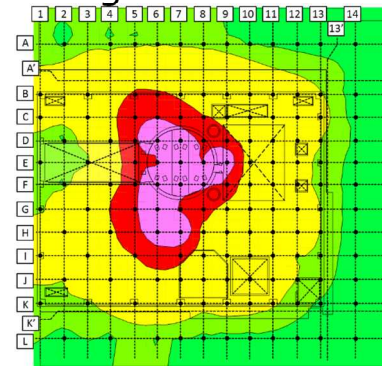
Horizontal maximum dose rate between before and after the installation of shields

Average 32.55mSv/h

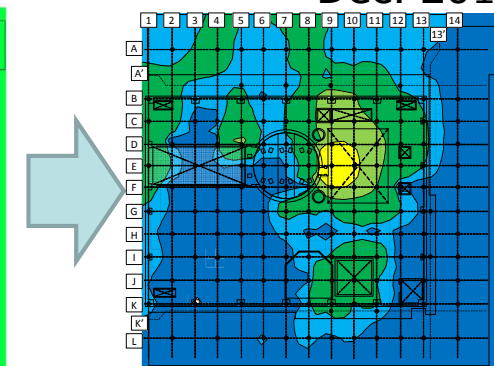
Average 1.65mSv/h (degree 95%)

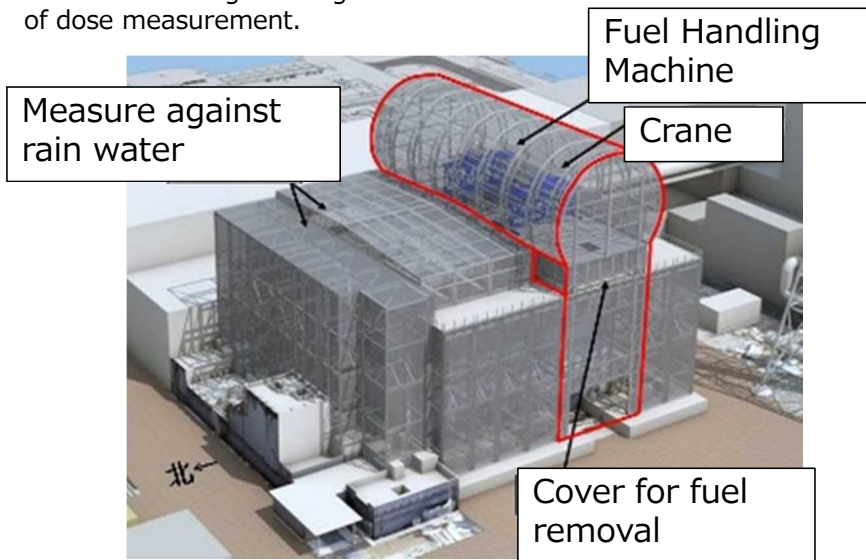
Cover for Fuel Removal (Image)

Preparations for the installation of a cover for fuel removal have started from January 5, 2017

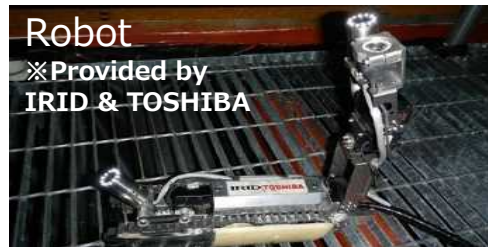
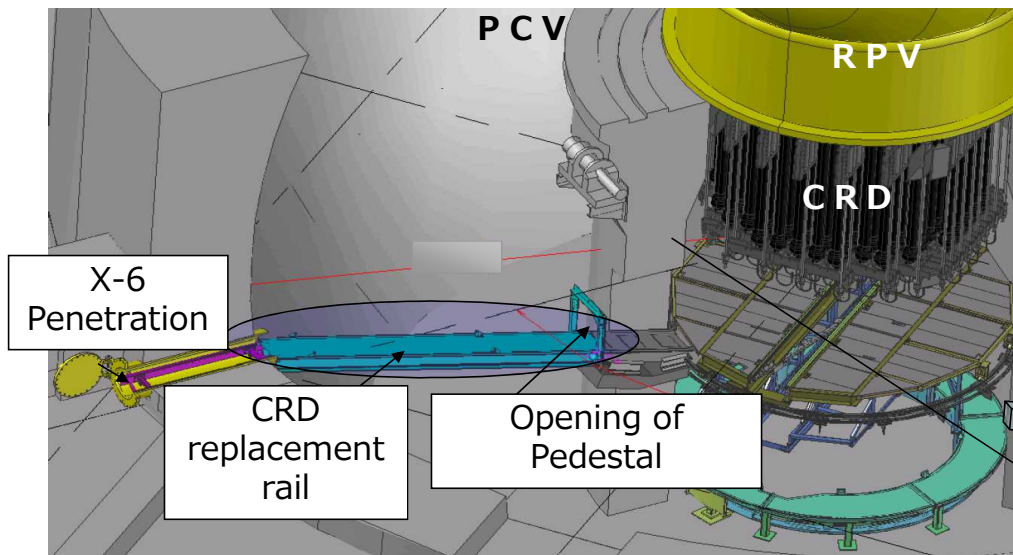
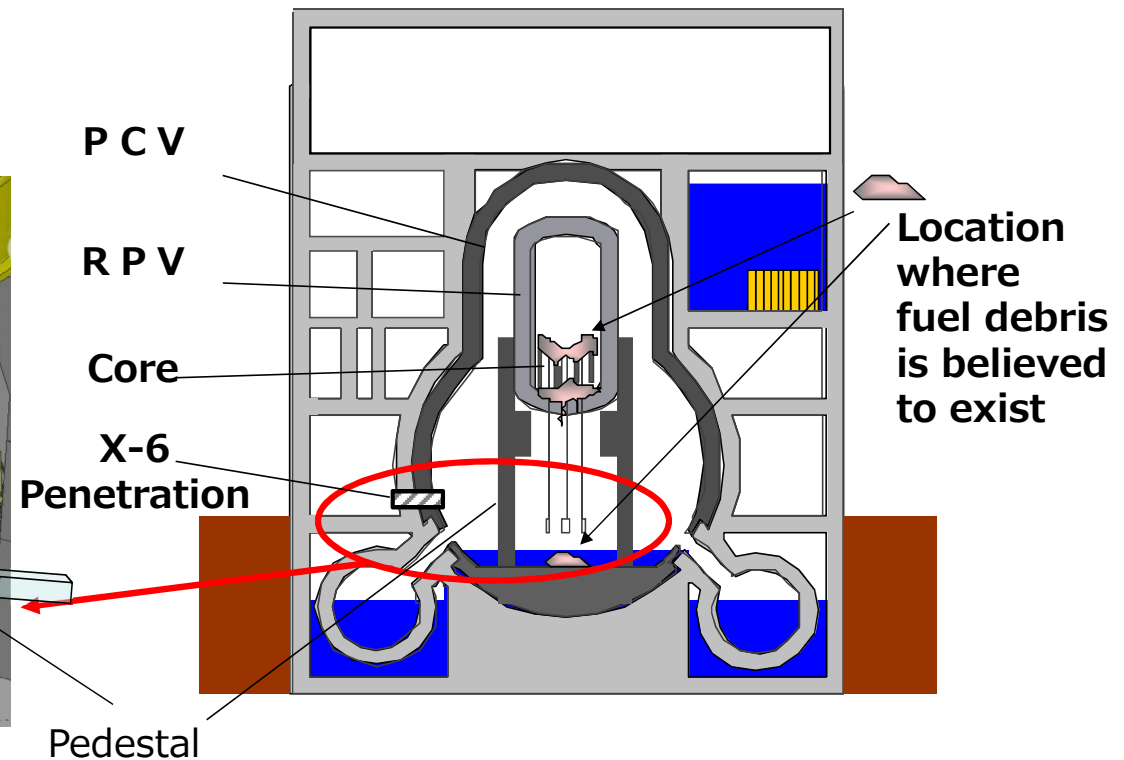
In preparation for fuel debris removal, exploration inside the Unit 2 reactor is scheduled in order to investigate conditions such as the location of fuel debris inside the PCV.

- X-6 penetration and CRD replacement rail will be used as a path for the robot to proceed inside the pedestal.
- It was found that the dose rate in the ducts at mid-to-high places on the first floor of the Reactor Building was high, so the dose rate in the ducts was reduced and the drilling work for X-6 penetration was completed on December 24. A preliminary survey will be conducted inside the pedestal using guide pipes, and then a self-propelled survey device will run inside the PCV, and an internal examination will be conducted.

The head camera with a lamp has a tilting and panning function.

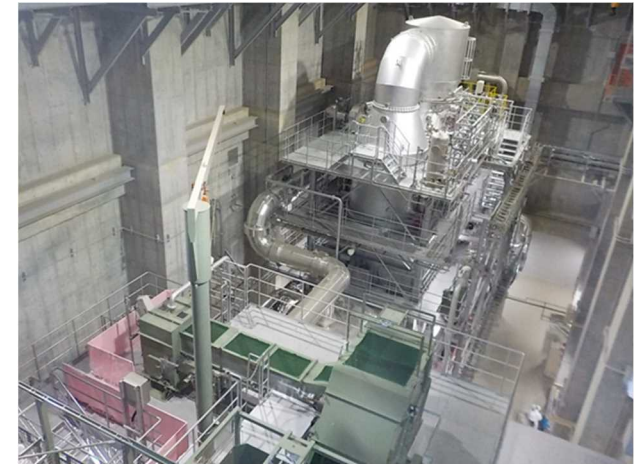
Overall incineration system (A system)

- Start of miscellaneous solid waste incineration system operations

Start of operations: From March 18, 2016

Processing results: used protective clothing 882t

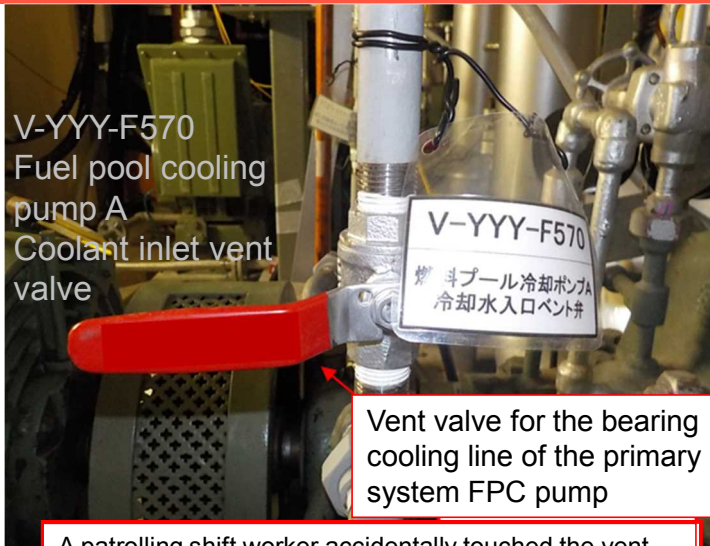
V-YYY-F570
Fuel pool cooling pump A
Coolant inlet vent valve

- On Dec 4, a patrolling shift worker accidentally touched the vent valve (fully closed) of the bearing cooling line of the primary system FPC pump for the Unit 1 Spent Fuel Pool (called SFP hereafter), thereby opening it slightly. Consequently, the system pressure of the secondary system for the common equipment in Units 1 to 3 gradually dropped to warning levels, and the common equipment was shut down manually.

Vent valve for the bearing cooling line of the primary system FPC pump

A patrolling shift worker accidentally touched the vent valve due to which that valve opened slightly. Thereafter, the system pressure gradually dropped through that valve, and as a result, lead to the shutting down of the pump for the secondary system common equipment.

- For important safety-ensuring equipment, such as the cooling equipment, recurrence prevention measures will be implemented for equipment as well as management and operating aspects so as not to cause shutdowns of important functions. **In particular, if the possibility of human error cannot be completely eliminated in regards to equipment, sound physical protection measures will be implemented to ensure that the issue does not lead to a shutdown of important functions.**
