Current State of Decommissioning and Contaminated Water Countermeasures at the Fukushima Daiichi Nuclear Power Station

December 1, 2014

Fukushima Daiichi D & D Engineering Company

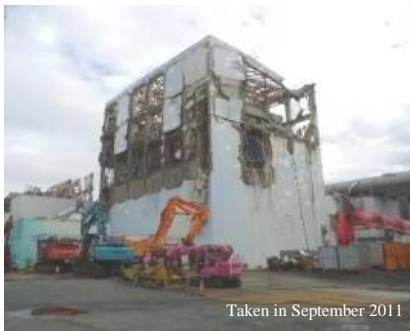
Prior to Debris removal

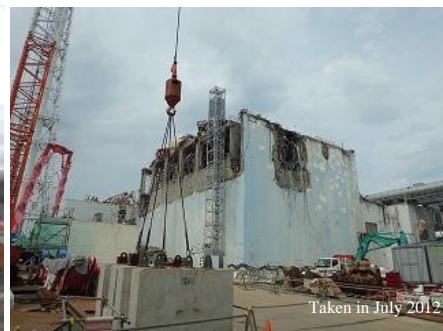
After Debris removal

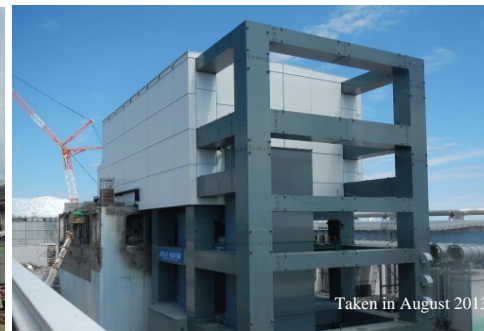
After Fuel removal cover installation

- The fuel removal cover supports fuel handling equipment and ensures that fuel removal work is not hindered by wind and rain, etc. while also suppressing the dispersion of radioactive material. First debris around the reactor building and on the refueling level was removed and the foundation for the fuel removal cover was constructed. After that a steel girder frame was built and wall and roofing panels attached thereby enabling the structure to be built in only approximately two years.

- This fuel cover is in the shape of an upside down L (cantilever-type) and is approximately 69m (NS) X approx. 31m (EW) X approx. 53m (height). Approximately 4,000 tons of steel was used for the crane support platform, which is almost the same amount as that used for the Tokyo Tower. Worker exposure was greatly reduced by employing bolts to connect steel frame to steel frame from the inside of thick pillars and bringing in wall/roof panels in large units thereby enabling construction to finish without any large accidents or disasters.

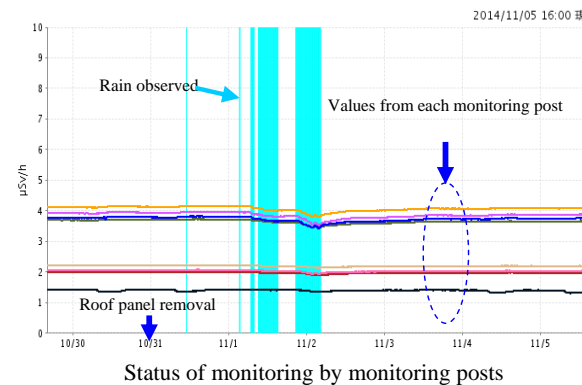
Status of monitoring by monitoring posts

- On October 22, holes started to be drilled in the roof of the building cover in order to spray anti-scattering agent in preparation for building cover dismantling which is scheduled to begin at the end of the fiscal year.
- Afterwards, the first roof panel was removed on October 31, followed by the second roof panel on November 10. The removed roof panels will be temporarily returned to the roof until the beginning of December of this year.
- There have not been any significant fluctuations in dust monitor readings on the refueling level or at monitoring posts.

Refueling level dust concentration prior to building cover dismantling: $2.1 \times 10^{-6} \text{Bq/cm}^3 \sim 7.2 \times 10^{-5} \text{Bq/cm}^3$ 【Period of measurement: October 17~22】

Refueling level dust concentration after commencement of building cover dismantling: $1.4 \times 10^{-6} \text{Bq/cm}^3 \sim 4.4 \times 10^{-5} \text{Bq/cm}^3$ 【Period of measurement: October 22~November 10】

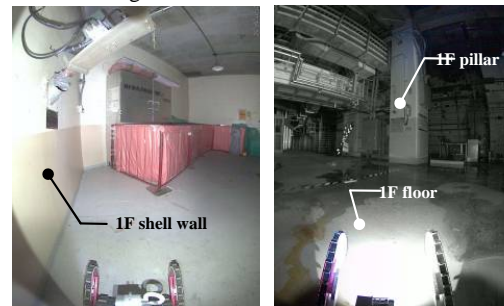
Reactor Building framework survey

- The reactor building structure survey did not find any damage to the shell wall or outer walls, which are vital for resisting earthquakes.
- When dose rates were measured after contamination using existing decontamination technology based on measured dose distributions, it was found that dose rates were 20~50mSv/h thereby greatly exceeding the objective of 1mSv/h (1m from the floor)
- Even if objective radiation level was achieved, a vast number of workers would be required in consideration of the amount of work that needs to be done.

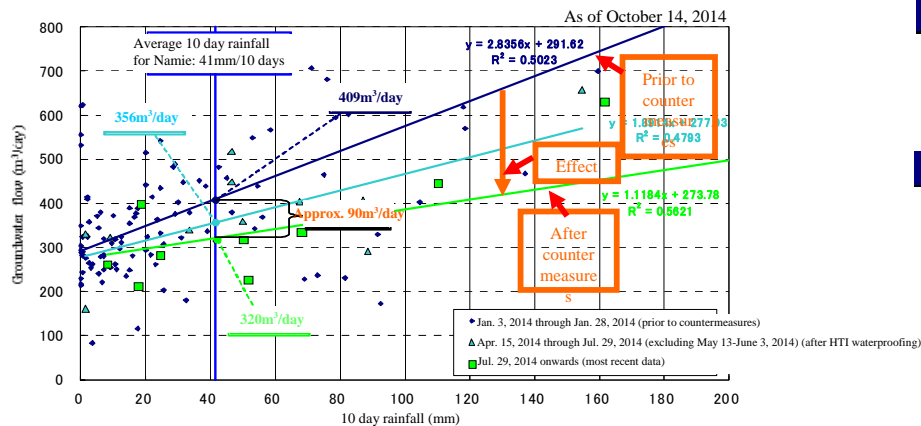
Groundwater bypass effect

- A groundwater bypass that consists of pumping of groundwater from wells upstream of the buildings has been created in order to reduce the amount of groundwater flowing into buildings and therefore suppress the increase in contaminated water since some of the groundwater flowing into buildings is coming in contact with contamination sources and becoming contaminated water. And an impervious wall made of frozen soil is also being constructed around the buildings in which contaminated water has accumulated in order to suppress the increase of contaminated water caused by groundwater flowing into the buildings.
- The frozen soil impervious wall is formed by sinking freezing pipes into the earth that lower the temperature of the soil around the pipes thereby freezing the soil.

- As of November 17, 2014, approximately 54,438m³ of groundwater has been pumped up over a total of 34 times and discharged upon having TEPCO and third-party agencies (Japan Chemical Analysis Center) confirm the water quality meets the objectives of the water.
- Water levels of groundwater around the buildings has decreased by approximately 20~25cm compared with before groundwater bypass pumping thereby indicating that the groundwater bypass is having an effect.
- The amount of groundwater flowing into buildings has decreased by approximately 90m³ per day as a result of countermeasures such as waterproofing the high temperature incinerator building.

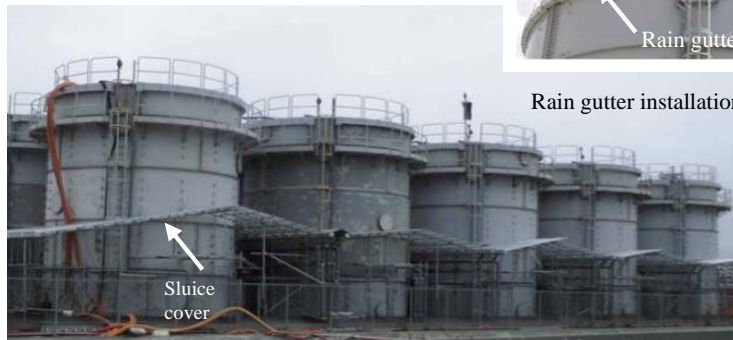
Rain countermeasures for tanks

- Highly reliable welded tanks are being used for additional tank installation. A certain degree of margin has been included in the construction plan to ensure that tank space does not run out. Some tanks are being manufactured at the Fukushima Daiini NPS in order to reduce worker exposure and work load.
- Tanks in site areas that have poor use rates are being removed and replaced with welded tanks. (Replacement)
- Implemented countermeasures to suppress rain water (rain gutters, sluice covers, etc.) have prevented water from overflowing from sluices even during the two large typhoons that hit Japan this year.
