Report on the  
Decommissioning  
Initiatives at the  
Fukushima Daiichi  
Nuclear Power Station

October 5, 2018

# Overview of Decommissioning Work at the Fukushima Daiichi Nuclear Power Station

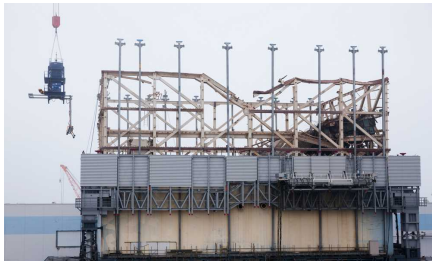
## Unit 1

Work of removing debris from the operating floor, etc. is carried out in preparation for fuel removal from the spent fuel pool. Moreover, additional internal investigation of the containment vessel and its analysis is being carried out in preparation for removing the fuel debris.

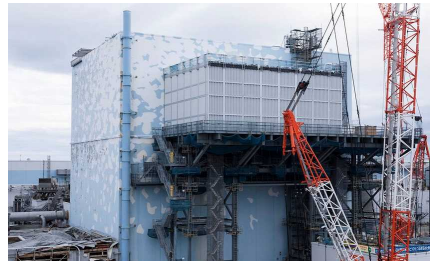
## Unit 2

An opening has been set up on the west-side of the building for extracting the fuel from the spent fuel pool. The investigation of the operating floor has been started. Moreover, additional internal investigation of the containment vessel and its analysis is being carried out in preparation for removing the fuel debris.

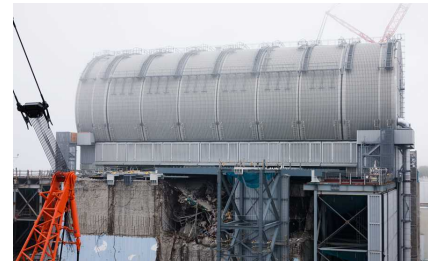
## Unit 3

Installation of equipment such as the fuel handling machine in preparation for fuel removal from the spent fuel pool has been completed. Trial runs of the fuel handling machine and cranes are being carried out. Moreover, the necessity of additional internal investigation of the containment vessel in preparation for removing the fuel debris is being examined.

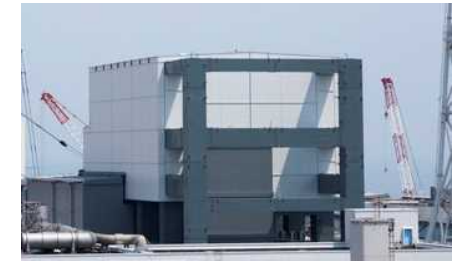
## Unit 4

Extraction of fuel from the spent fuel pool was completed on December 22, 2014 and thus the risk arising from nuclear fuel has been eliminated.

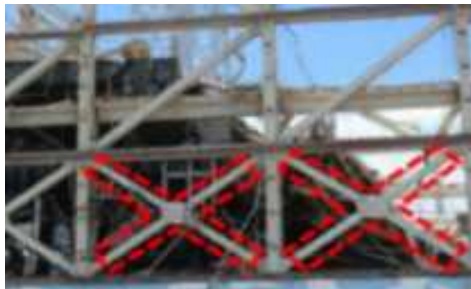
Work for removing debris on the southern side of the operating floor

In order to protect the spent fuel pool while carrying out work for removing debris from the southern side of the operating floor, preparations are being made so debris can be removed with the help of an X brace (X shaped steel frame). During these 3 months, training on the precision of the work procedures and training on remote operation are carried out.

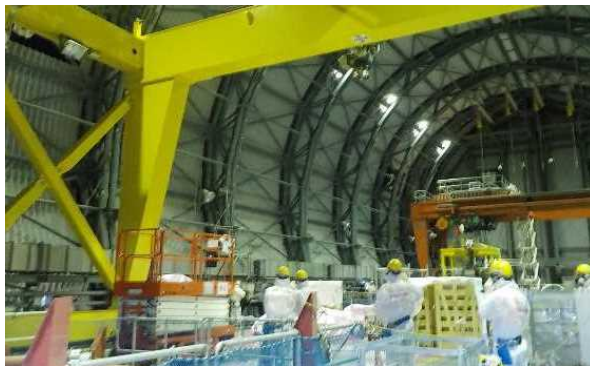
#### ► Overview of training on actual equipment

- A series of remote operations of the fuel handling machine from extracting the fuel from the rack to placing it in the on-site transport container are carried out using simulated fuel.
- On-site transport container is installed inside the spent fuel pool. A series of remote operations from closing the primary lid, checking to ensure that the container is sealed to lifting up the on-site transport container are carried out.
- A series of operations from lowering the on-site transport container to the ground, closing the secondary lid to loading onto the vehicle dedicated for on-site transportation are carried out (Manned operations).

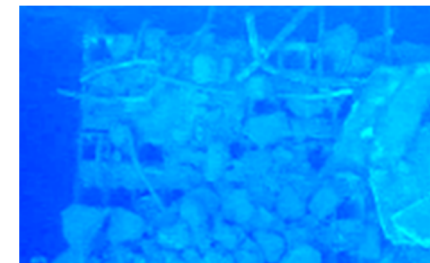
Image taken at the time of internal investigation of the pool in FY 2015

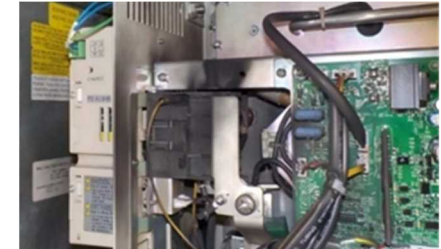
Soot inside the main winding inverter (May 11)

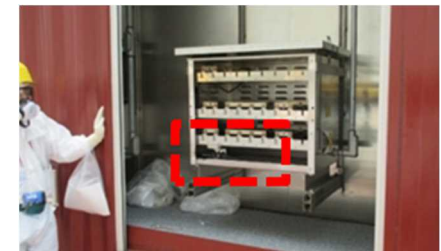
Picture of the inside of the brake register

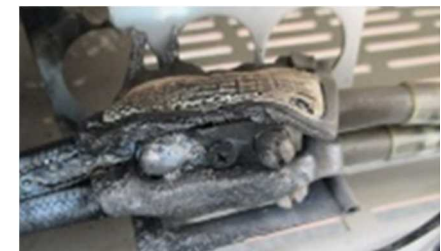
The next day, when the event was investigated, it was found that the insulator of the terminal strip in the brake register on the back side of the crane control panel and the head of the bolt had melted.

Damage of the inside of the brake register (May 12)

As a result of the investigation, it was found that the parameter settings of the brake unit were low settings configured at the time of shipping from the US (settings in accordance with the power supply voltage of 380V prevalent in the US).

Hence, the continuous current flow makes the brake register and its inside panel becoming hot, which result in the deformation of the insulator of the terminal strip, and lead to a short circuit inside.

The short circuit / ground fault current must have flown from the brake register to the main winding inverter thereby damaging the inverter.

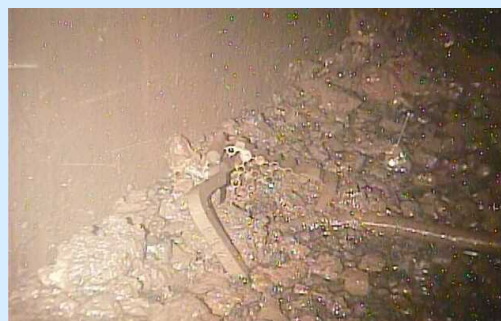
Investigation device for Unit 2

- ▶ Sediment deposits were found throughout the bottom part inside the pedestal.  
Fallen objects such as fallen grating, parts of fuel assemblies, etc. were found. The sediment deposits in the periphery were presumed to be fuel debris.

No major damage was seen on the surface of the wall or existing structures inside the pedestal.

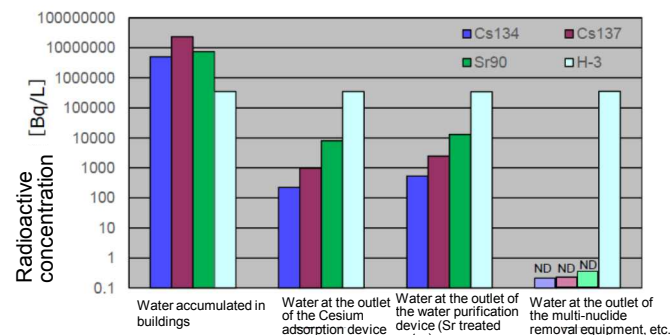
Radioactive concentration of the main nuclides in the contaminated water treatment process

(Supplementary items)  
 Water accumulated in buildings: Concentration of water accumulated in the HTI building  
 However, H-3 is the concentration of water at the outlet of the Cesium adsorption device  
 Water at the outlet of the Cesium adsorption device: Concentration of water at the inlet of the water purification device  
 Sampled on: March 8, 2016  
 (Sr90 from the water at the outlet of the Cesium adsorption device: March 5, 2016)  
 Water at the outlet of the multi-nuclide removal equipment: March 21, 2016  
 Water at the outlet of the multi-nuclide removal equipment: Concentration at the A system of the additionally installed multi-nuclide removal equipment.  
 When the value is lower than or equal to the detection limit (ND), the detection limit is shown.

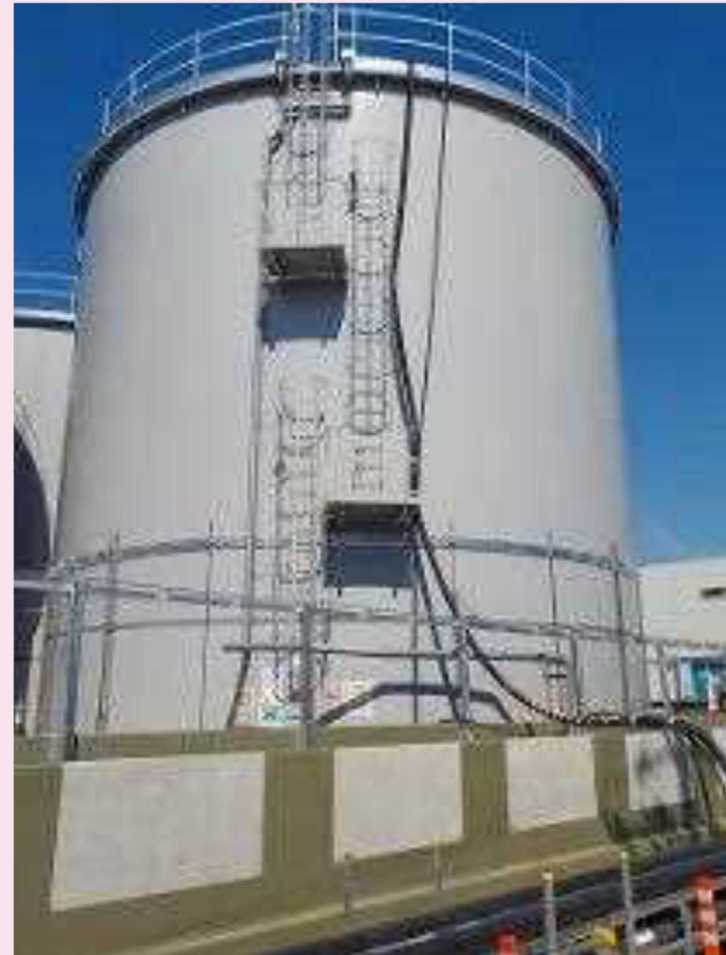
Tanks are being replaced sequentially with welded tanks to reduce the risk of leakage.

Moreover, in the vicinity of the tanks, weirs are set up to prevent the water from flowing into the site environ if by chance there is ever any leakage.

Further, patrolling of tanks and monitoring of water level (monitoring at all times), etc. are conducted constantly to be prepared in case there is leakage.

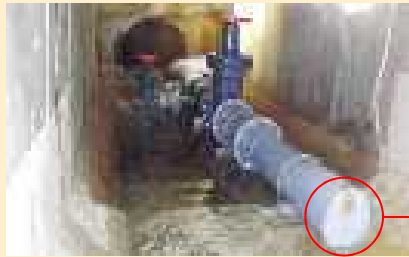
- ▶ Measures such as internal filling of trenches or installation of check valves in the drainage channel, etc. are carried out in preparation for increase in the quantity of contaminated water generated during heavy rains such as typhoon..

Installed check valve

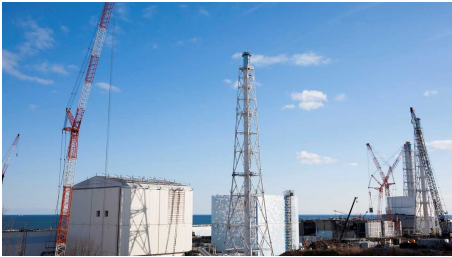
#### What is meant by work of disassembling the exhaust stacks in Units 1 & 2

the exhaust stacks in Units 1 & 2 meet the seismic resistance standards. However, based on the fact that there are locations with damage and ruptures, from the perspective of further reducing risks, the upper portion of the exhaust stacks are planned to be disassembled so as to secure increased seismic tolerance.

The work of disassembly is carried out in an unmanned manner using a stack shell disassembling device and steel tower disassembling device that can be operated remotely, thereby placing importance on reducing the exposure of workers.

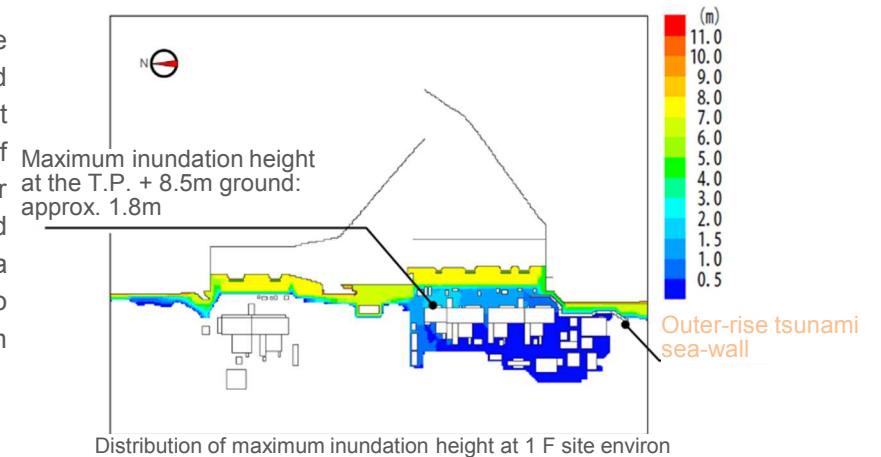
Since the earthquake along the Kuril-Kamchatka Trench is believed to be connected to the northern part of the Japan Trench (northern part of Sanriku offshore), although smaller than the 3/11 tsunami, it is believed that there will be an upsurge of a massive tsunami leading to maximum inundation of about 1.8m in front of Units 1 and 2.

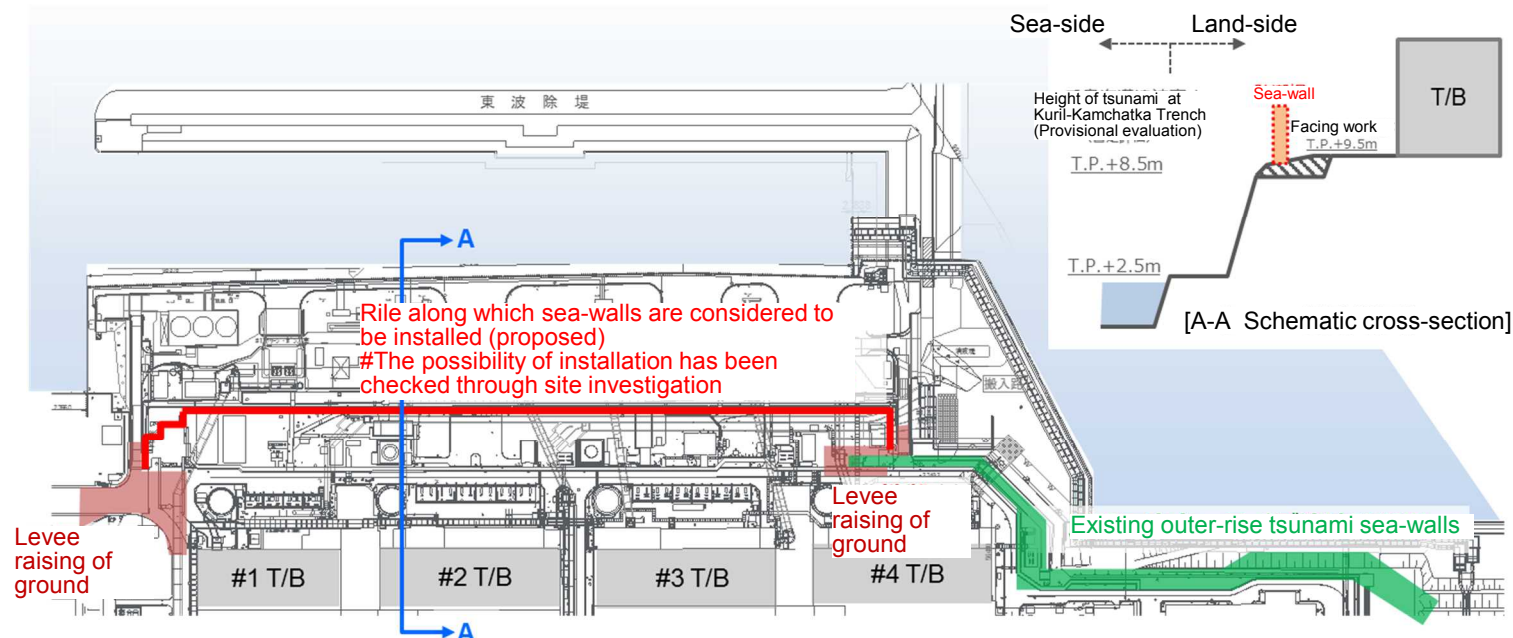
## Tsunami countermeasures ③

In response to the Kuril-Kamchatka Trench tsunami, controlling flooding into the reactor buildings, etc. and preventing increase of accumulated water in association with inflow into the buildings or extending the existing outer-rise tsunami sea-walls and installing sea-walls as independent safety measures for reducing the tsunami, induced damage of important equipment, are being considered.
