Briefing for the Nuclear Reform Monitoring Committee

September 15, 2022

# **Progress of Decommissioning at the Fukushima Daiichi Nuclear Power Station**

Fukushima Daiichi Decontamination &  
Decommissioning Engineering Company

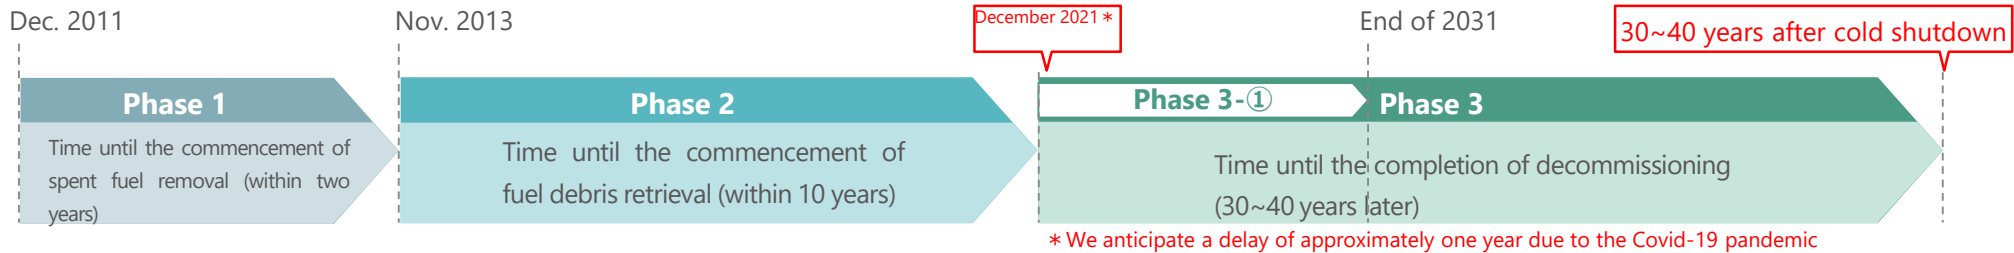
# Mid/Long-Term Roadmap

Phase 3-① will last until the end of 2031 and has been positioned as the, "time during which multiple schedules are carried out in a planned manner in order to commence more full-scale decommissioning."

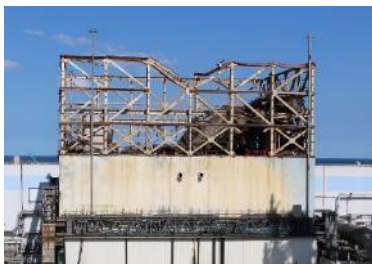
## Unit 1

Construction on a large cover began in September 2021 in preparation for the removal of fuel from the spent fuel pool after dismantling of the remaining portion of the building cover.

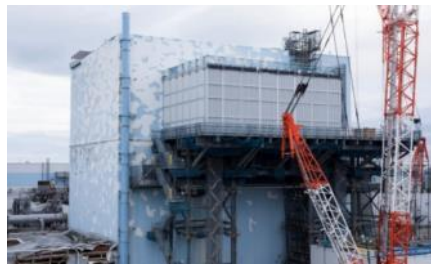
## Unit 2

Internal investigations of the primary containment vessel are being conducted in preparation for fuel debris retrieval.

A fuel removal platform anticum will be constructed on the south side of the reactor building in preparation for spent fuel removal. Preparations are also underway to commence fuel debris retrieval as this will be the first unit from which fuel debris will be retrieved.

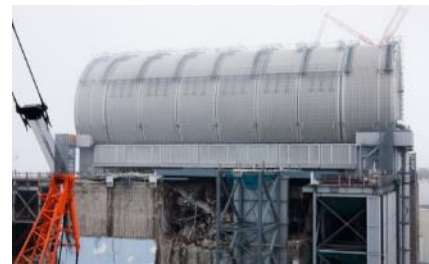
## Unit 3

**Fuel removal completed on February 28, 2021 (566 assemblies)**

Removal of the fuel from the spent fuel pool (566 assemblies) was completed on February 28, 2021. The necessity to conduct additional internal investigations of the primary containment vessel is being deliberated in preparation for fuel debris retrieval.

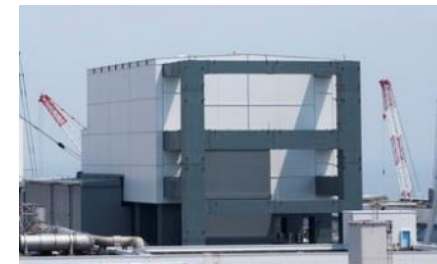
## Unit 4

**Fuel removal completed on December 22, 2014 (1,535 assemblies)**

Removal of the fuel from the spent fuel pool (1,535 assemblies) was completed on December 22, 2014 thereby eliminating risks associated with fuel.

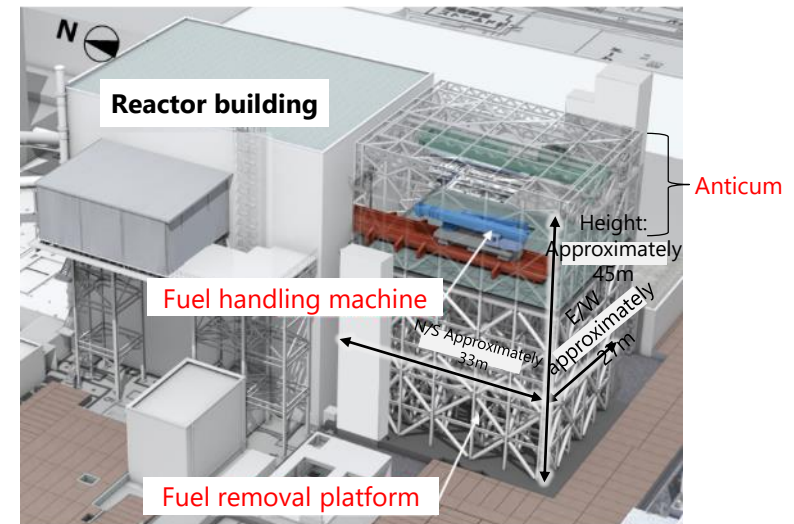
Concept diagram of the platform

- Unit 2: Work platform installation preparations
  - Fuel will be removed using a fuel handling machine from a fuel removal platform built on the south side of the reactor building.
  - ✓ On the operating floor shielding installation that began on February 17, 2022 was completed at the end of May and on August 22 we began removing the FHM operations room.
  - ✓ Outside the building excavation for ground improvement roadbed to build the platform foundation has been completed, and on June 16 we began installation of rebar for the foundation construction. Foundation construction should be completed by around November

\* The actual platform may differ from this diagram

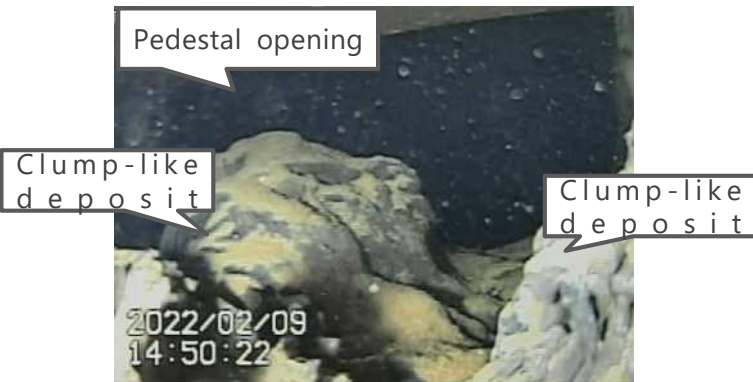
Inside the pedestal opening

- Clump-like and shelf-like deposits were found over a wide area in the primary containment vessel → It is assumed that they contain deposits originating from fuel debris due to the presence of thermal neutron flux
- At the pedestal opening, exposed rebar from the concrete covering the pedestal was found → Based on the information we have at current time, we've examined the potential impact on the plant from pedestal damage and have determined that the possibility of large failure is low.

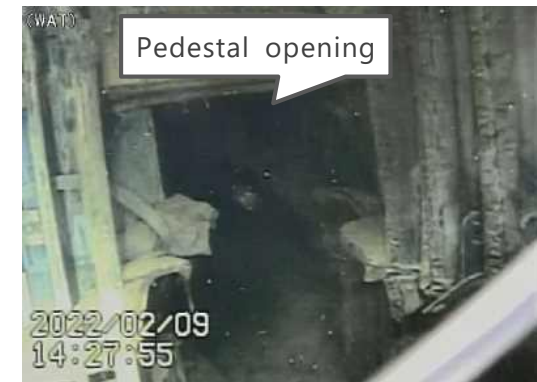
Birds eye view of the pedestal opening

Investigation of the area near the pedestal opening using ROV-A (for installing guide rings) (February 9 investigation)

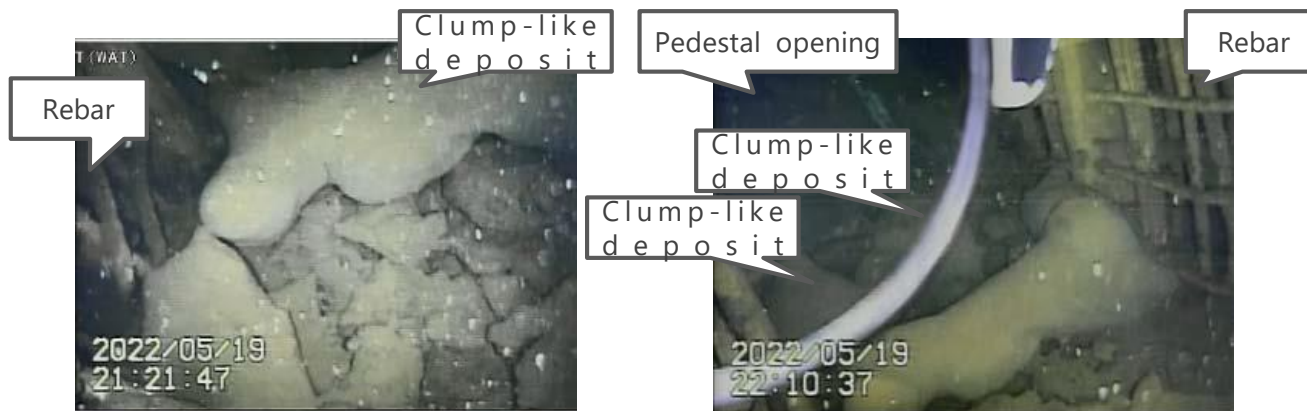
Pedestal opening (immediately inside)

Birds eye view of the pedestal opening (immediately inside)

Investigation of the area near the pedestal opening using ROV-A2 (detailed visual investigation) (from May 19 investigation)

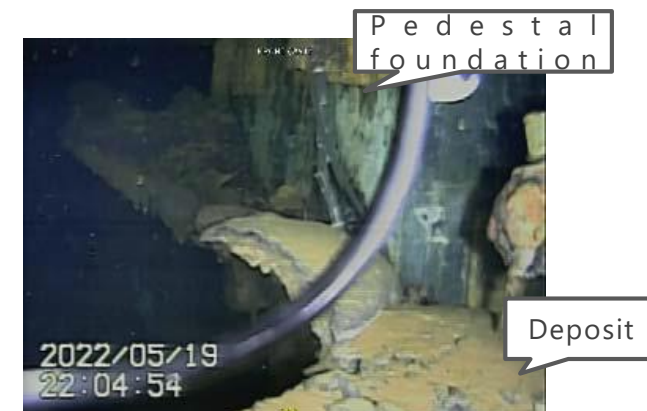
Above the deposits in the pedestal opening (right side of the foundation)

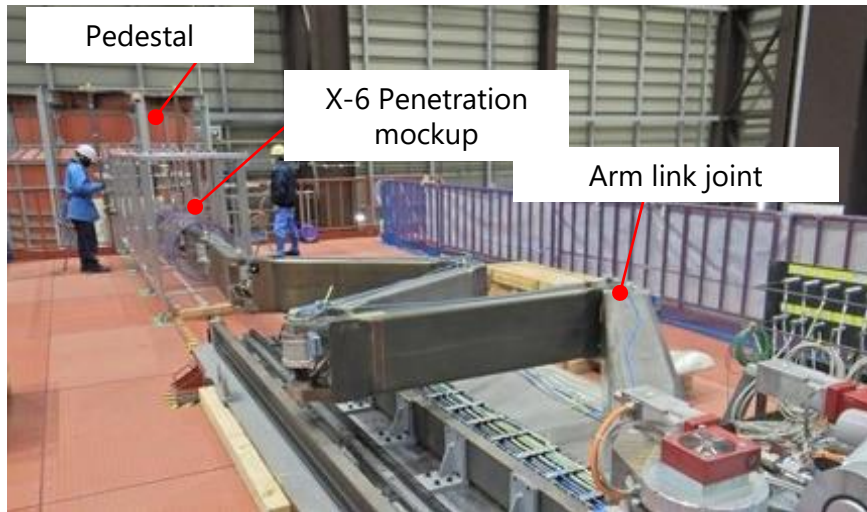
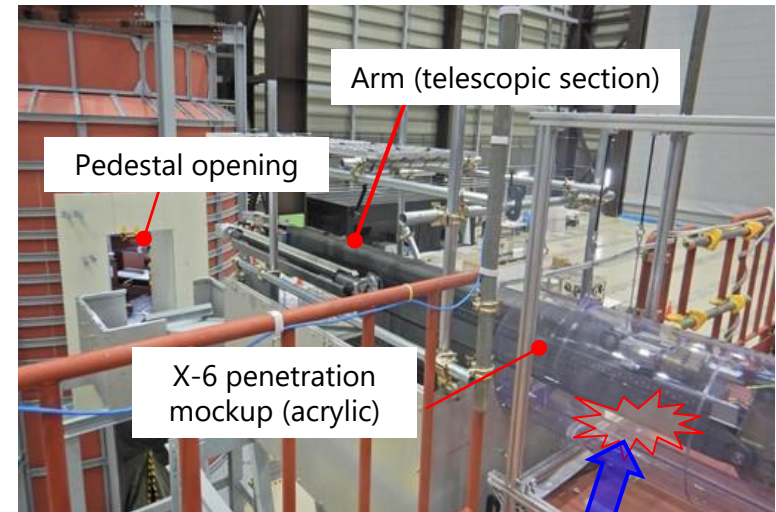
- Robotic arm performance tests
  - An acrylic mockup of the X-6 penetration was used to test the telescopic motion of the robotic arm (point of origin →extension →retraction)
  - An area for improvement that was identified was "improvement of the accuracy of arm link joint positioning." Positioning accuracy will be further improved at Naraha in order to reduce the risk of contact when passing through narrow areas like the X-6 penetration and areas inside the pedestal.

Reduce the risk of contact  
(Minimum clearance: Approx.  
15mm)

X-6 penetration insertion performance tests at the Naraha Remote Technology Development Center

Currently, improvements, such as control program corrections, etc. are being made to enable the discrepancies between data ascertained through mockup tests and the results of prior simulations to be compensated for thereby reducing the risk of contact during fuel debris retrieval.

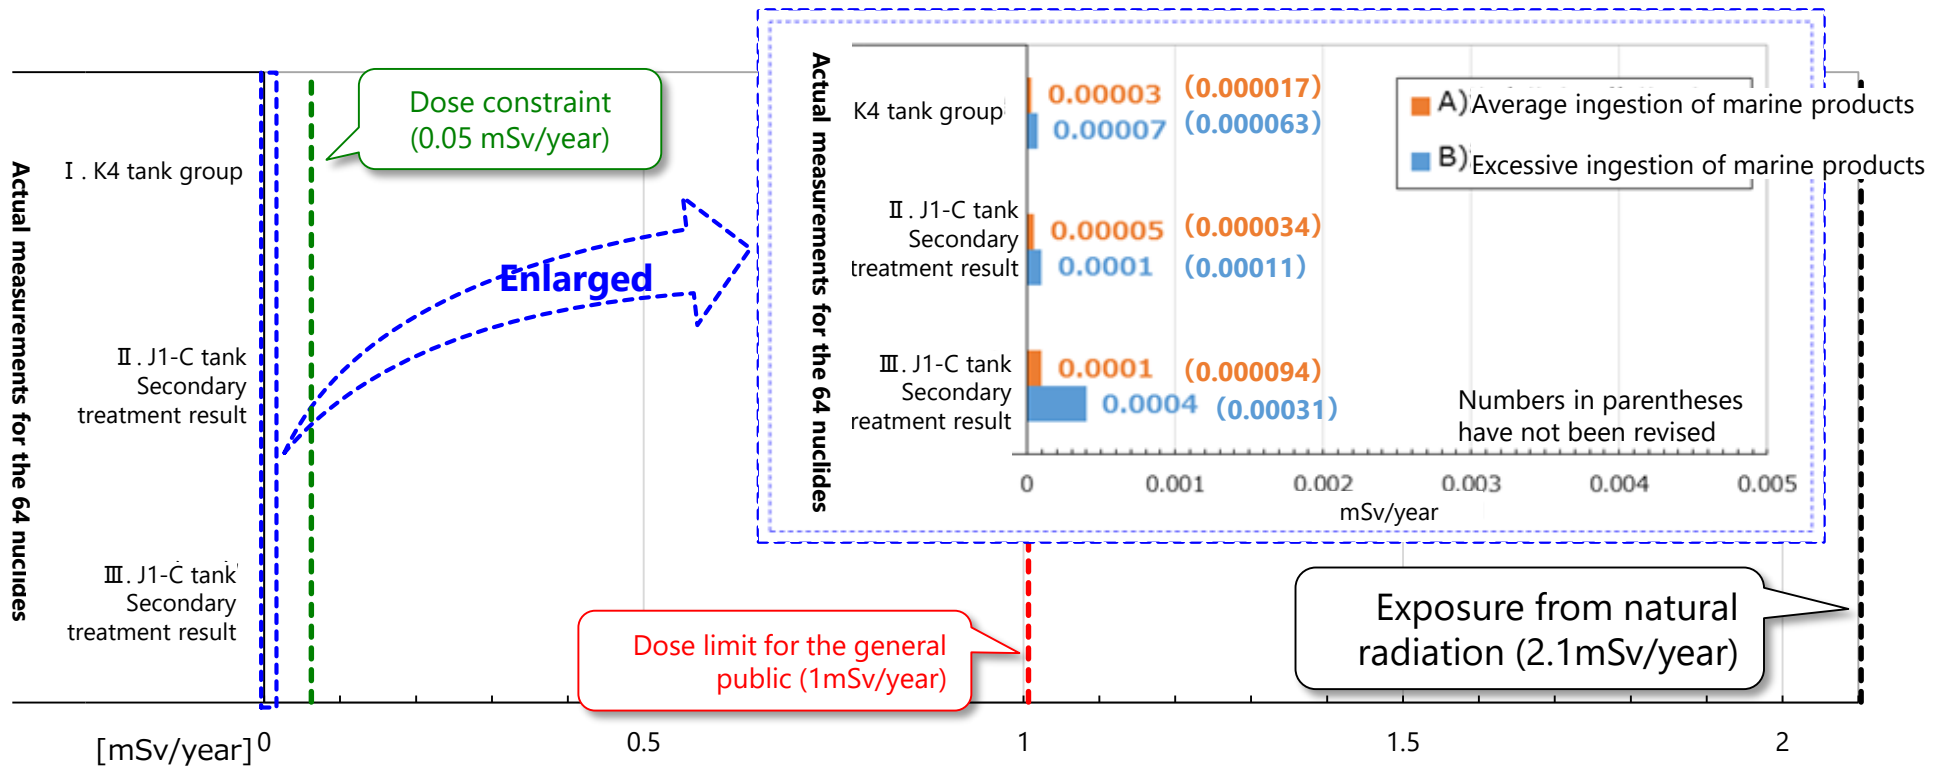
# Human exposure assessment results

- Assessment results based on actual measurements of the 64 nuclides show that exposure for the general public will be approximately 1/30,000~1/3000 that of dose limits (1mSv/year), which is approximately 1/2000~1/100 that of the dose target for domestic nuclear power stations (0.05mSv/year) that corresponds to dose constraints
