March 8, 2022 19th Nuclear Reform Monitoring Committee Meeting

## **Status of Initiatives at Fukushima Daiichi**

Fukushima Daiichi Decontamination & Decommissioning Engineering Company

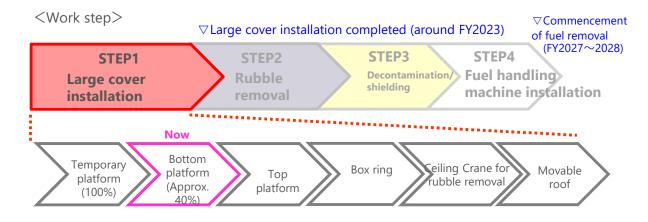
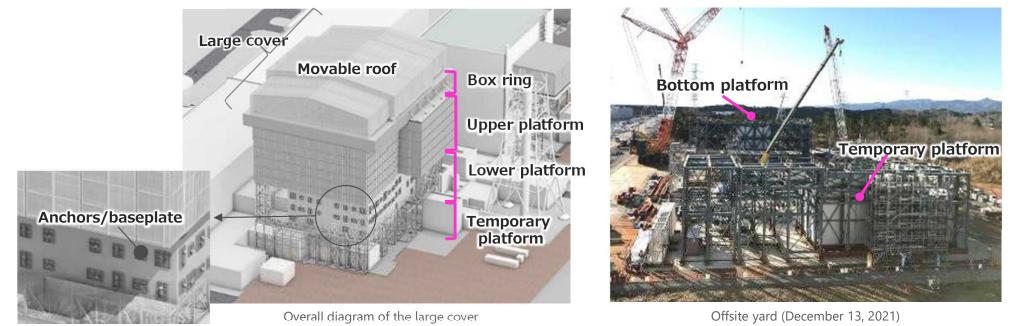
# Pool fuel removal: Unit 1 Large cover installation

- We are in the process of installing a large cover to encompass the reactor building in preparation for the commencement of fuel removal in FY2027~2028.
- The large cover is a steel structure comprised of a bottom platform, a top platform, a box ring, and a movable roof, with the bottom platform secured to the reactor building using anchors and base plates.
- Basic assembly of the steel frame is taking place off-site, and basic assembly of the temporary platform has been completed. Basic assembly of the bottom platform is approximately 40% complete (as of December 2021)
- We have inspected the outer walls of the reactor building (October-December 2, 2021) and have confirmed that cracks and concrete integrity are within design limits, and that it will be possible to secure the large cover using anchors as planned.

\* This is merely a Concept diagram, so it may differ from the actual structure

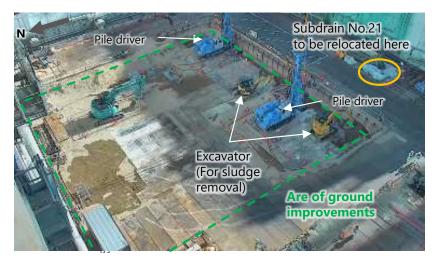
- Progress status of ground improvements
  - Pile driving began in October 2021 and as of January 26, 2022, 25 out of 74 piles have been driven into the ground (progress rate: approximately 34%)
  - All piles should be in place by April 2022

Assembly yard on the south side of the Unit 2 reactor building (January 8, 2022)

- STEP 3 ground improvements are underway in preparation for construction of the fuel removal platform
- In off-site yard is being prepared for basic assembly of the frame structure in preparation for frame structure construction of STEP 4

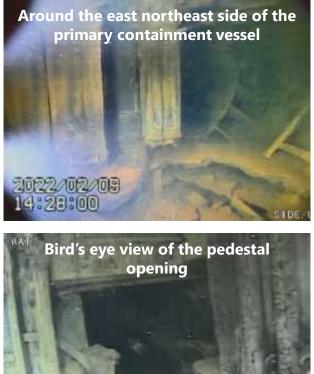
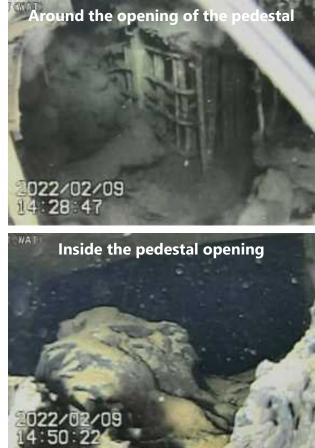
### Commencement of investigations using a submersible remotely operated vehicle (ROV)

- Investigations include detailed visual investigations of the inside and outside of the pedestal, measuring deposit thickness, detecting deposit debris, sampling deposits, and of the 3-D mapping of deposits.
  - From February 8, 2022, we have been installing rings (guide rings) to prevent the cable to the submersible ROP from becoming entangled.
  - Conditions to the east-northeast of the PCV (215°) and the area around the pedestal opening were investigated in order to obtain information for future investigations, and deposits found.

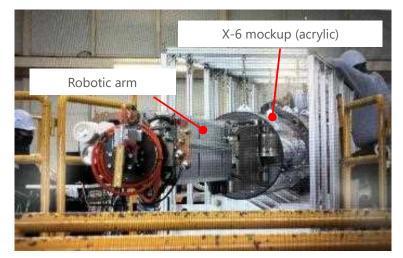
- The trial removal device (robotic arm) arrived in Japan on July 10, 2021
- Performance tests commenced at a factory in Kobe, Japan in August 2021 and concluded on January 21, 2022
  - Tests of passing the robotic arm through a mockup of the X-6 penetration w ere conducted and there were no problems
  - The robotic arm was extended to full-length to check operability and acquire data on sagging

Tests to pass the robotic arm through the X-6 penetration When tip of arm is extended

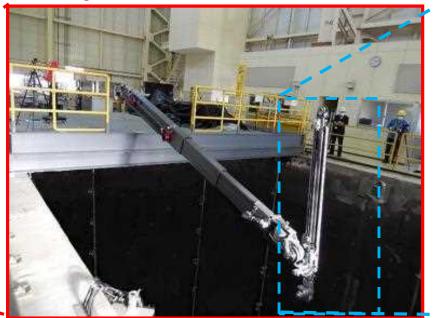
※ A video produced by the International Research Institute for Nuclear Decommissioning (IRID) on the development of technology for performing detailed investigations of the inside of the primary containment vessel (voluntary project) (field demonstration of detailed internal investigation technology and the X-6 penetration) can be found on YouTube at the following link https://voutube/m01KASVOac Arm during maximum extension

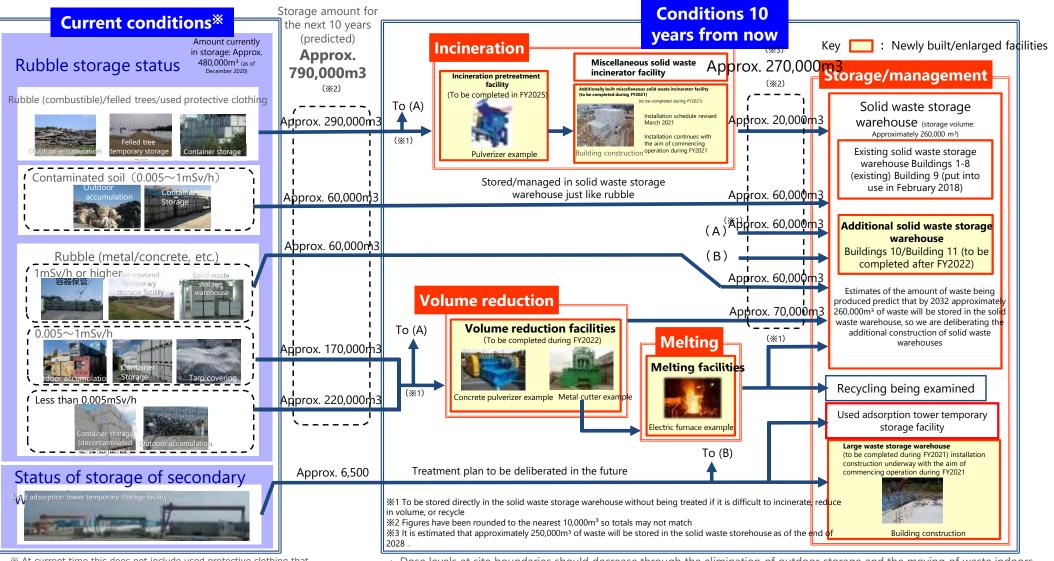
## Solid waste storage and management plan

- In light of the actual amount of waste generated, such as rubble, etc., as of the end of March 2021, and the most up-to-date construction plans, we have forecasted the amount of waste that will be generated over the next approximate 10 years, and are checking the impact that this will have on facility construction.
- We predict that we will be able to achieve our Mid/Long-Term Roadmap target (during FY2028) for the elimination of the temporary storage of rubble, etc. (excluding reuse and repurpose Inc.), and are moving forward with plans towards achieving that target.

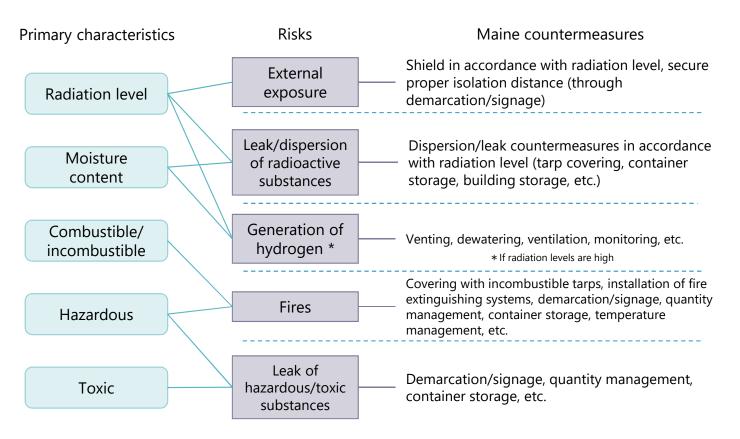
- Materials on-site shall be stored suitably regardless of their "positioning" as construction materials, temporarily accumulated items, or rubble, etc.
- The nature of the materials on-site shall be focused on and if any safety measures are found to be insufficient, priorities shall be set and corrections will be made.

Demarcation/signage for temporary accumulation locations

Temporary tarp covering of notch tanks

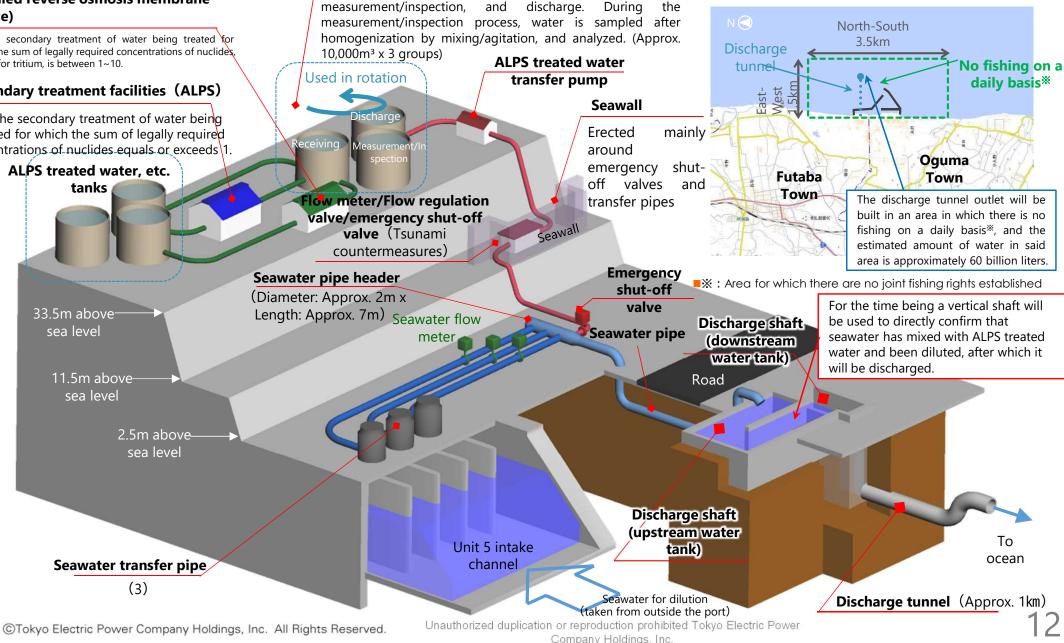
## Treated water countermeasures: **Overview of ocean discharge facilities**

#### Secondary treatment facilities (newly installed reverse osmosis membrane device)

For the secondary treatment of water being treated for which the sum of legally required concentrations of nuclides, except for tritium, is between 1~10.

#### Secondary treatment facilities (ALPS)

For the secondary treatment of water being treated for which the sum of legally required concentrations of nuclides equals or exceeds 1.

Consists of three sets of tanks for receiving, measurement/inspection, 10,000m<sup>3</sup> x 3 groups)

**Measurement/inspection facilities** (K4 tank group)
