**Report on the Recent Fatal Accidents at Fukushima Daiichi and Daini, and on the Serious Injury at Kashiwazaki-Kariwa, and on Efforts to Prevent Future Serious Accidents**

**March 30, 2015**

**Nuclear Power & Plant Siting Division  
Fukushima Daiichi D&D Engineering Company**

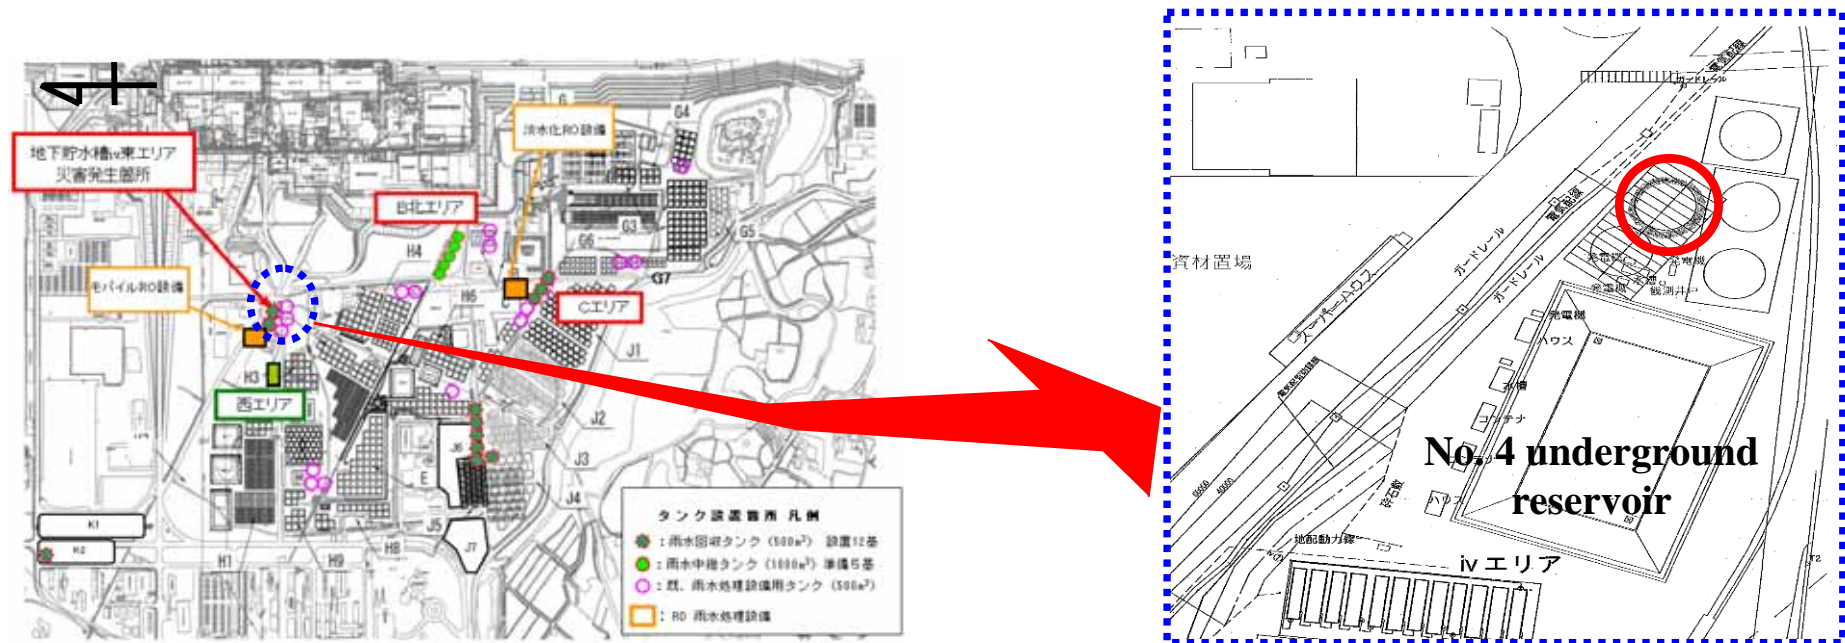
- **Date:** January 19, 2015 around 9:06 AM
- **Place:** Rain collection tank No. 2 (East side of No. 4 underground reservoir area)
- **Workers:** 3 (1 TEPCO employee, 2 contractor employees)
- **Equipment:** Tyvek suits, full face masks, helmets, safety boots, gloves (two pairs: rubber gloves and cotton gloves), safety belt
- **Situation:** During on-site rain collection tank installation the contractor fell from the roof of the aforementioned tank (Approx. 10 m) when making preparations to inspect the inside of the tank after water filling tests. The worker was rushed to the on-site emergency medical center and then to a hospital for further treatment at 10:31 AM on the same day but was pronounced dead by a physician at 1:22 PM on the following day (20<sup>th</sup>) after all treatment options had been exhausted.

Causes	Countermeasures
<p><i>Design:</i></p> <ul style="list-style-type: none"> <li>•The design of the hatch on the roof of the tank allowed the hatch cover to fall through</li> </ul>	<ul style="list-style-type: none"> <li>•Hatch lids on tanks to be built will be designed so that they cannot fall</li> </ul>
<p><i>Communications/Training:</i></p> <ul style="list-style-type: none"> <li>•There is insufficient sharing of information about similar incidents (Falling of Unit 5/6 Area F tank hatch lid)</li> <li>•No actions were taken to predict dangers or ensure safety.</li> <li>•Independent worker action was not stopped</li> </ul>	<ul style="list-style-type: none"> <li>•Improvements shall be made to how operational experience data is used, in sharing information with other power stations, in safety management, and in the degree of TEPCO's involvement in safety of contractors' work.</li> <li>•Contractors shall implement safety education about the risk of injuries from falls for all employees and workers, and will train workers on how to use their experience to increase awareness of possible risks.</li> <li>•TEPCO shall leverage safety information (such as nonconformity information), operational experience information, and accident information, in order to improve danger prediction and safety awareness. We will also use countermeasures on a daily basis.</li> </ul>

<p><i>Safety Procedures/Rules:</i></p> <ul style="list-style-type: none"> <li>•Inspection procedures and methods were not clear</li> <li>•One worker tried to open the roof hatch lid that weighs approx. 43 kg by himself</li> <li>•The safety rule was not observed requiring that safety belts be worn when working on the top of tanks (television locations).</li> </ul>	<ul style="list-style-type: none"> <li>•Inspection and operating procedures will be established.</li> <li>•Signs stating that hatches must be removed by at least two workers shall be posted as "hatch warnings."</li> <li>•The requirement for full harness-type safety belts to be used at all times will be reiterated.</li> </ul>
