# Report on the Investigation and Study of Unconfirmed/Unclear Matters

## Progress Report No.2

August 6, 2014

Tokyo Electric Power Company, Inc.

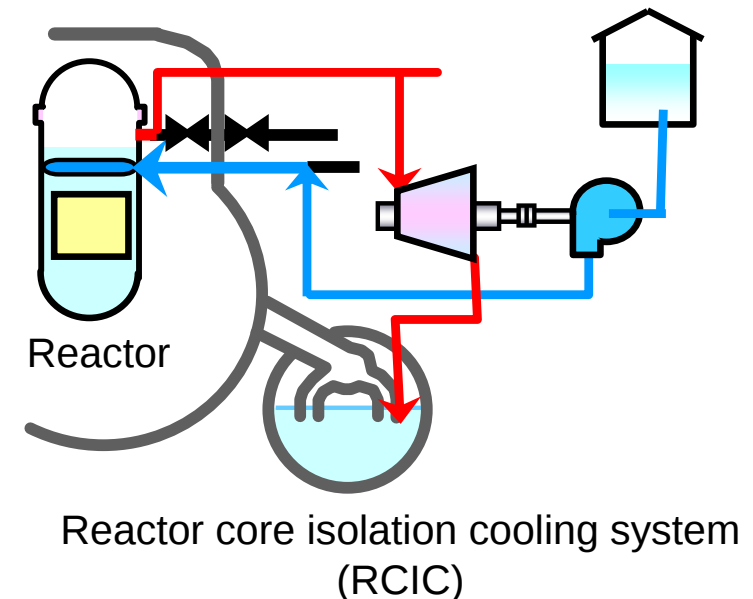
The RCIC shutdown occurring in Unit 3 at 11:36 of March 12 is likely to have been caused by an electric trip, due to high turbine exhaust pressure.

In addition to measures to bolster the HPCI system's functions,  
**an operational procedure to release the turbine exhaust pressure interlock is being prepared as part of tsunami response procedures.**

As part of review aiming to voluntarily improve the power station's safety, this will be reflected onto Tsunami Accident Management procedures. (January 2012)

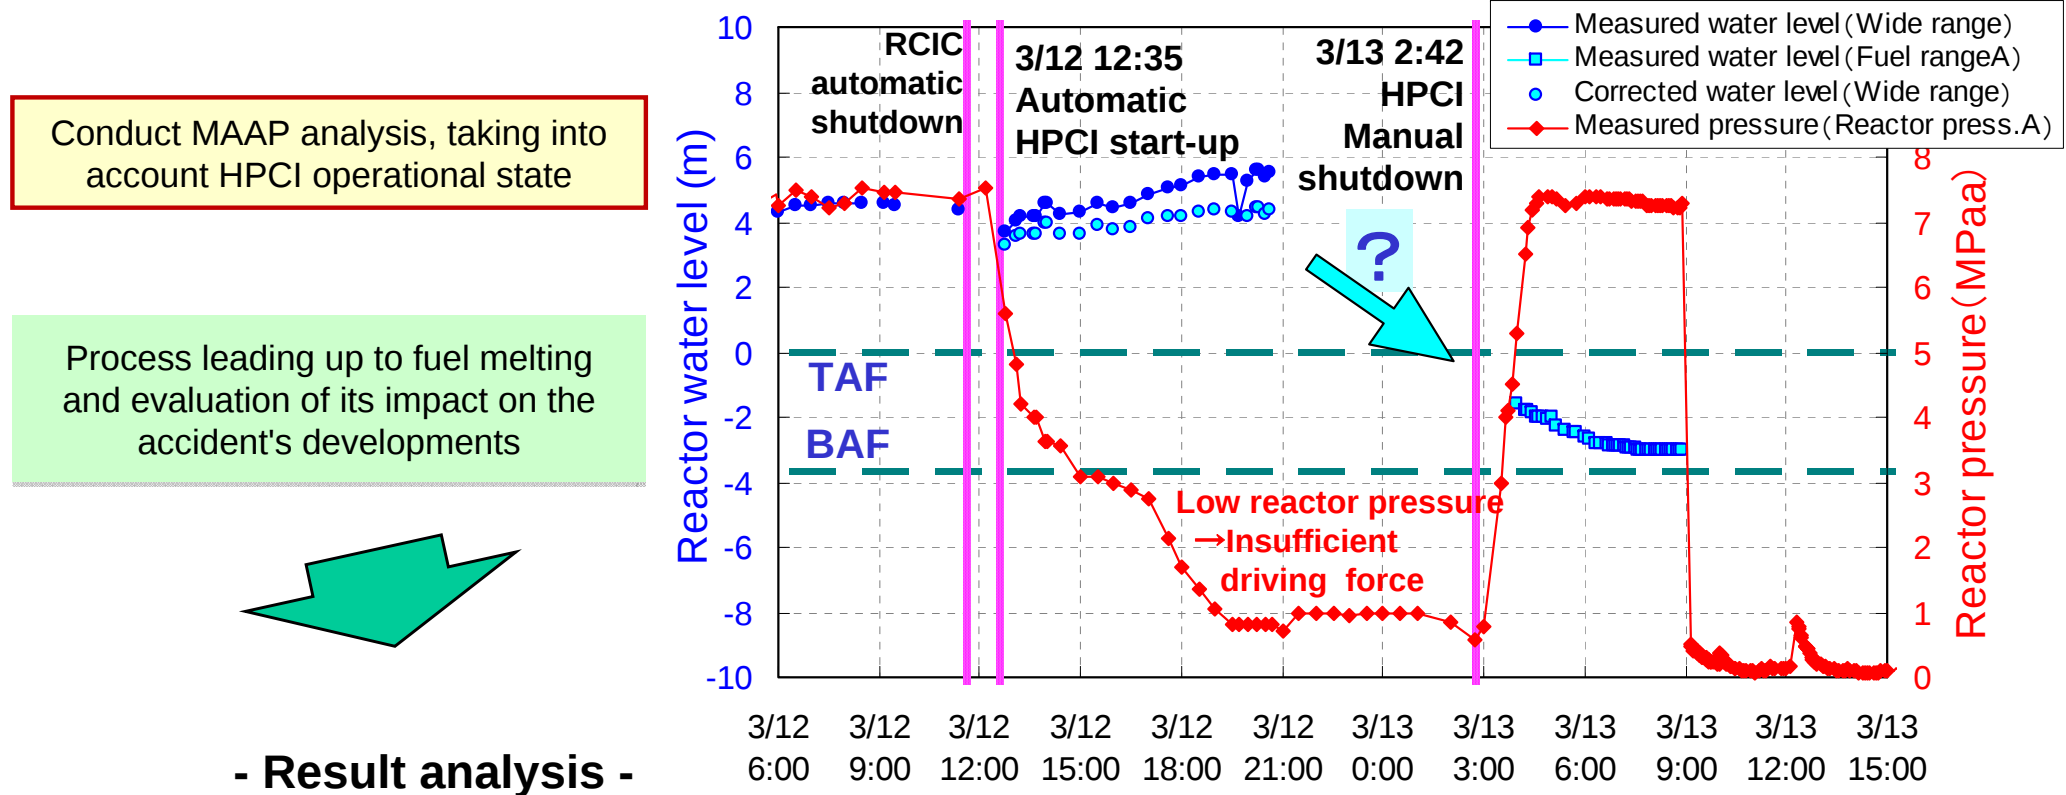
#### Process leading up to fuel melting

A zirconium-water reaction caused as the water level dropped resulted in fuel melting before the **water level reached the fuel's bottom.**

While uncertainty in the model and in the quantity of cooling water injected from fire engines makes the results of analysis somewhat unreliable, **the RPV did rupture, causing the majority of fuel to drop into the PCV.**

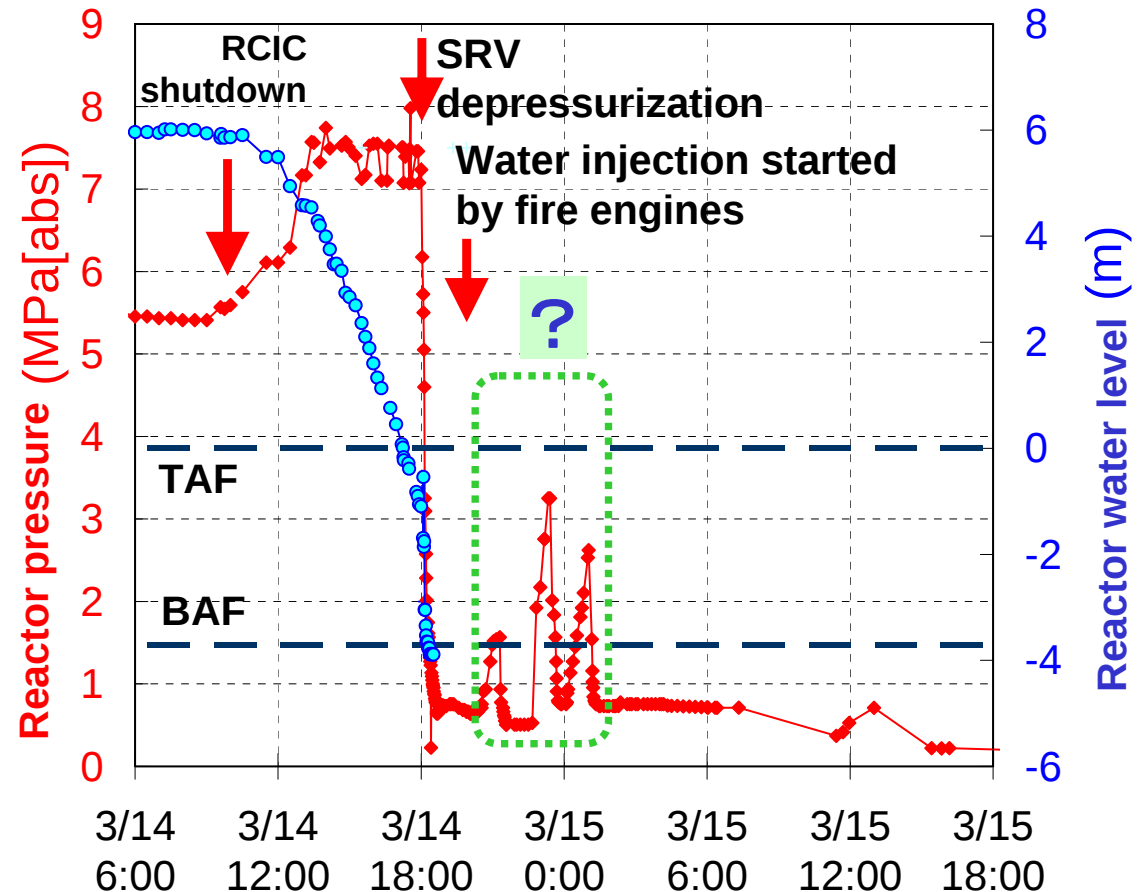
## (2) Process leading up to fuel melting

**We estimate a scenario where, after reactor depressurization, the steam generated by cooling water injection from fire engines caused a zirconium-water reaction, in turn causing reactor pressure to rise and lead to fuel melting.**

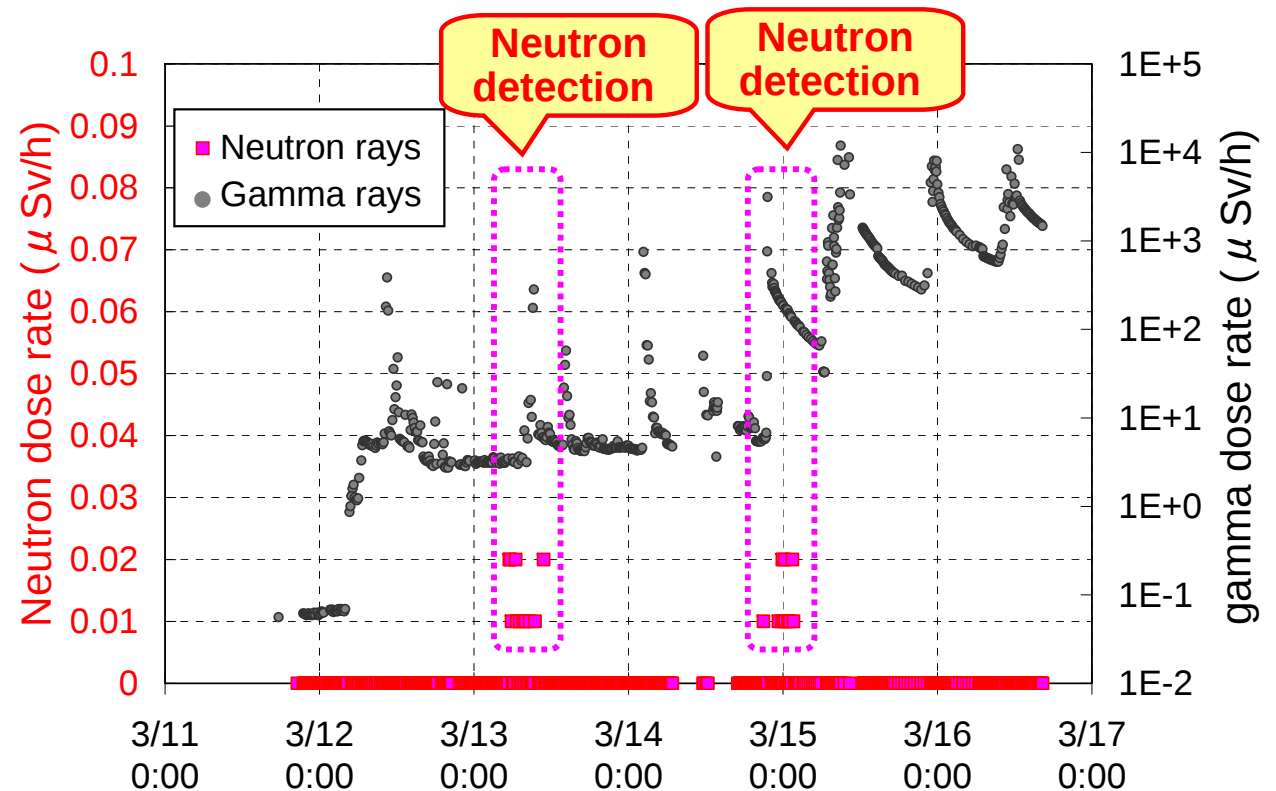
The timing of neutron detection and the increase in the gamma dose rate are not correlated.

The neutrons detected in the morning of March 13 and in the night of March 14 were released in the course of fuel melting at Units 3 and 2, respectively. Neutrons may have been generated by the spontaneous fission of released actinides.

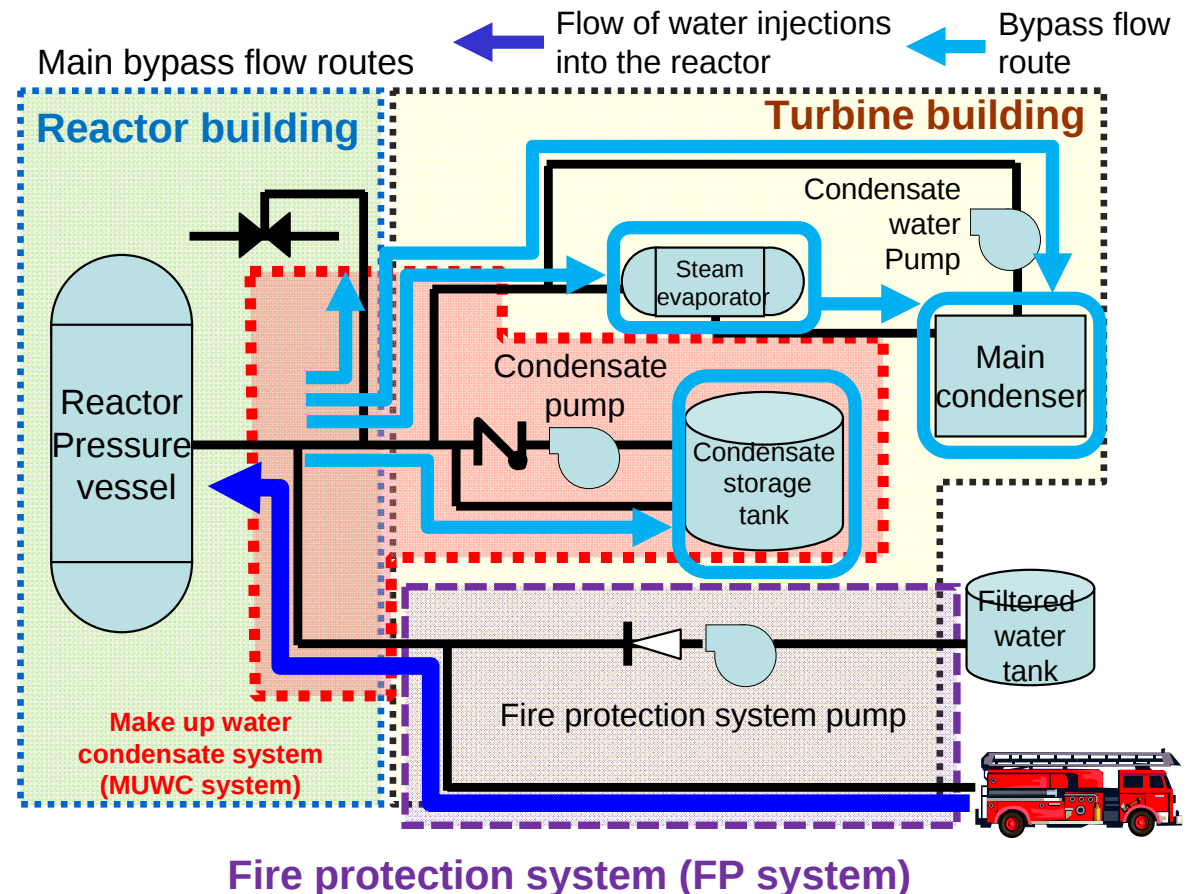
**20% to 50% of cooling water may have been injected into the reactor.**

If we assume fire engine discharge pressure to have been constant at 1MPa, then about 20% to 50% of water injected reached the reactor.

Note, however, that records of discharge pressure and flow rate, etc. from fire engines are few, and leave many aspects unclear; therefore, we will need to continue our review by conducting sensitivity analysis and comparison with plant response.
