Current State of decommissioning and contaminated water measures at Fukushima Daiichi Nuclear Power Station

August 24, 2015

Fukushima Daiichi Decontamination & Decommissioning Engineering Company (FDEC)

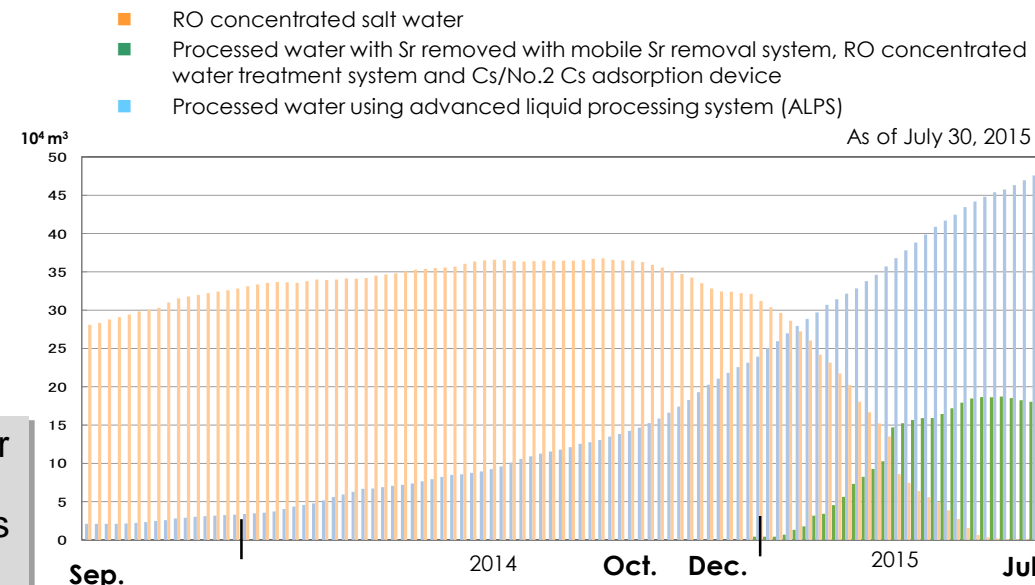
Contaminated water treatment facility	1 Advanced Liquid Processing System (ALPS)	2 Extended Advanced Liquid Processing System	3 High-performance Advanced Liquid Processing System	4 Mobile Sr removal facility	5 RO concentrated water treatment facility	6 Sr removal by installing Cesium adsorption	7 Sr removal by installing No.2 Cesium adsorption
Removal ability	Less than the notified concentration limit of 62 nuclides			1/10 ~ 1/1,000 of Strontium (SR)			
Treatment capacity	250m3/day x 3 systems	250m3/day x 3 systems	500m3/day	300m3/day x 2 series 480m3/day x 4 facilities	500 ~ 900m3/day	600m3/day	1,200m3/day
Status	Trial run in progress			Shutdown (Usage method for the next term being studied)		In operation

Change in the amount of treated contaminated water due to the contaminated water purification facilities

- The contaminated water (RO concentrated brine) was purified through seven facilities, including Advanced Liquid Processing System (ALPS), the residual water at the bottom of the tanks was removed, and the purification was completed on May 28.
- Hereafter, re-purification of the Strontium treated water and pumping and purification of the residual water at the bottom of the tanks will be implemented.

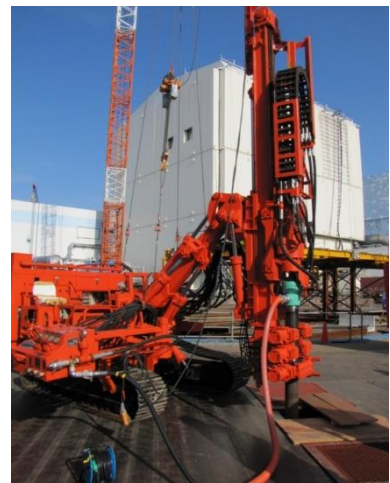
Situation of installation of frozen ducts

- Among the frozen ducts of the landside impermeable walls, the installation of the frozen ducts for the three regions on the mountain side to be frozen on priority was completed on July 28.
- For the seaside parts, the implementation plan was approved by the regulatory commission on July 31, so we plan to proceed with work sequentially.
- Freezing tests were started at 18 places from April 30 with the purpose of verifying the operating status of the entire coolant circulating system and the effect of the groundwater discharge. Currently, the coolant supply temperature is stable near -30°C without any refrigerator failure. For the underground temperature in the vicinity of the frozen ducts, a trend of fall in temperature is being confirmed depending on the layout of the frozen ducts, and isolation from sight tubes.

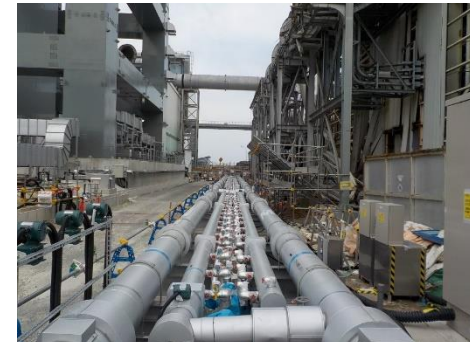
Situation of installation of cooling pipes

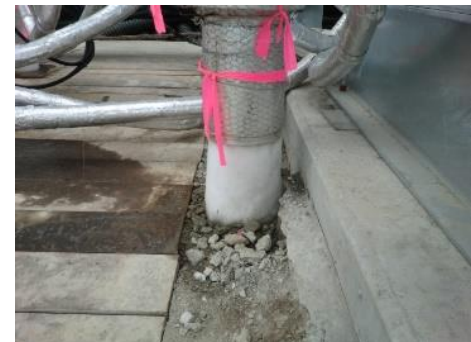
Situation of trial freezing

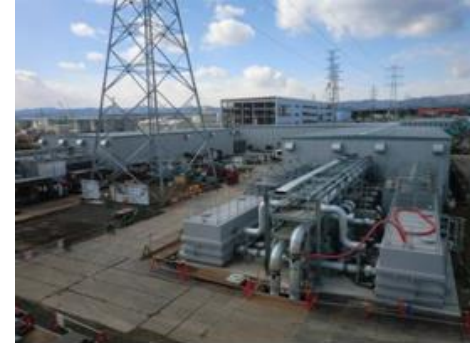
Freezer plant building

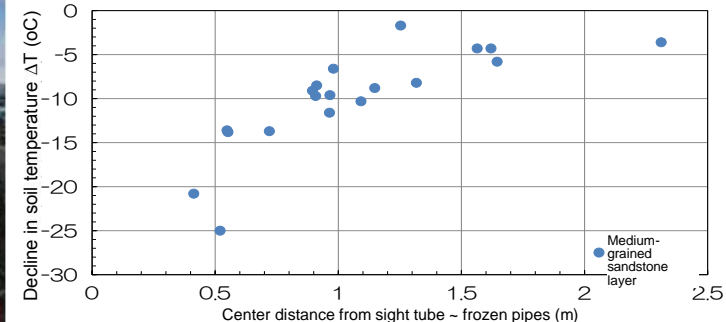
Isolation from the frozen ducts and underground temperature

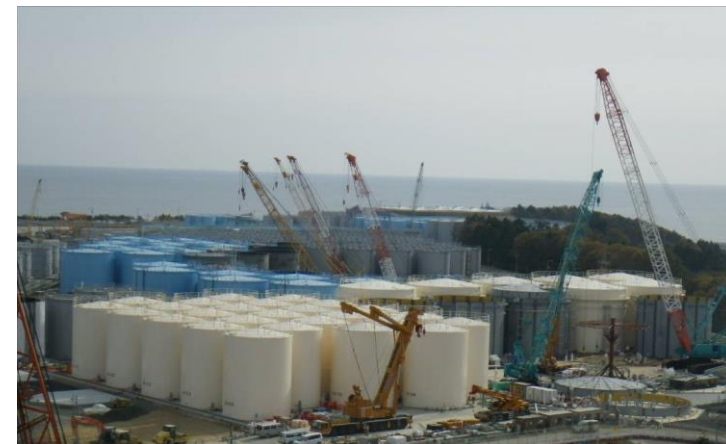
Tank construction and removal progress report

- To make sure that the receiving capacity for contaminated water is adequate, the construction of cylindrical steel tanks (welded joints (welded-type tanks)) was implemented in sequence keeping a margin in the plan, and in March 2015, 2 years ahead of schedule from the plan in the mid/ long-term road map, a total tank capacity of $800,000\text{m}^3$ was ensured. In continuation, the plan is to ensure $900,000\text{m}^3$ by March 2016.
- To improve the reliability of tanks, we are replacing (removing and installing) the flange-type tanks with welded-type tanks.

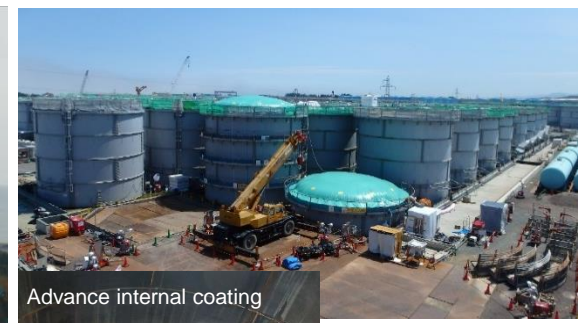
Advance internal coating

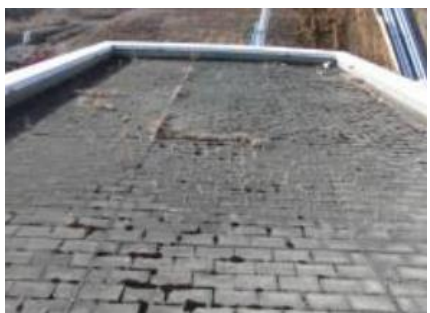
Prior to countermeasures

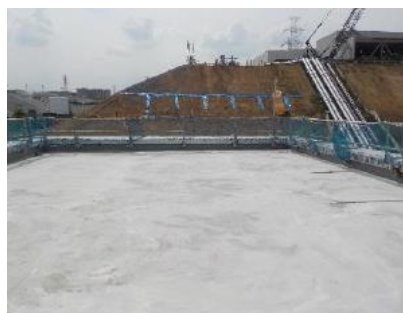
After countermeasures

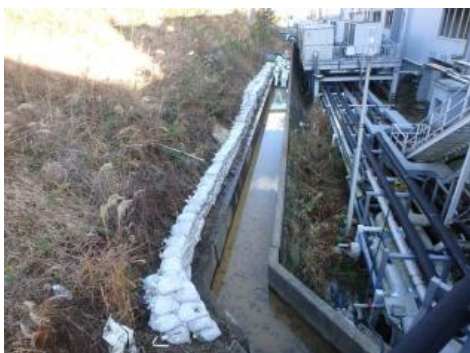
Cleaning of side ditch that leads to drainage channel K

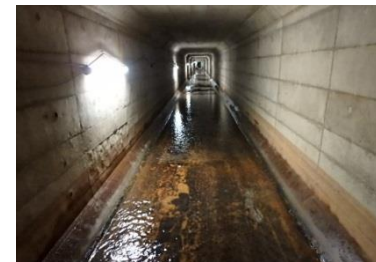
Cleaning of drainage channel K and installation of purification material

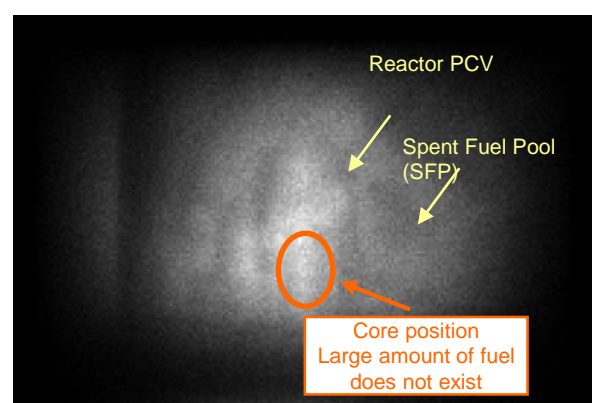
- To inspect the state of the fuel debris in the Unit 1 reactor, the position of the fuel debris was measured using cosmic ray muons.
- Due to the measuring of results from two directions and assessing them three dimensionally, we could verify the large absorbers (fuel in the Spent Fuel Pool (SFP)), which were expected to be seen, but the large fuel mass inside the reactor could not be verified.

Measurement results

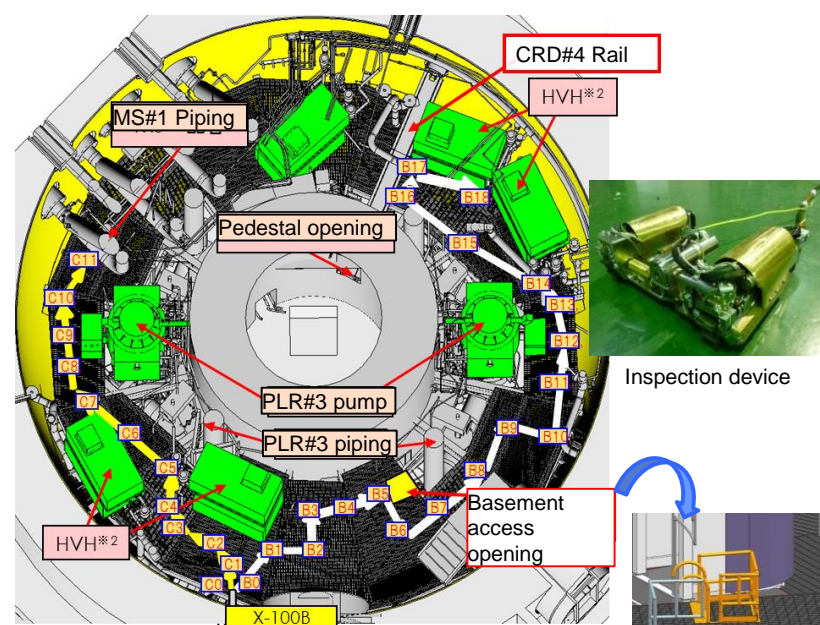
Inspection access route inside Unit PCV

- At Unit 1, from April 10 to 20, the state of the environment of the grating periphery and existing structures on the 1st floor outside the pedestal in the reactor containment vessel was inspected using robots. Valuable information, such as the state of damage and temperature inside the PCV and radiation level information, was obtained.

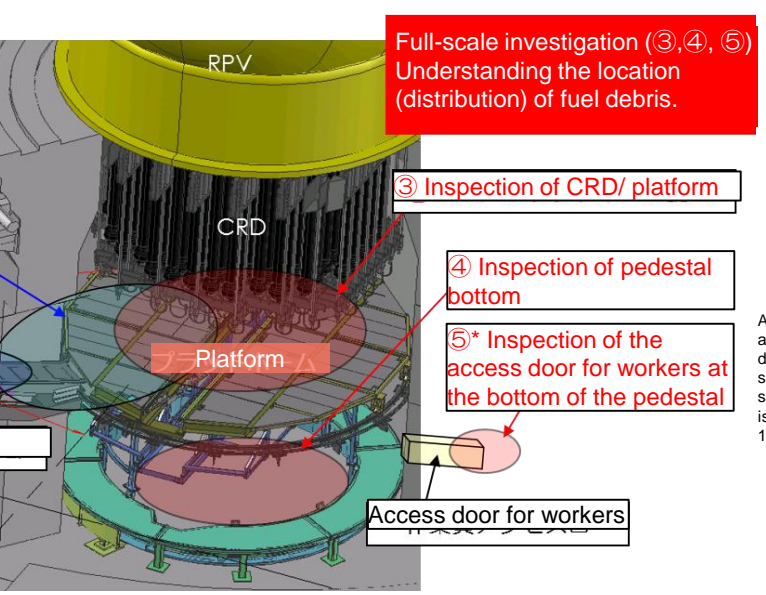
Preliminary survey (①,②)
Obtaining the access route inside the pedestal and the status and environmental conditions inside PCV.

① Inspection of the state of CRD rail/ pedestal opening
Implemented with inspection from X-53 penetration (August 2013)

② State/ environmental inspection inside pedestal
Inspection from X-6 penetration is planned

③ Inspection of CRD/ platform

④ Inspection of pedestal bottom

⑤* Inspection of the access door for workers at the bottom of the pedestal

Plan of investigation inside Unit 2 pedestal (image)

- At Unit 2, in order to grasp the location (distribution) of fuel debris inside pedestal, it is planned to put in the inspection device from containment vessel penetration (X-6 penetration).

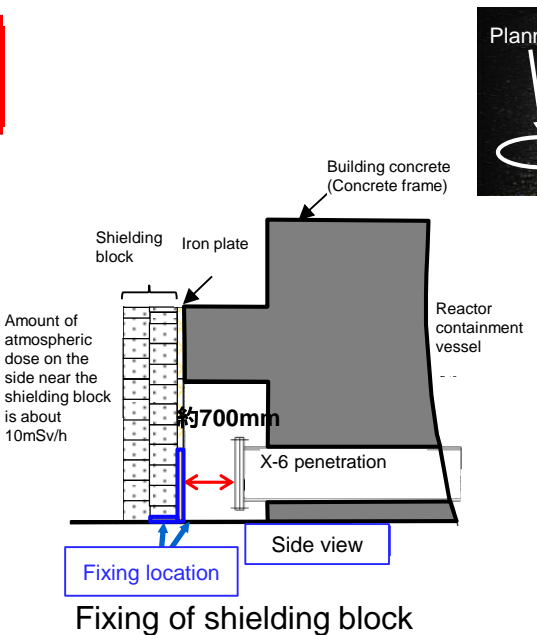
Fixing of shielding block

- The remote removal of the shield block installed in front of X-6 penetration section where the inspection device is installed, was started, but the operation has been suspended with 7 blocks that are stuck fast and cannot be removed. We intend to resume the removal as soon as the preparations are in place.

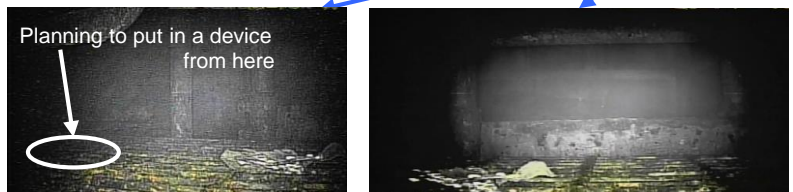
Access opening

Measurement result of temperature and dose rate inside Unit 1 containment vessel

Dose rate (Sv/h)	Temperature (°C)
5.3~9.7	17.8~21.1

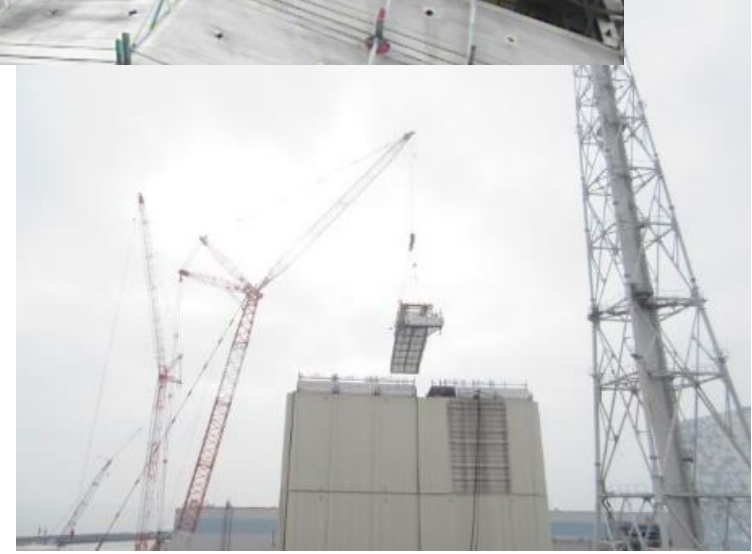
Removal of roof panel

- Removal of cover began on October 22, 2014. Investigation of dust after removal of 2 roof panels found no scattering of dust or situation that could immediately cause damage to fuel inside spent fuel pool. (roof panel restored on December 4, 2014)
- Removal of cover restarted on July 28. Removal of rubble will be steadily advanced.

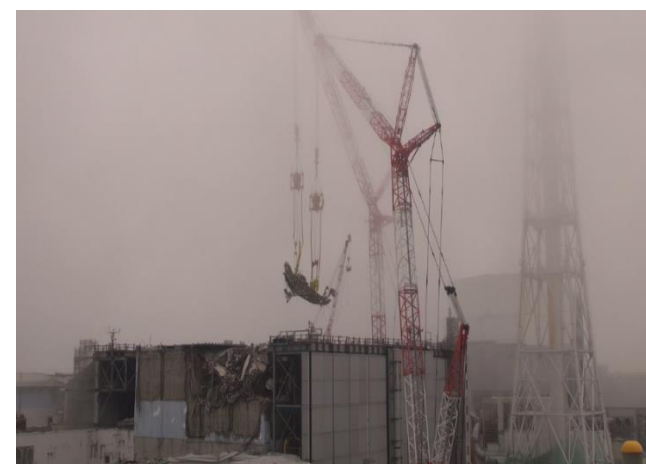
Removal of refueling equipment

- Work to remove refueling equipment (approximately 20t) which is the largest rubble inside Unit 3 spent fuel pool was conducted on August 2.
- Detailed removal plan which had been examined (investigation of situation inside pool and situation of rubble, development of dedicated hoisting tool, mock-up test, preparation of various risk measures) bore fruit and removal work was safely completed.
- Work to remove rubble inside spent fuel pool and work to install fuel removal cover will be continued for fuel removal. At the same time, fuel removal training is conducted with remote operation.

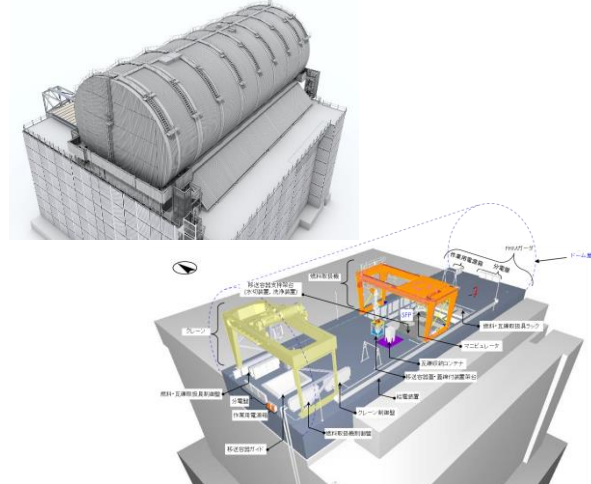
Image of fuel removal equipment

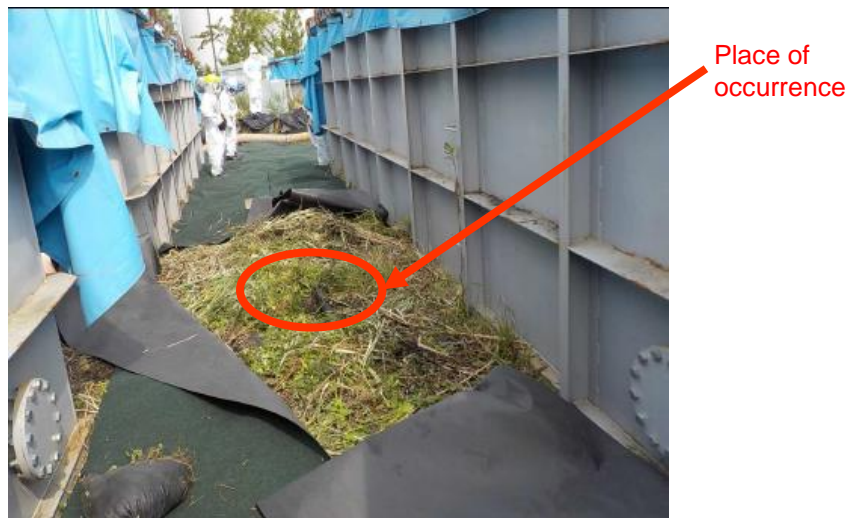
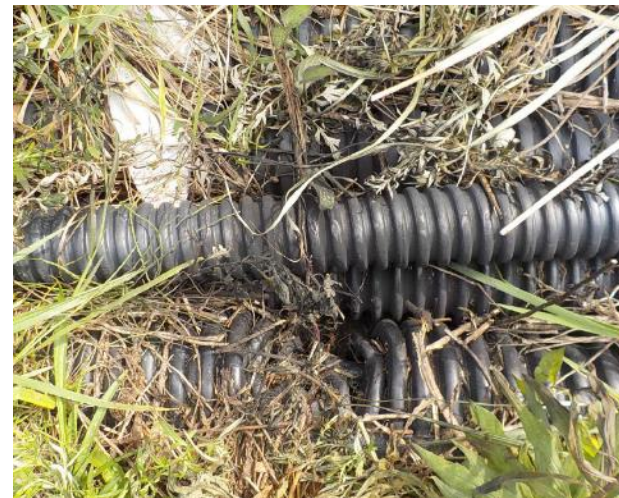
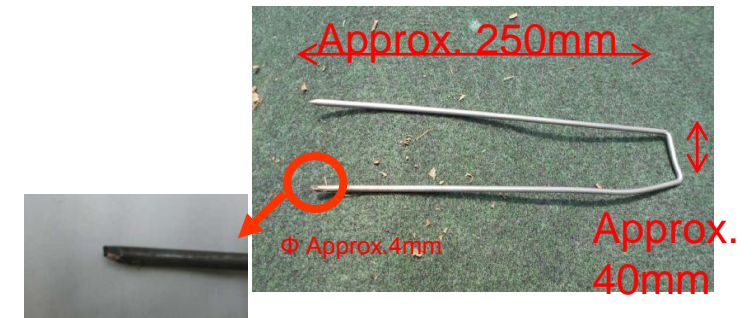
Grounding alarm in the power-supply facility and generation of white smoke from Eflex pipes

- Around 8:30 on July 28, 2015, in the vicinity of the notch tanks to the west side of the Advanced Liquid Processing System (ALPS) building, when the weed-proof sheet for cogon grass measures was being fixed with pins and laid, the internal power panel grounding alarm rang and emission of smoke from the Eflex pipes in the vicinity was confirmed.
- It was found that when pins were hammered and fixed into the weed-proof sheet laid for the cogon grass measures, a pin penetrated an Eflex pipe under the sheet, and damaged the power cable housed within, due to which grounding occurred and led to a burnout.
- Since this event has possibility of severely affecting facilities and becoming a fatal accident, problems will be examined in depth and measures to prevent recurrence will be implemented.

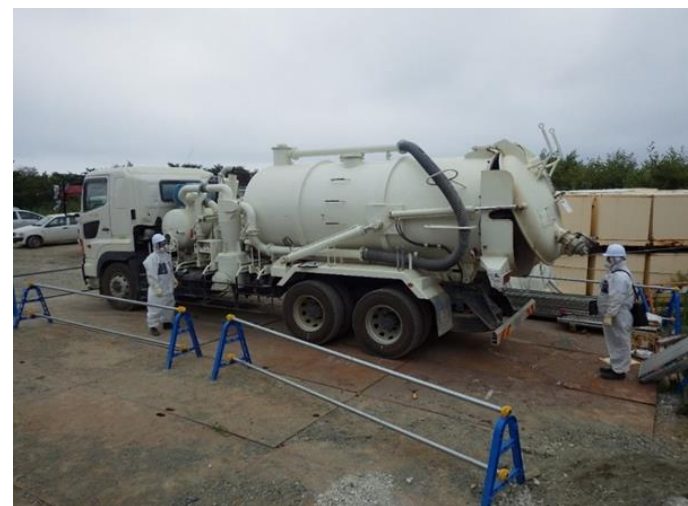
Arrangement of personnel during operation of tank cover

- Around 6:25 on August 8, 2015, the upper half of the body of a contractor worker who was cleaning the construction vehicle used for land-side impermeable wall construction work near the soil disposal area on Fukushima Daiichi Nuclear Power Station premises was caught in the tank cover at the rear of the vehicle and said worker died.

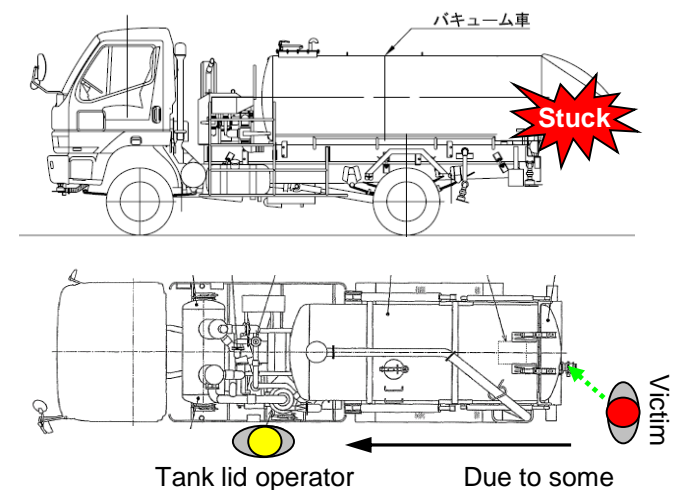
Due to some reason, the victim moved between the tank and its lid and got stuck
