# **The Status of Nuclear Safety Reform Initiatives**

Tokyo Electric Power Company Holdings, Inc.

# Contents of this report

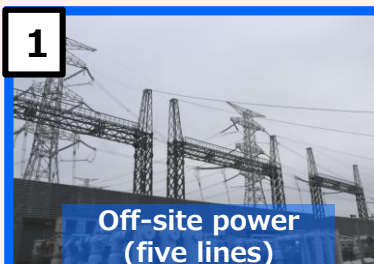
1

Off-site power  
(five lines)

Five off-site power transmission lines have been built to ensure that necessary power can be received from off-site in the event of an accident

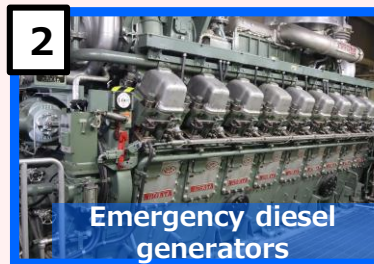
2

Emergency diesel  
generators

Started up in the event that off-site power was lost in order to provide required power. Can be used to cross-feed power to all units

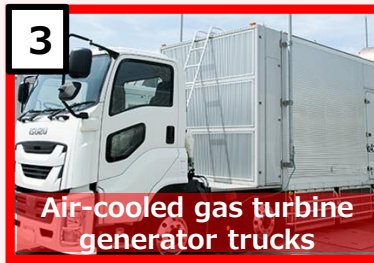
3

Air-cooled gas turbine  
generator trucks

Equipped with generators that produce electricity using turbines powered by diesel combustion gases, these trucks can provide power to large cooling systems. Parked in areas that would not be affected by a tsunami.

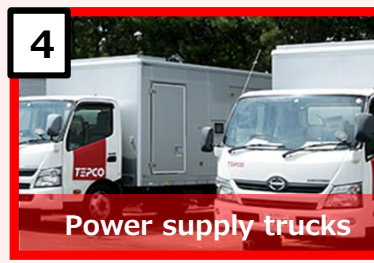
4

Power supply trucks

Highly mobile trucks that can be moved to wherever power is needed. Parked in areas that would not be affected by a tsunami

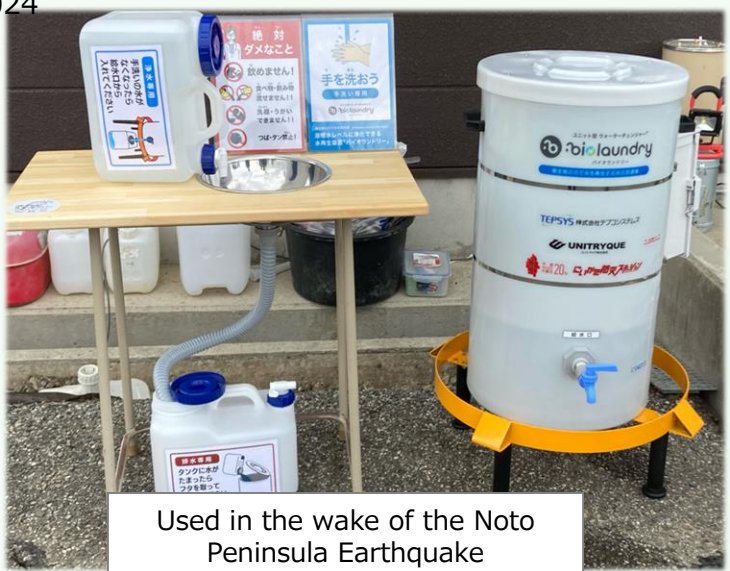
- In 2020 we signed a comprehensive agreement on coordination pertaining to preparedness/disaster reduction
- Through joint research we have developed preparedness products, such as a water changer® and a preparedness vaccine breaker kit®, that was commercialized with the help of companies in Niigata Prefecture.
- The water changer® was used in the aftermath of the Noto Peninsula Earthquake that occurred on January 1, 2024

Used in the wake of the Noto Peninsula Earthquake

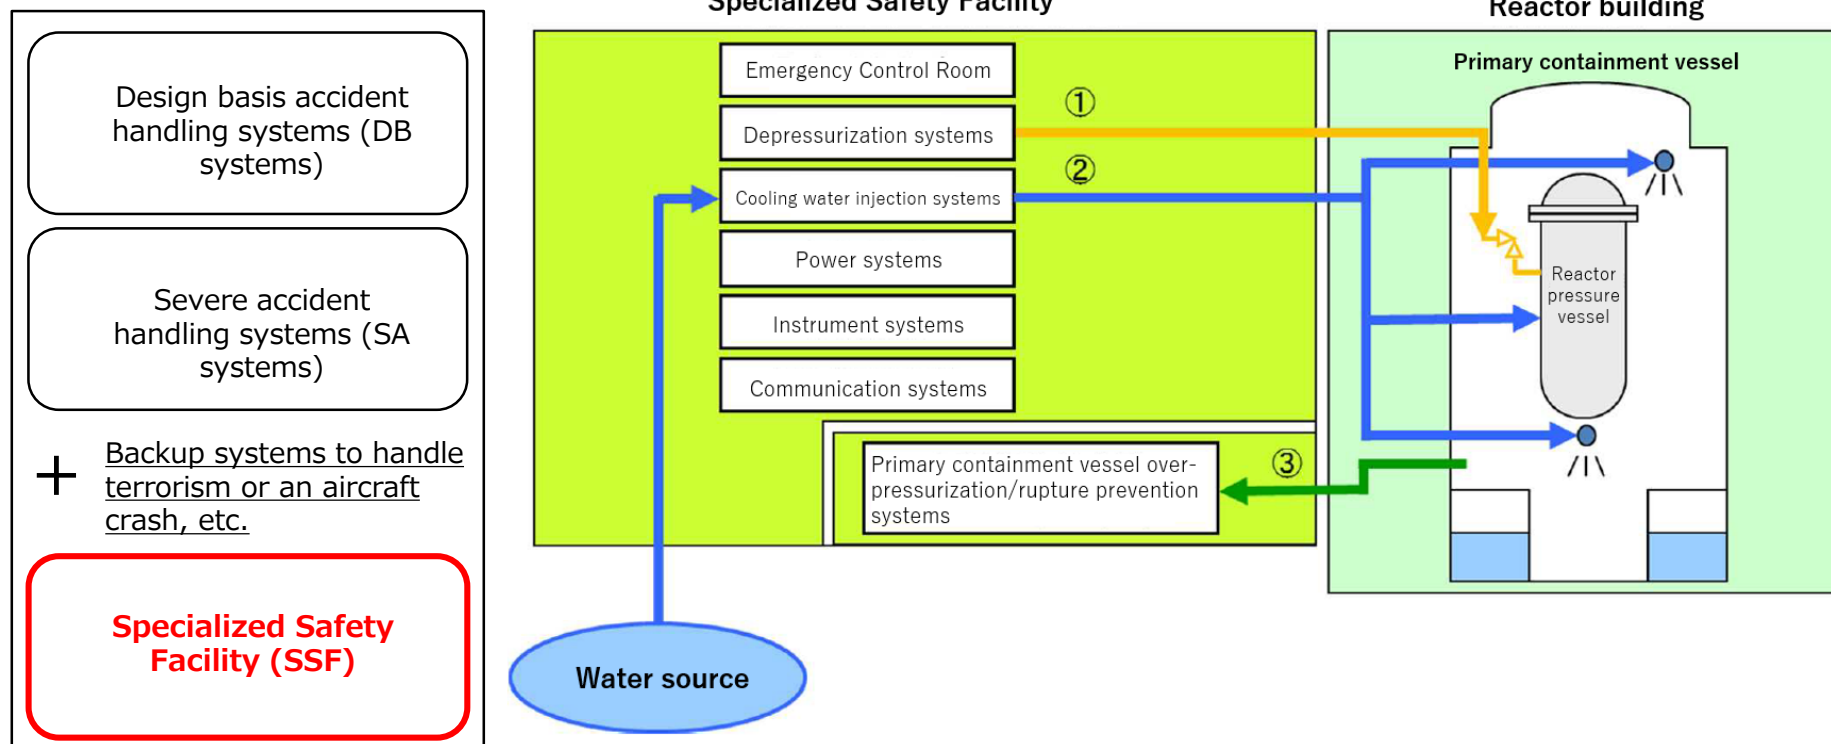
- Specialized Safety Facility (SSF) are backup systems used to prevent damage to the primary containment vessels in the event that facilities are rendered inoperable on a wide scale as a result of "widescale damage caused by the intentional crashing of an aircraft" into a power station
- The schedule is under detailed review but specifications are still being solidified so the anticipated completion dates of construction have been changed and the Nuclear Regulatory Agency notified

※ Unit 7: March 2025→August 2029; Unit 6: September 2026→September 2031
